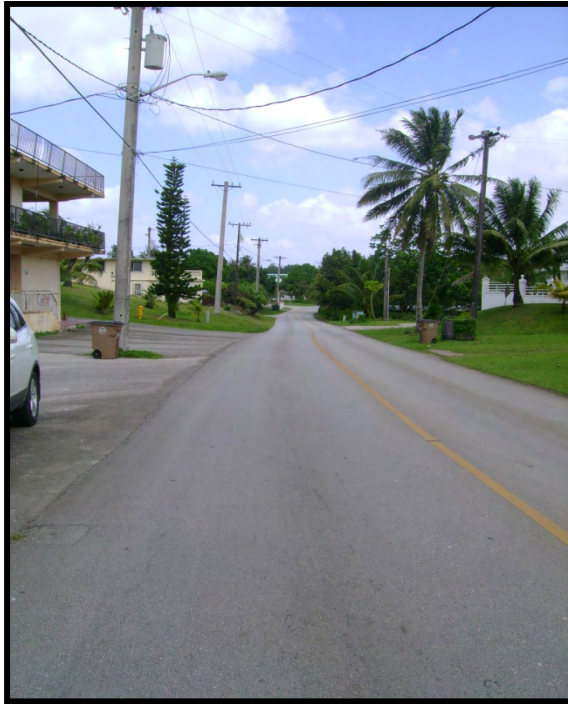
AG-101

LOCATION: San Vicente Solomon Drive & Francisco Javier Ave

MITIGATION TYPE: Storm Drain Improvements/ Treatment BMP Improvements

SITE ASSESSMENT: This is a ponding basin with dry wells. Ponding basin is undersized and more dry wells are needed. Surrounding home floods when basin overflows. High flows go to dry wells and low flows percolate. Much of Agana Heights runoff discharges to this basin.

RECOMMENDED IMPROVEMENTS Recommend placement of 6 new injection wells at this site along with an increase of the infiltration basin size by 5,000 square feet. This will accommodate the increase in capacity required to prevent flooding.

COST: \$2,360,000

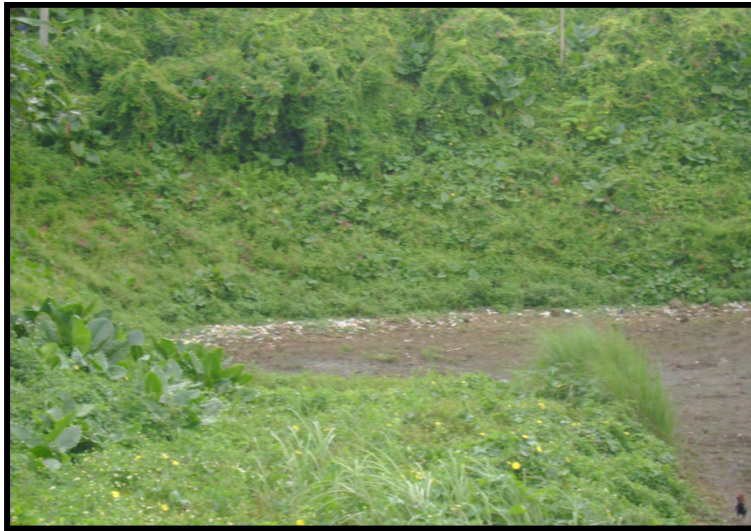
AG-102

LOCATION: Joseph Cruz Ave & As Kotla Court

MITIGATION TYPE: Storm Drain Improvements/ Treatment BMP Improvements

SITE ASSESSMENT: Along this street, there is no drainage system and there is flooding of homes at the low point of the street. Also upstream from the low point at 439 Joseph Cruz Ave, the home's backyard gets flooded.

RECOMMENDED IMPROVEMENTS To prevent further flooding of properties, two 200 linear foot infiltration basins are recommended for construction along the crowned street at its low point.

COST: \$70,100

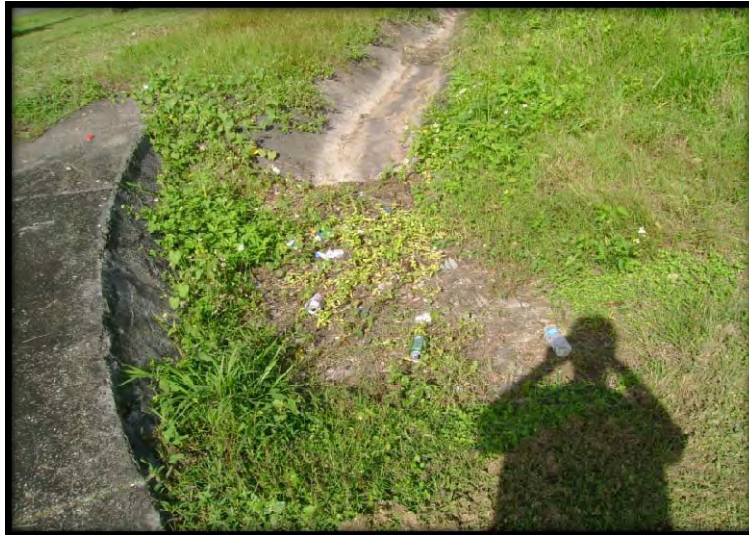
AS-103

LOCATION: RT 1 & Asan River Bridge

RECOMMENDED IMPROVEMENTS Recommend replacing the existing 8" DIP Water Main obstructing flow upstream of the existing bridge with a new 8" DIP Water Main (equipped with air release valve) connected to the bridge deck in order to move the water line out of the flow path and prevent excessive sediment and debris deposition upstream of the bridge.

COST: \$10,700

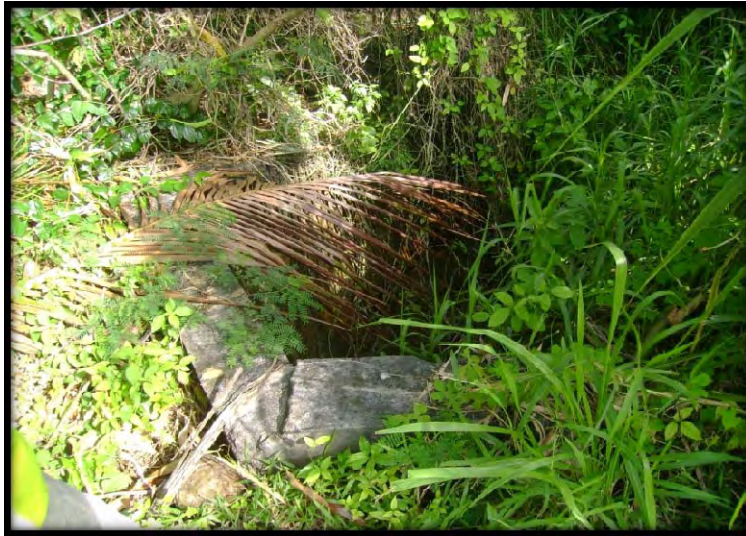
AS-104

LOCATION: RT 1 & Msgnr Jose A Leon Guerrero St

RECOMMENDED IMPROVEMENTS Improvements to the drainage conveyance system at this site are needed. There are three grated inlets located on this site, two of which are covered in debris. Recommend clearing debris and upsizing conveyance line (as per the Flood Control Document) to a 6'x4' RCB for 100 linear feet.

COST: \$167,000

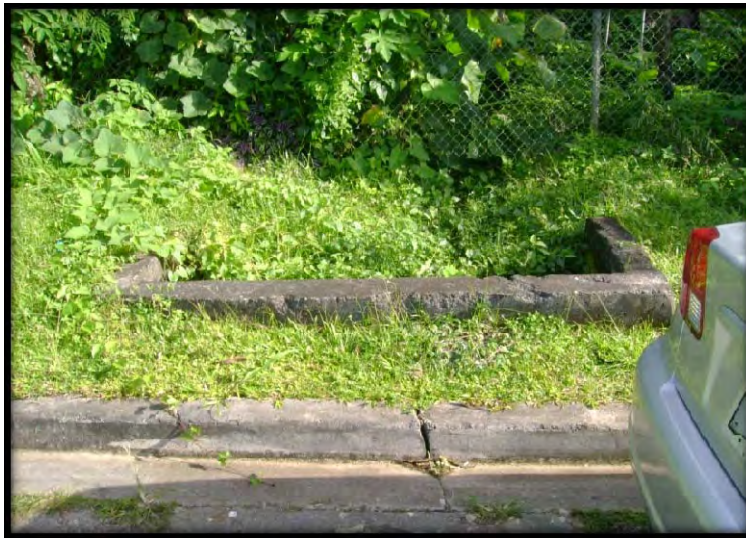
AS-107

LOCATION: West San Carlos Ct & Msgnr Jose A Leon Guerrero St

RECOMMENDED IMPROVEMENTS Improvements to the storm drain at this site are needed. The existing drainage system needs to be upsized to a 30" RCP conveyance system (per FCD) for 1,000 linear feet and two catch basins are proposed to eliminate existing street flooding issues.

COST: \$1,170,000

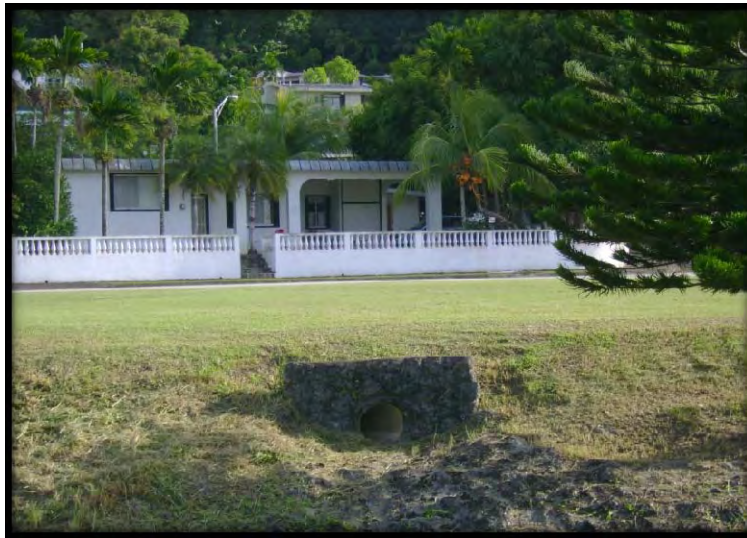
AS-108

LOCATION: Santa Ana St & Santa Ana Lane

RECOMMENDED IMPROVEMENTS The cross culvert at this site needs to be replaced with 100 linear feet of 3'x3' RCB equipped with headwalls upstream and downstream and 100 sq ft rip rap stabilization downstream of the culvert. Approximately one quarter acre of debris should be removed along the channel. Recommend placement of hydromulch w/ a bonded fiber matrix over approximately 1 acre of the adjacent hillside.

COST: \$170,000

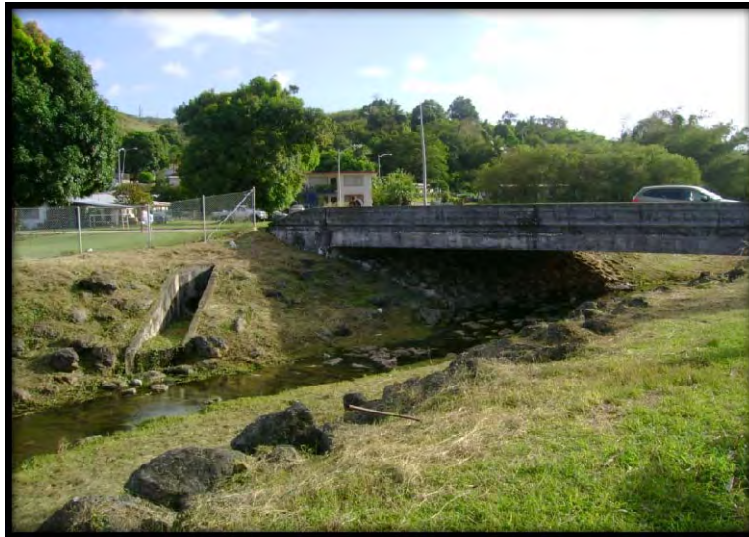
AS-109

LOCATION: Sen Juan Tim Tovas St & Msgnr Jose A Leon Guerrero St

RECOMMENDED IMPROVEMENTS The cross culvert at this site needs to be replaced with 100 linear feet of 3'x3' RCB equipped with downstream headwall and 100 sq ft rip rap stabilization downstream of the culvert. Approximately one quarter acre of debris should be removed along the channel.

COST: \$87,000

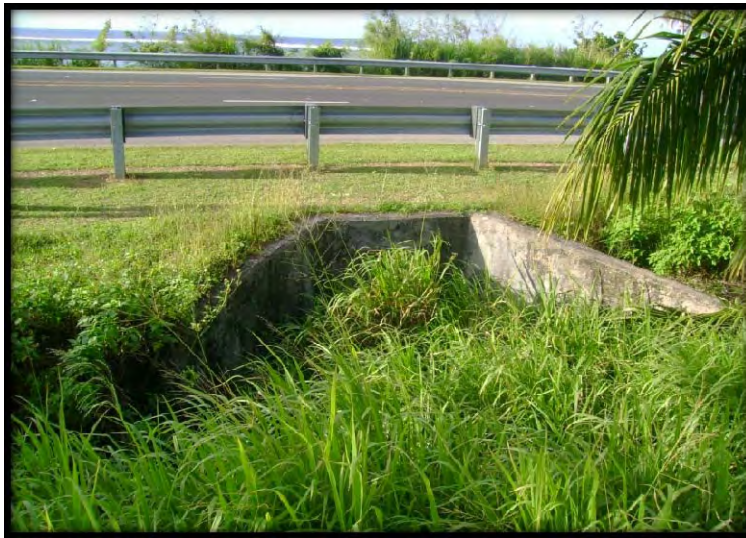
AS-110

LOCATION:	Msgnr Jose A Leon Guerrero St & Asan River
MITIGATION TYPE:	Conveyance Improvements
SITE ASSESSMENT:	There is 30" RCP culvert outletting to the Asan river, just north of the Asan River bridge over Msgnr Jose A Leon Guerrero st. This culvert and headwall are in good shape, and there are no signs of erosion around outlet, needs to be replaced with a 3'x3' RCB. The existing 30" RCP is undersized.
RECOMMENDED IMPROVEMENTS	The culvert at this site needs to be replaced with a 3'x3' RCB for 200 linear feet equipped with upstream and downstream headwall structures outletting flow to a 100 square foot rip rap energy dissipator.
COST:	\$156,000

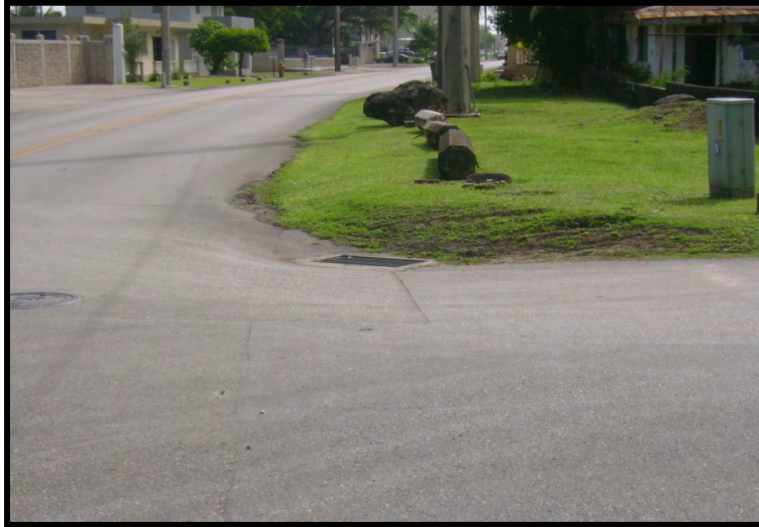
HA-102

LOCATION: RT 4 & RT 7B

RECOMMENDED IMPROVEMENTS To prevent further silt buildup and ponding at this site, recommend replacement of existing cross-culvert under Rte 4 with a 200'x4'x4' RCB equipped with upstream headwall and 100 SF rip rap for channel stabilization.

COST: \$245,000

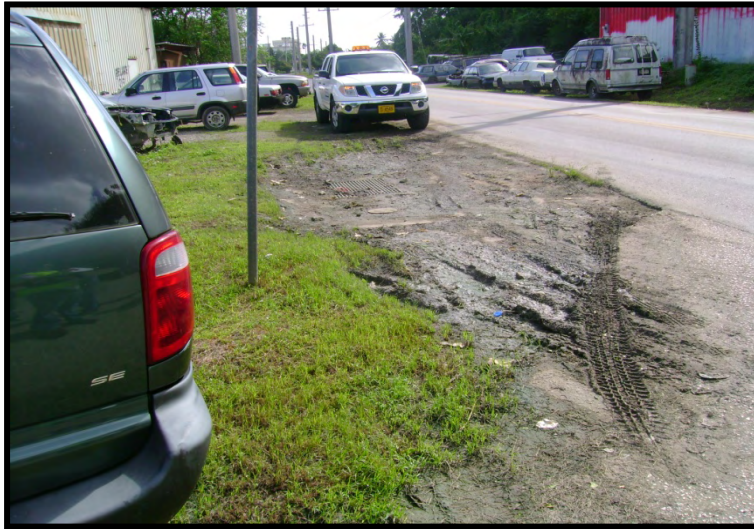
HA-103

LOCATION: RT 7A & 6th St

RECOMMENDED IMPROVEMENTS Recommend storm drain improvements at the intersection of Route 7A and 6th St consisting of 2-100' long bioswales placed adjacent to the roadways, routing surface flow to 2 new catch basins located at the intersection. Note that the 2 bioswales are being proposed since this area is considered a "hotspot". Connect the 2 new catch basins to a new storm drain pipeline in Route 7A routing flow to the Hagatna River via 1000-ft of 30" RCP. There are a total of 6 dry wells which, according to DPW, need to be abandoned and the site.

COST: \$1,240,000

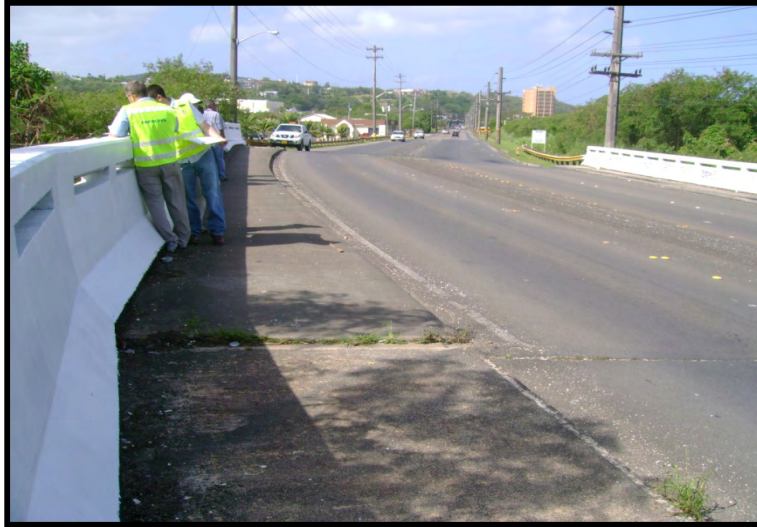
HA-106

LOCATION: RT 7A & O'Brien Drive

RECOMMENDED IMPROVEMENTS The drainage system that currently runs along Route 7A needs to be upsized. Recommend placement of 4,000 linear feet of a 48" RCP outleting to a new headwall/wingwall structure and a 100 square foot energy dissipator.

COST: \$5,100,000

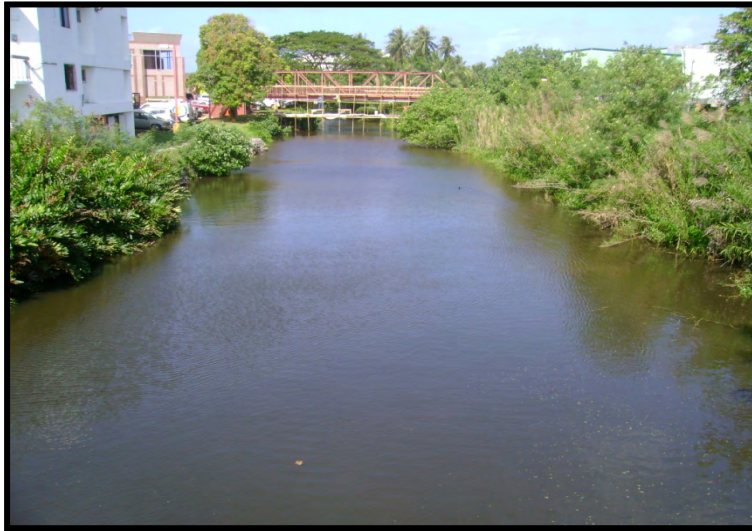
HA-107

LOCATION: RT 7A & Minondo Bridge

RECOMMENDED IMPROVEMENTS To prevent further undermining at the approach slabs, four new wingwall structures at the abutment are needed and a 400 square foot rip rap energy dissipator is needed.

COST: \$90,300

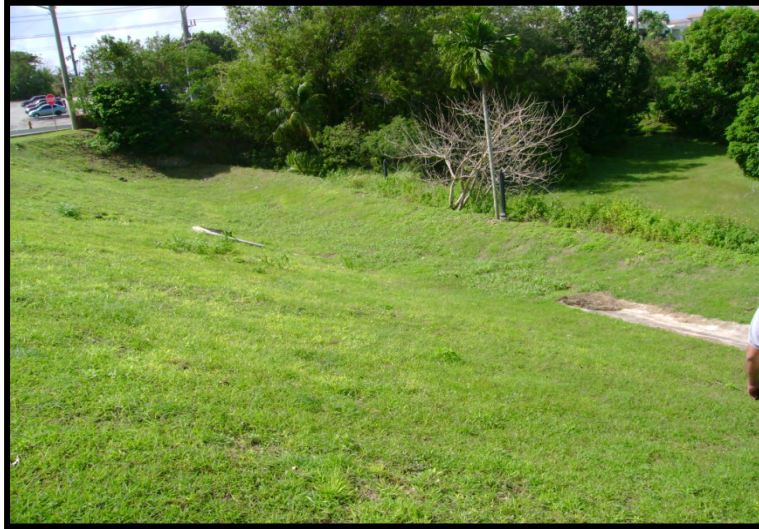
HA-108

LOCATION: Chalan Santo Papa Juan Pablo Dos & Agana River Bridge

RECOMMENDED IMPROVEMENTS Recommend placement of a drainage conveyance system along Ch Santo Papa Juan Pablo Dos to capture the runoff (prior to it going through the private properties) and route to Hagatna River including 100'x24" RCP with headwall/wingwall structure. Also recommend one acre of debris removal upstream and downstream of bridge.

COST: \$119,000

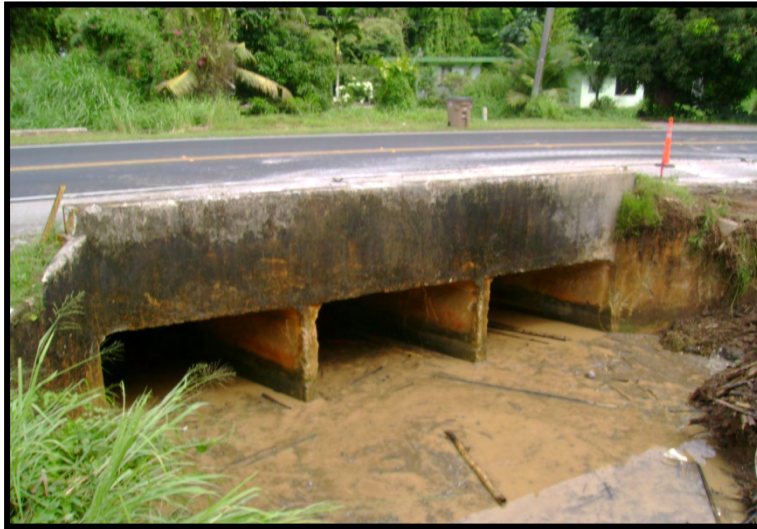
HA-109

LOCATION: RT 7 & RT 33

RECOMMENDED IMPROVEMENTS The present infiltration gallery above Route 7A does not have enough capacity to handle all the runoff it receives. Need to expand infiltration basin by 5,000 square feet (50'x100') and add 6 injection wells within the basin.

COST: \$2,360,000

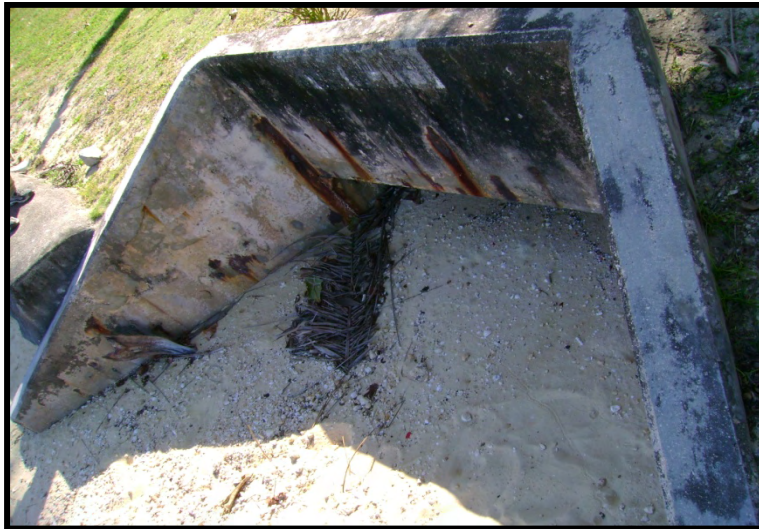
HA-111

LOCATION: RT 1 & East Hagatna Beach

RECOMMENDED IMPROVEMENTS To prevent further erosion of the shoreline and clogging of the outlet, a new headwall/wingwall structure with 100 square feet of rip rap outlet pad is recommended at downstream side of culvert.

COST: \$31,100
