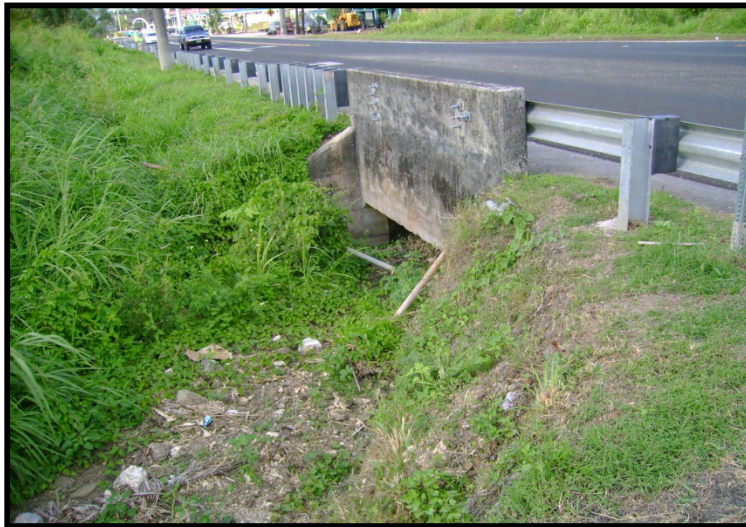
AG-104

LOCATION: RT 6 & RT 7

MITIGATION TYPE: Conveyance Improvements/ Conveyance Maintenance

RECOMMENDED IMPROVEMENTS Erosion control and maintenance is needed at this site. Remove one acre of debris removal including some sediment removal to promote drainage and place 500 square feet of rip rap for channel stabilization for a distance of 25 feet upstream and 25 feet downstream of the existing culvert. Place headwall/wingwall structures on upstream and downstream sides of culvert.

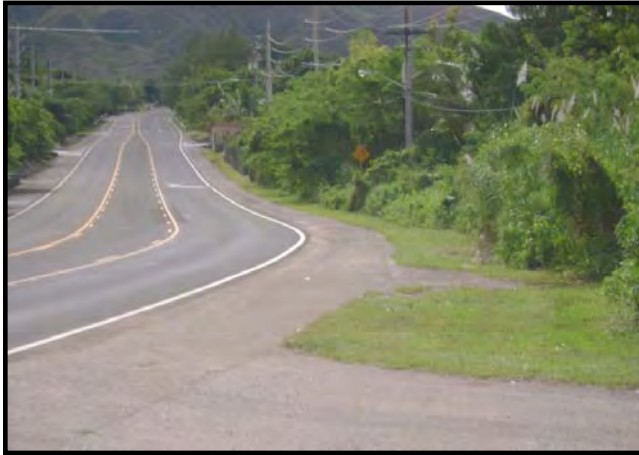
AV-101

LOCATION: RT 2 & Chalan Josen Milagro

RECOMMENDED IMPROVEMENTS: A storm drain system is needed to collect and convey street runoff from Rte 2 at Chalan Josen Milagros to the Talefac River. Propose installation of approximately 1250' of dual 3'x5' RCB along the west side of Rte 2, conveying flow the river. Propose a headwall/wingwall structure equipped with 100 SF rip rap energy dissipator at outlet to the river. Propose 1200 ft ditch along Rte 2 outleting to catch basins (2 total) connected to proposed RCB below. Recommend 1/4 Ac debris removal at Chalan Josen Milagros and Rte 2. Recommend placement of drainage ditch to route flow with Chalan Josen Milagros Development to shoreline (approximately 800 feet long).

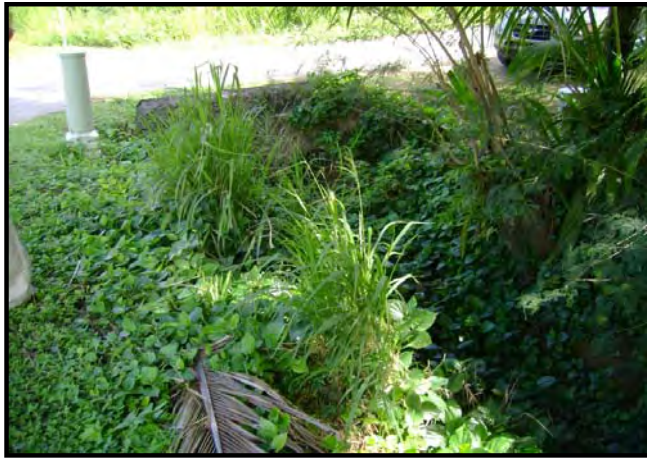
AV-102

LOCATION: RT 2 & Tun Ramon Chele Rd

RECOMMENDED IMPROVEMENTS: Recommend placement of 1,000 square feet of rip rap channel stabilization along channel embankments for a distance of 50-ft upstream of double 36" cross culvert located at Tun Ramon Chele Rd to stabilize the channel upstream of culvert.

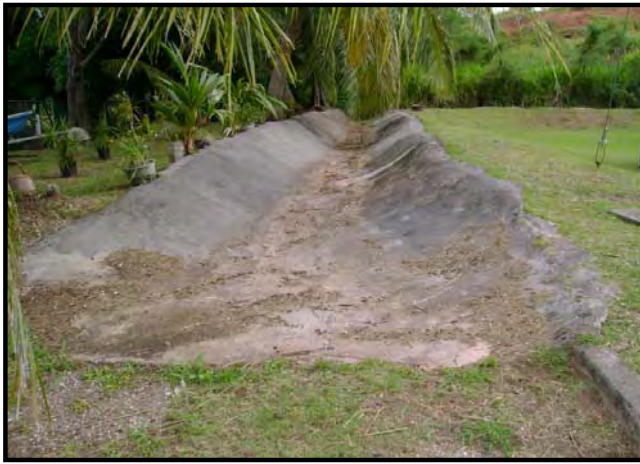
AV-104

LOCATION: Pagachao Dr & Kalachucha St

RECOMMENDED IMPROVEMENTS: Recommend placement of hydroseed and bonded fiber matrix over 1 acre of hillside where soil is exposed to prevent further erosion.

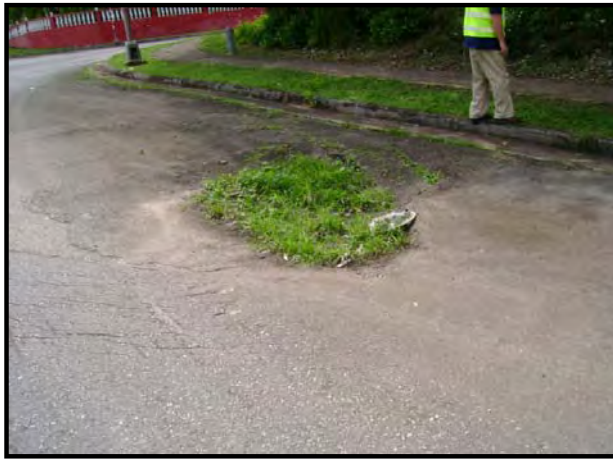
AV-105

SITE ASSESSMENT: There is a sinkhole along Pagacho Dr just west of Mike Cruz St. The sinkhole location is in line with a sewer line. The broken sewer line needs to be fixed to stop undermining of the street.

RECOMMENDED IMPROVEMENTS: There is a broken sewer line on this site that needs to be fixed to stop the undermining of the roadway. One new sewer manhole and the placement of a 24" RCP for 20 linear feet will be needed to stop the undermining.

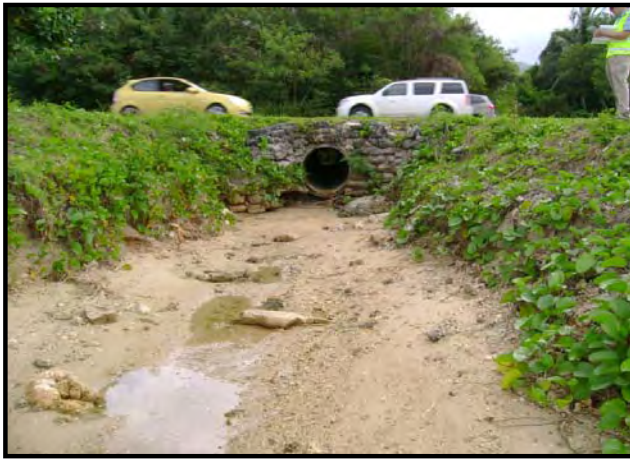
AV-107

LOCATION: RT 2 & north of Chalan Lada

RECOMMENDED IMPROVEMENTS: Maintenance and improvements are needed for the drainage conveyance system at this site. A quarter acre of debris removal is needed (both upstream and downstream) along with placement of headwall/ wingwall structures and a 100 SF rip rap energy dissipator placed upstream and downstream of the culvert.

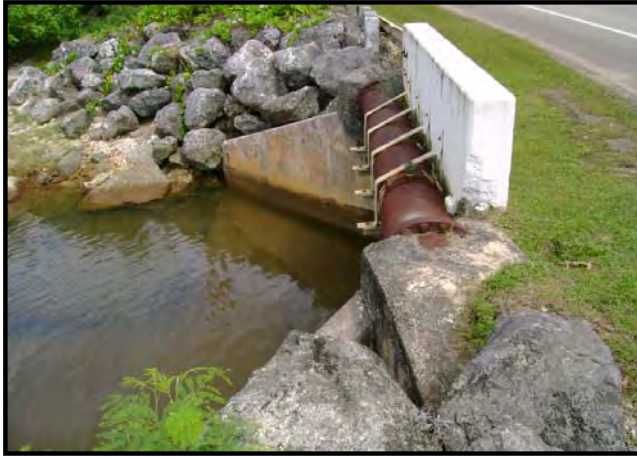
AV-108

SITE ASSESSMENT: A 11'x3.5' RCB routes Chaligan Creek across Route 2. There is erosion around the wingwalls; need to add erosion stabilization (riprap). Downstream, the existing concrete channel slab is being undermined, and needs to be repaired, and a cutoff wall needs to be added along with riprap.

RECOMMENDED IMPROVEMENTS Erosion control and maintenance to the drainage conveyance system are needed at this site. A quarter acre of debris removal is needed both upstream and downstream of the culvert. Approximately 50 sq feet of rip rap should be placed along the upstream wingwalls to prevent further undermining. Approximately 50 sq feet of grouted rip rap should be placed along the bottom and toe of slope of the downstream side of the culvert to prevent further undermining of the bottom slab.

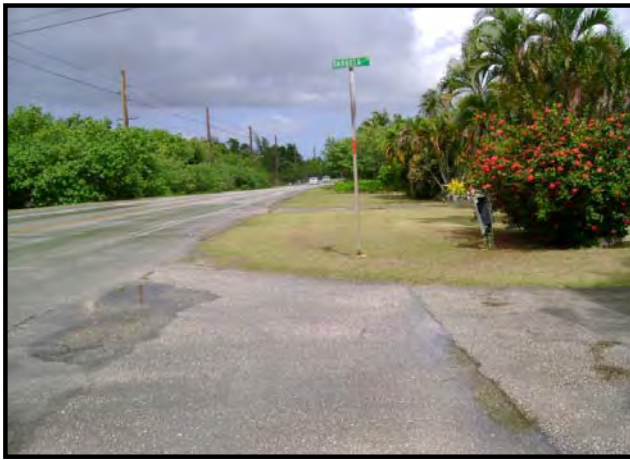
AV-109

LOCATION: RT 2 & Babauta Rd

RECOMMENDED IMPROVEMENTS: A storm drain system is needed to collect and convey street runoff from Rte 2 at Babauta under Rte 2. Propose 100' bioswale placed adjacent to Rte 2, conveying flow to a low point along Rte 2 where a grated catch basin will intercept the treated runoff and outlet it through approximately 100 feet of 24" RCP placed across Rte 2, outletting to a headwall/wingwall structure equipped with a 100 sq ft rip rap energy dissipator located along the shoreline.

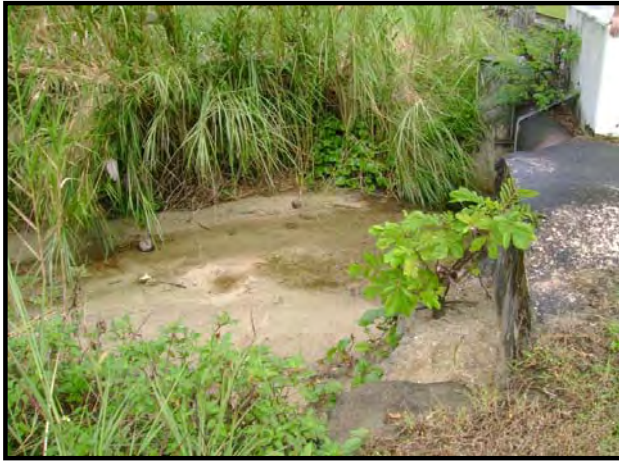
AV-110

LOCATION: RT 2 & Auau Creek

RECOMMENDED IMPROVEMENTS Recommend a quarter acre of debris removal, 1000 square feet of rip rap channel stabilization placed a distance of 50 feet downstream of the culvert and 400 cubic yards of dredging for a distance of 50 ft downstream of the culvert.

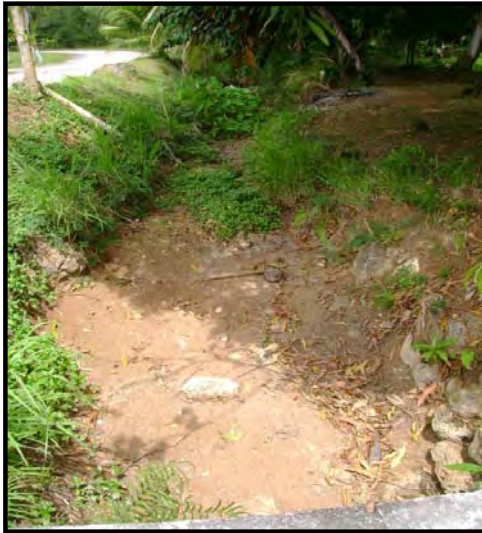
AV-112

LOCATION: Finile Dr

RECOMMENDED IMPROVEMENTS: Erosion control and maintenance to the drainage conveyance system are needed at this site (Finile Drive and Rte 2). A quarter acre of debris removal is needed along with placement of 1000 square foot rip rap embankment stabilization for a distance of 50-ft upstream of culvert and placement of a 100-ftx12-inch concrete encasement of an existing sewer line located at the upstream side of the culvert

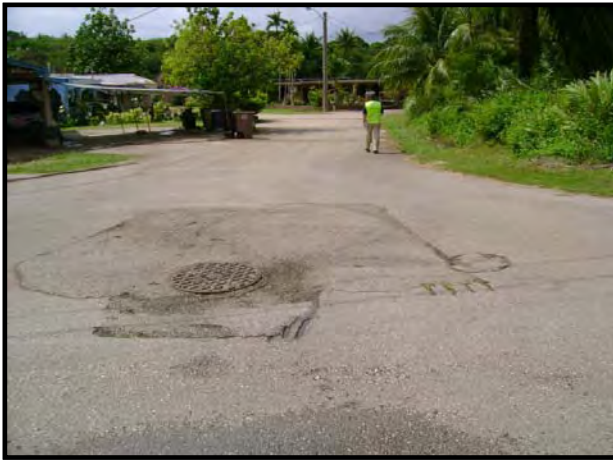
AV-113

LOCATION: Orong Circle & Finile Dr

RECOMMENDED IMPROVEMENTS Recommend improvements to the existing storm drain system along Orong Circle to stop flooding in street. The drainage system should include approximately 200 LF of ditch located adjacent to the road, routing flow to 2 grated catch basins located at the low points in the road, connecting to 100'x18" RCP that will route flow adjacent to a private residence to the natural flow path located behind the residence (an easement will most likely be required for the 18" RCP). Also recommend one quarter acre debris removal downstream of the 18" RCP outlet and placement of headwall/wingwall structure with 100 SF rip rap energy dissipator placed at the outlet of the storm drain.

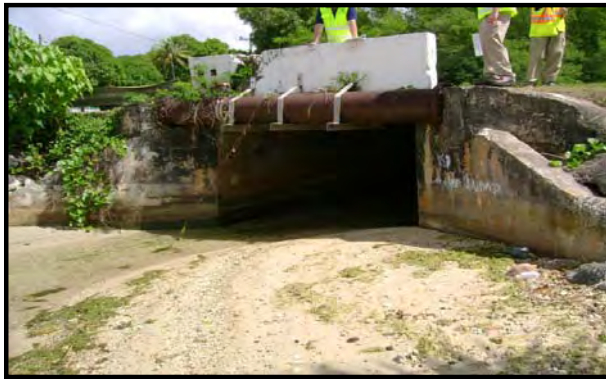
AV-114

SITE ASSESSMENT: A 10'x8' RCB routes Finile Creek under Rt2. The upstream and downstream headwall and wingwalls need to be replaced. Sediment and debris need to be removed upstream. Stabilization (riprap) of the embankment and roadway along Route 2 both in the upstream channels and the downstream channels are needed. A lateral 24" RCP culverts runs under Finile Dr and discharges to Finile Creek, this culvert needs the removal of debris and sediment and the addition of headwalls.

RECOMMENDED IMPROVEMENTS: Recommend placement of 2,000 square feet of rip rap channel stabilization along Finile Creek channel embankment for a distance of 50-ft upstream and downstream of cross culvert located at Rte 2 to stabilize the channel embankment. Also recommend placement of new headwall/ wingwall structures at both ends of Finile Creek Culvert under Rte 2 and for adjacent 24" RCP lateral running along Finile Drive.

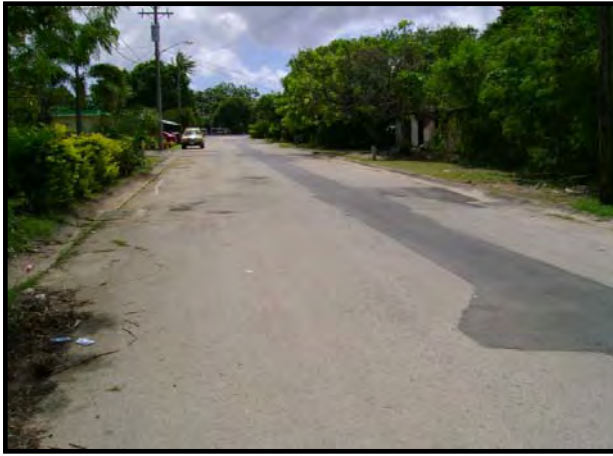
AV-115

SITE ASSESSMENT: A drainage conveyance system along the street is not working properly and street floods. Need to depress existing grated inlets and replace existing gutters with wider gutters.

RECOMMENDED IMPROVEMENTS Recommend improvements to the existing storm drain system along Tomas Mesa Street to stop flooding in street. The drainage system should include concrete ditches adjacent to the road (4 ditches at 100-ft length) routing flow to new grated catch basins at the low point of the 2 sides of the crowned road. The grated catch basins should connect to a 100-ft x 24" RCP storm drain that will route the flow to the Finile Creek. Place a headwall structure equipped with 100 SF rip rap energy dissipator at outlet to river. May require easement to route flow to Finile Creek.

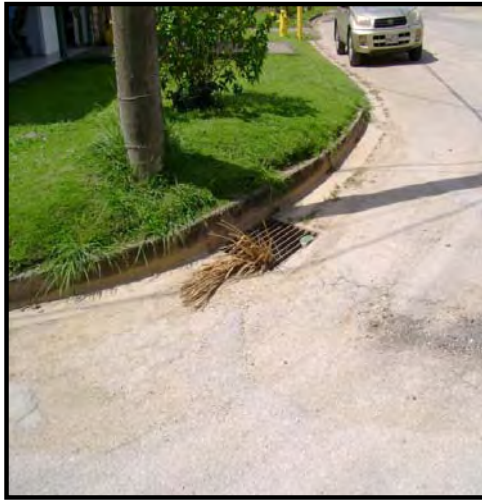
AV-116

LOCATION: San Vicente Ave & San Roque St

RECOMMENDED IMPROVEMENTS Recommend improvements to the existing storm drain system at this intersection to stop flooding in street. Recommend adding 4-100-ft ditches routing flow to 2 and 2 existing catch basins. Connect the new catch basins with the existing catch basins via 100-ft of 24" RCP.

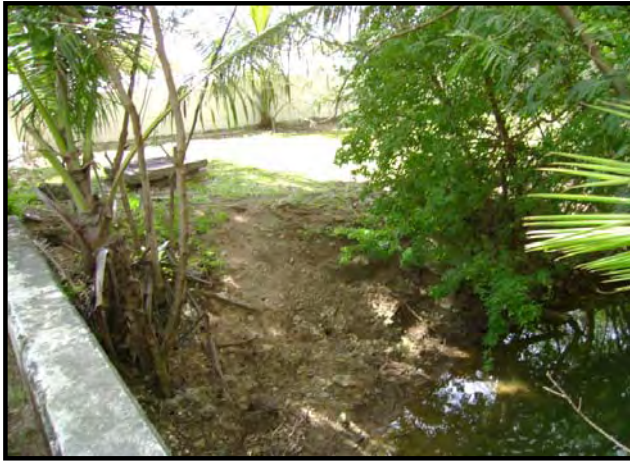
AV-117

LOCATION: RT 2 & Salinas River

RECOMMENDED IMPROVEMENTS: The downstream channel at this site needs stabilization for the embankment and removal of debris/sediment. Recommend a quarter acre of debris removal and the placement of 1,000 square feet of rip rap channel stabilization for a distance of 50-ft downstream of the culvert routing Salinas River under Rte 2.

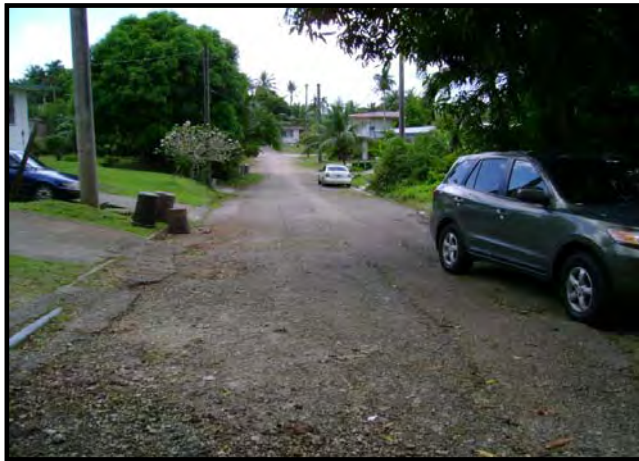
AV-118

LOCATION: Erskin Dr

RECOMMENDED IMPROVEMENTS Recommend storm drain improvements along Erskin Drive from Commissioner Charfauros Ct to Bruce St including: 1) placement of a concrete ditch along south side of Erskin for a distance of 2500 feet, 2) placement of 50'x24" RCP cross culverts at each intersection (6 total equipped with headwalls) to route flow from conc ditch to channel located on opposite side of Erskin, 3) addition of 2 catch basins connecting to 100'x24" RCP storm drain at Commissioner Charfauros Ct routed to conc channel located on north side of Erskin.

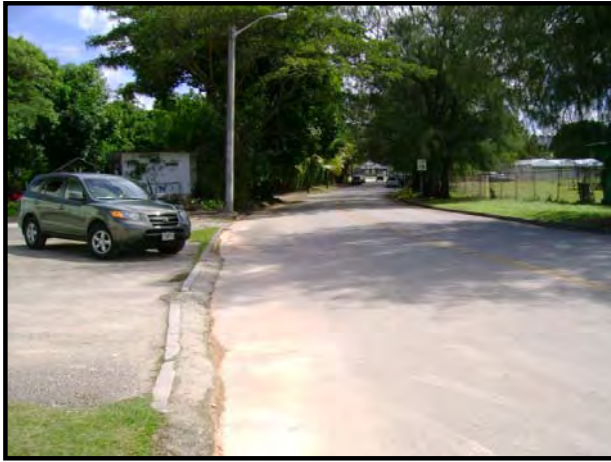
AV-119

LOCATION: Father Follard St & Bruce St

RECOMMENDED IMPROVEMENTS Recommend improvements to the existing storm drain system at this intersection to stop flooding in street. Recommend placing new catch basin on north and south corners of Father Follard and Bruce St connecting to 100'x24" RCP to exist catch basin on south corner of Father Follard and Rte 2. Place 400-ft ditch adjacent to street to convey flow to new catch basins. Also recommend one quarter acre debris removal and placement of 1000 SF rip rap at outlet of system, downstream of Rte 2.

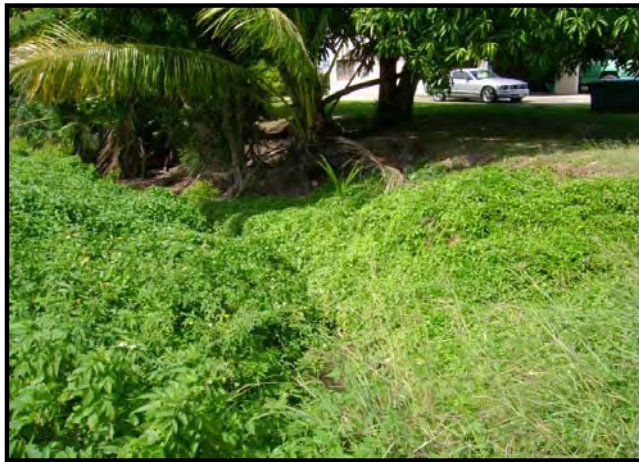
AV-120

LOCATION: RT 2 & Father Follard St

RECOMMENDED IMPROVEMENTS Recommend improving the drainage system along Father Follard Drive by replacing the undersized catch basin with 2 new catch basins connected by approximately 100 feet of 24" RCP and adding approximately 100' of ditch adjacent to road on both sides of the 2 new catch basins. The new system will connect to the existing cross-culvert under Rte 2. A quarter acre of debris removal downstream of this culvert is needed (in the downstream channel). Also recommend placement of 1000 SF of rip rap along the embankments of the downstream channel for a distance of approximately 50 feet.

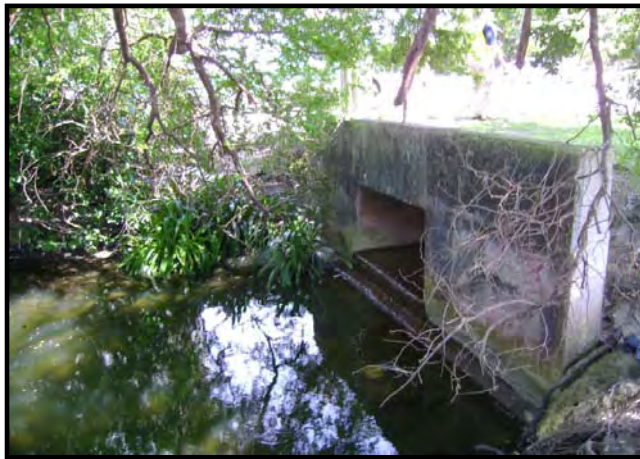
AV-121

LOCATION: RT 2 & Erskin Dr

RECOMMENDED IMPROVEMENTS Recommend improvements to the existing drainage conveyance system located mainly on the west side of Rte 2 (downstream side of 6'x3' culvert at this site). Recommendations include: 1) placement of a new headwall/wingwall structure with 100 SF rip rap energy dissipator at the downstream side of the 6'x3' culvert, 2) placement of 1000' concrete ditch along west side of Route 2 (north of channel) outletting to a grated catch basin located upstream of Elite Bakery - catch basin to connect to 50' of 24" RCP routing flow southward to new headwall/wingwall structure at channel, and 3) placement of 400 ft long ditch located along west side of Route 2, south of channel, outletting to a grated catch basin that connects to 50' of 24" RCP storm drain conveying flow northward to headwall/wingwall structure proposed in channel.

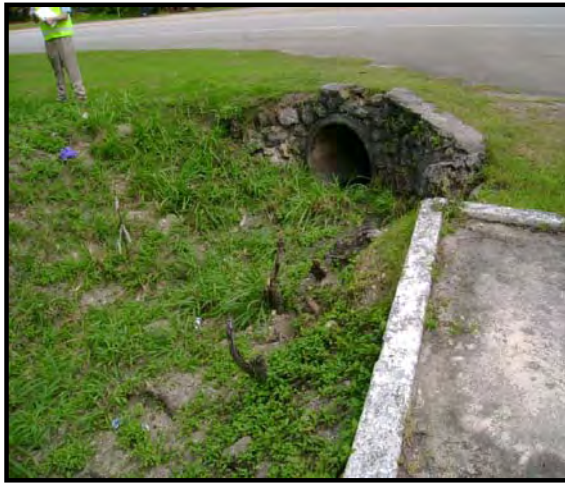
AV-122

SITE ASSESSMENT: A 36" RCP cross culvert runs under Route 2. The upstream and downstream headwalls and wingwalls need to be replace. Vegetation and debris need to be removed in the upstream channel. Add embankment stabilization(riprap) along downstream channel. A lateral 24" RCP culvert discharges to the upstream channel to the 36" cross culvert, the upstream channel to the 24" RCP needs embankment stabilization(riprap).

RECOMMENDED IMPROVEMENTS The upstream and downstream headwall/wingwall structures on this site need to be replaced and erosion control is needed. Recommend placement of 2,000 square feet of rip rap channel stabilization along channel embankments for a distance of 50-ft upstream and downstream of 36" cross culvert located at Rte 2 to stabilize the channel embankment. Also recommend placement of new headwall/ wingwall structures at both ends of culvert along with a quarter acre of debris removal within channel.

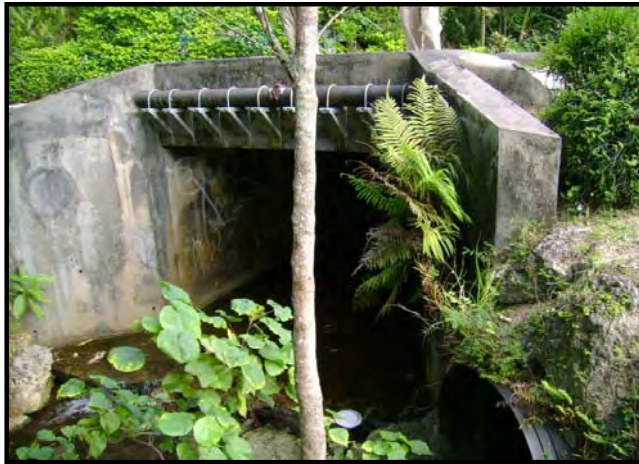
AV-124

SITE ASSESSMENT: The Togcha River crosses the R R Cruz St at two locations where two 10'x10' RCB culverts route the river flow. At the upstream RCB, the downstream headwall has cracks and pieces of the structure are falling apart - the headwall and wingwalls need to be repaired or replaced. At the same location, a 60" HDPE lateral culvert needs a headwall. At both RCB locations, the river needs debris/sediment/vegetation removal and embankment stabilization.

RECOMMENDED IMPROVEMENTS Recommend placement of new headwall/wingwall structures on the upstream and downstream sides of the 2 culverts located at the 2 crossings of the Togcha River. Recommend placing the 60" HDPE lateral through the wingwall of the upstream culvert. Also recommend removal of one quarter acre of debris throughout and placement of 1,000 square feet of rip rap channel stabilization (for a distance of 10 feet upstream and downstream of each culvert).

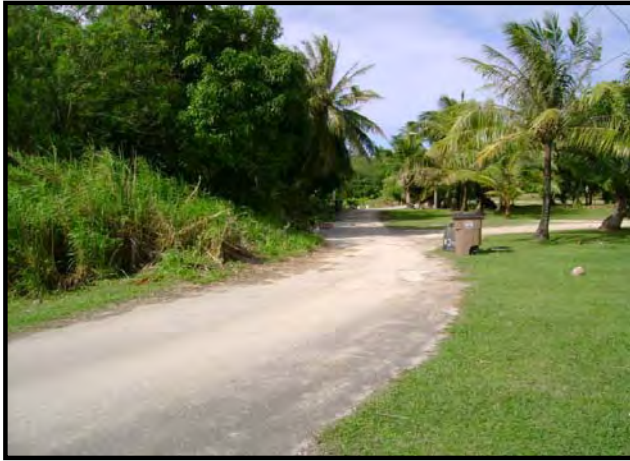
AV-125

LOCATION:	Salinas Rd
MITIGATION TYPE:	Storm Drain Improvements/ Storm Drain Maintenance/ Treatment BMP Improvements
SITE ASSESSMENT:	Along Salinas Rd there are about four homes that flood due to debris accumulation and overgrown vegetation next to the road. Remove debris and vegetation, add swales and culverts along the road, and route the runoff to the Togcha river.
RECOMMENDED IMPROVEMENTS	Recommend addition of a storm drain system along Salinas Road to stop flooding of homes. The drainage system should include swales adjacent to the road (2 bioswales at 50-ft length) routing flow to a catch basin at the low point in the road. The grated catch basin should connect to a 100-ft x 24" RCP storm drain that will route the flow to the Togcha River (at Salinas and Baubata intersection). Place a headwall/wingwall structure equipped with 100 SF rip rap energy dissipator at outlet to river.
COST:	\$134,000

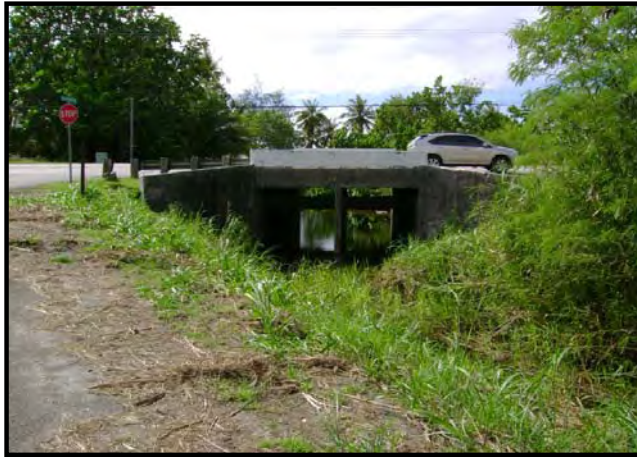
AV-126

LOCATION: RT 2 & Togcha River

RECOMMENDED IMPROVEMENTS Maintenance and improvements to the drainage conveyance system is needed at this site. A quarter acre of debris removal will be needed, 1,000 square feet of rip rap channel stabilization 30 linear feet of concrete encasement, and two new headwall/wingwall structures will be needed.

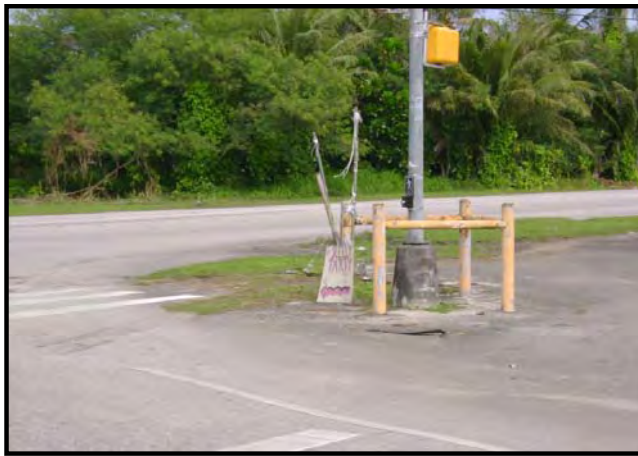
AV-127

LOCATION: RT 2 & RT 12

RECOMMENDED IMPROVEMENTS Recommend addition of a drainage conveyance system at Rte 2 and Rte 12 to eliminate roadside ponding. The drainage system should include ditches adjacent to the road (totaling 400-ft length) routing flow to 2 catch basins connecting to 200 LF of 24" RCP storm drain equipped with a headwall/wingwall structure with 100 SF rip rap energy dissipator at the outlet. The flow will be routed to the Togcha River.

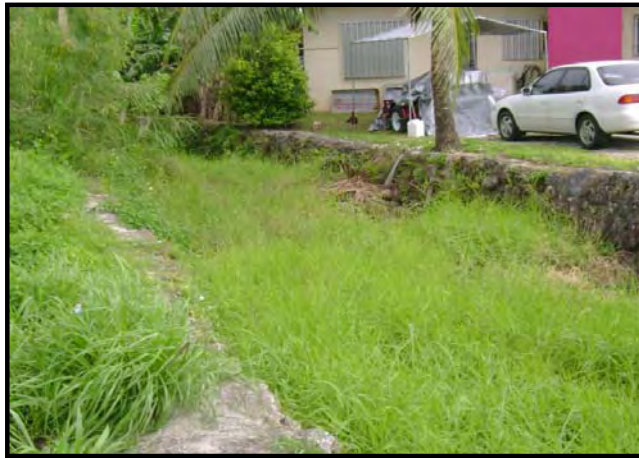
AV-128

LOCATION: RT 2 & north of RT 12

RECOMMENDED IMPROVEMENTS To minimize flooding of adjacent properties, a 2-ft high berm (5 ft wide) is recommended along both embankments of the channel on the upstream side of the culvert for a distance of approximately 100 feet. Remove one quarter acre of debris (on upstream and downstream sides of culvert). Place 500 square feet of rip rap for berm at the top of embankment on both sides of channel. Replace existing headwall on upstream culvert with taller headwall/ wingwall structure.

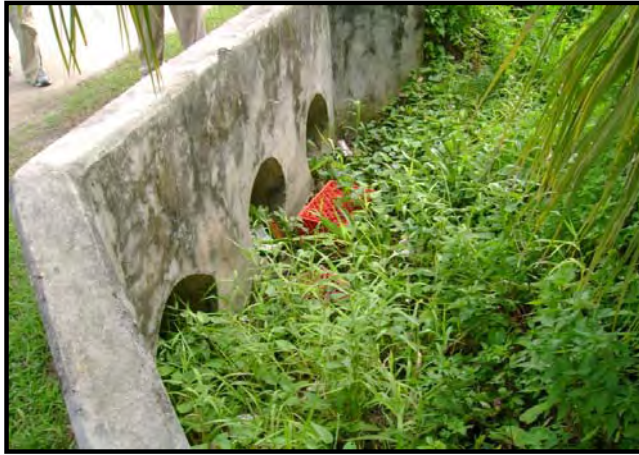
AV-129

LOCATION:	north Perino St
MITIGATION TYPE:	Storm Drain Improvements/ Storm Drain Maintenance / Conveyance Maintenance
SITE ASSESSMENT:	At the north end of Perino St there are 3-24" RCP cross culverts that run under the street. Both the upstream and downstream channels are covered with trash/debris/vegetation that need to be removed.. Add swales along Perino and route them to the cross culvert to prevent flooding of the street
RECOMMENDED IMPROVEMENTS	Recommend improvements to the existing storm drain system along Perino to stop flooding in street. The drainage system should include concrete ditches or swales adjacent to each side of the crowned road (2 ditches at 1000-ft length) routing flow to the triple 24" RCP culvert crossing Perino Street. Also recommend debris removal upstream and downstream of the culvert and placement of a 100 SF rip rap energy dissipator at culvert inlet and outlet.

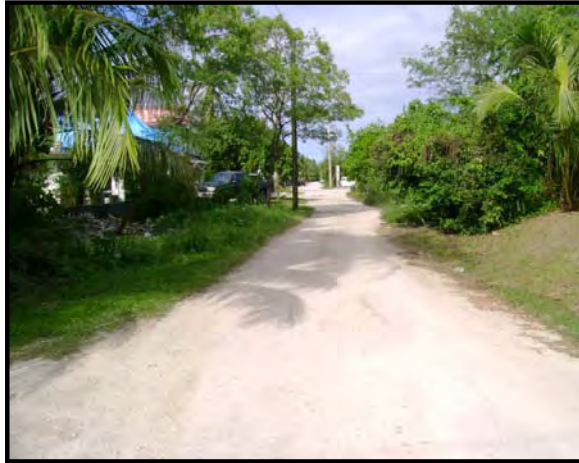
AV-130

LOCATION: south Perino st

RECOMMENDED IMPROVEMENTS A drainage conveyance system is needed along Perino Street that will route the street runoff to the proposed drainage conveyance system at the intersection of Route 12 and Route 2. Recommend placement of two catch basins placed at this street's low point connecting to a 24" RCP for 200 linear feet that routes the flow to the system at Rte 2 and Rte 12. Also a quarter acre of debris removal is needed at this site.

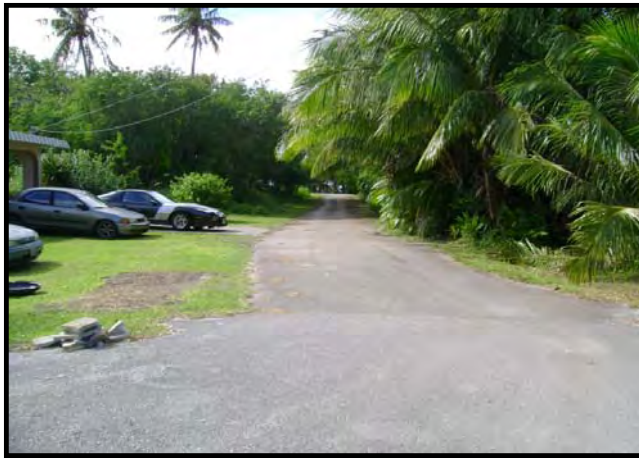
AV-131

LOCATION: Tun Leon Rd

RECOMMENDED IMPROVEMENTS Recommend addition of a drainage conveyance system along Tun Leon Road to stop flooding of homes. The drainage system should include swales adjacent to the road (2 bioswales at 100-ft length) routing flow to the south to a culvert conveyance system consisting of 300' x 24" RCP equipped with 2 headwall/wingwall structures outleting to a 100-ft rip rap energy dissipator at the Gaan River embankment. One quarter AC of debris removal will also be required.

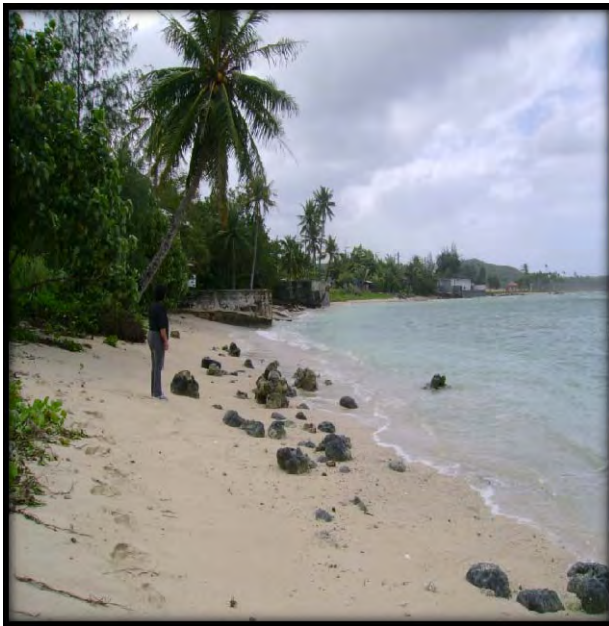
AS-102

SITE ASSESSMENT: There is significant costal erosion from Masso River(south) to Fonte River (north). There still some home foundations left along the coastline.

RECOMMENDED IMPROVEMENTS To prevent further shoreline erosion, placement of 50,000 square feet of rip rap coastal stabilization (approximately 10-ft in width along the shoreline) from the Fonte River outlet to the Asan River outlet (approximately 5000 feet) is recommended.

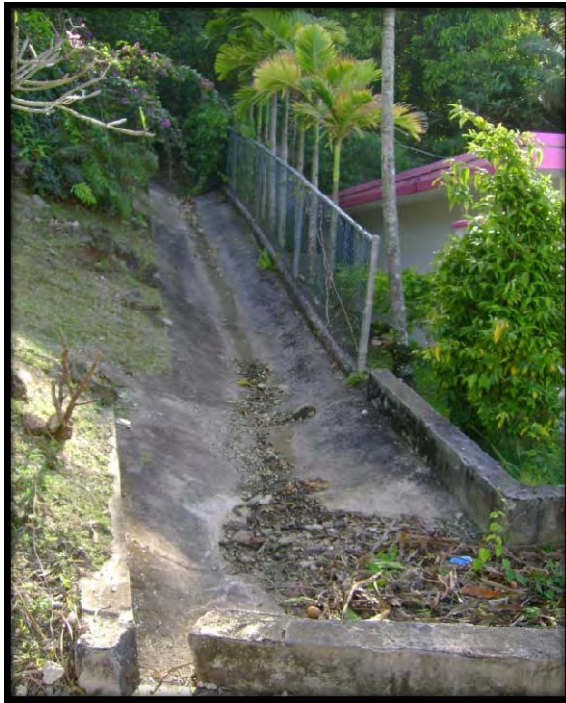
AS-106

SITE ASSESSMENT: A concrete lined channel discharges to an inlet located behind the sidewalk and this inlet discharges to a double grated inlet on the street. There is significant debris and sediment from hillside, the receiving inlet is clogged. Erosion control is needed upstream. As per the Flood Control Document, the connecting storm drain needs to be replaced with a 100'x24" RCP.

RECOMMENDED IMPROVEMENTS: Erosion control, maintenance and improvements to the storm drain system are needed at this site. A quarter acre of debris removal and placement of one acre of hydromulch with bonded fiber matrix is recommended along the hillside to eliminate further sedimentation and clogging of the downstream inlet. As per the Flood Control Document, the connecting storm drain needs to be replaced with a 100'x24" RCP.

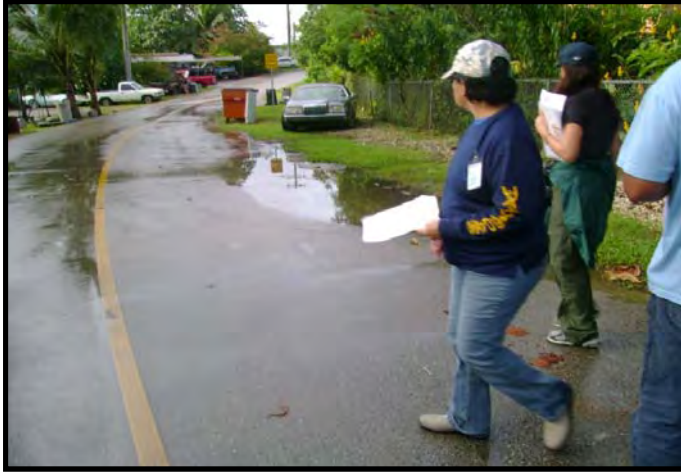
BV-101

SITE ASSESSMENT: Runoff floods one property, existing infiltration trench can't handle volume of runoff. Need to maintain existing infiltration trench.

RECOMMENDED IMPROVEMENTS: Recommend placement of a 200 linear foot infiltration trench adjacent to the existing infiltration trench along with maintenance of the existing infiltration trench to enable proper infiltration.

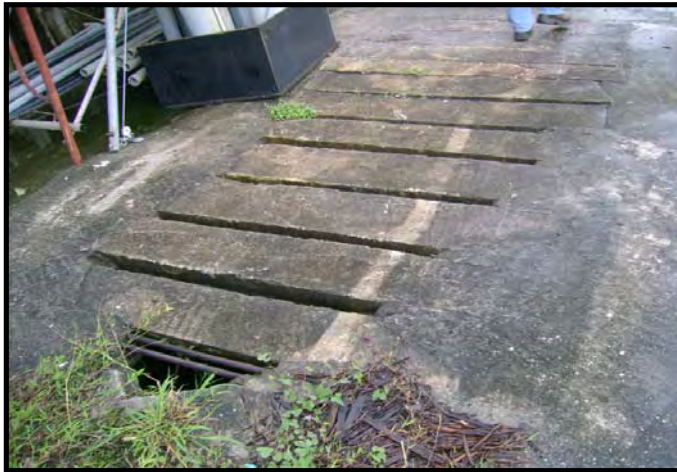
BV-102

SITE ASSESSMENT: Along Rt16, adjacent to Cepeda way, there is an existing concrete ditch that runs parallel to Rt16, a portion of this ditch was covered with a concrete slab and a few openings left on top. Need to remove concrete top and replaced it with a metal grate (or replace system with a storm drain system with 3 catch basins and pipeline to outlet offsite). The existing concrete slabs prevents maintenance of the ditch and also does not allow runoff to enter ditch properly.

RECOMMENDED IMPROVEMENTS Recommend replacement of the existing concrete drainage structure located along Route 16 adjacent to Cepeda Way with three catch basins connecting to a 24" RCP (approximately 100 linear feet in length) connecting to the existing Rte 16 storm drain via a manhole structure.

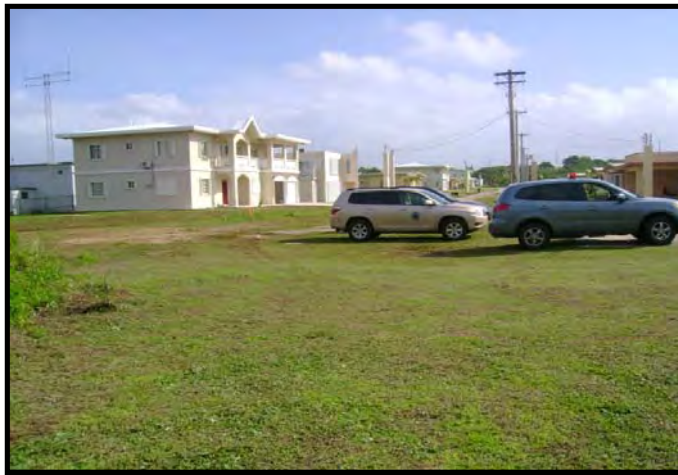
BV-107

LOCATION:	Rosario Loop Rd & Pangelinan Way
MITIGATION TYPE:	Storm Drain Improvements/ Treatment BMP Improvement
SITE ASSESSMENT:	Rosario Loop is off Pangelinan Way and adjacent to the airport. This is a new development and street is not paved yet -it has a gravel surface. Three homes get flooded. A future cul-de-sac within the loop will be an ideal location to build an infiltration basin or an infiltration trench.
RECOMMENDED IMPROVEMENTS	Recommend placement of a 200'x200' infiltration basin at this site along with a drainage system along Rosario Loop. Two catch basins should be placed along the street to intercept and convey flow to a 24" RCP for 100 linear feet, outleting to a headwall/wingwall structure and a 100 square foot rip rap energy dissipator placed at the infiltration basin. Recommend placement of 100 LF of ditch along each side of the crowned roadway to convey flow to proposed catch basins.

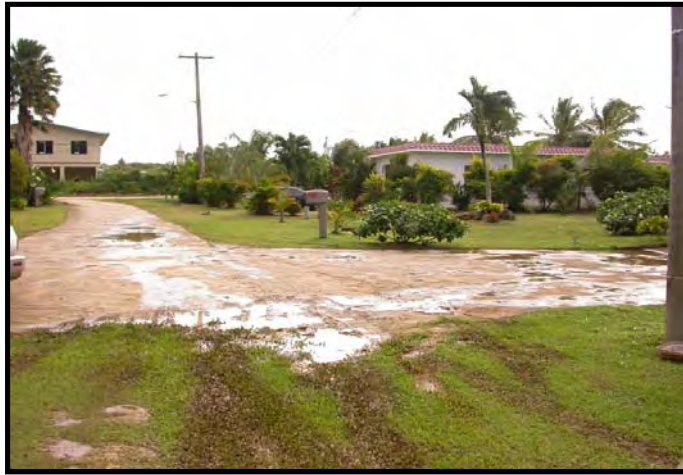
BV-109

SITE ASSESSMENT: At the end of Lizama St there is a Cul-de-Sac where a temporary basin was created to take care of the flooding generated by the new development. Since this basin is at the low point, this temporary should be made into a permanent infiltration basin, need to acquire right of way for basin and for an access road to basin.

RECOMMENDED IMPROVEMENTS Recommend making temporary infiltration basin into permanent infiltration basin to be owned and maintained by DPW (requires ROW acquisition and fencing for 800 linear feel around perimeter of the existing infiltration basin).

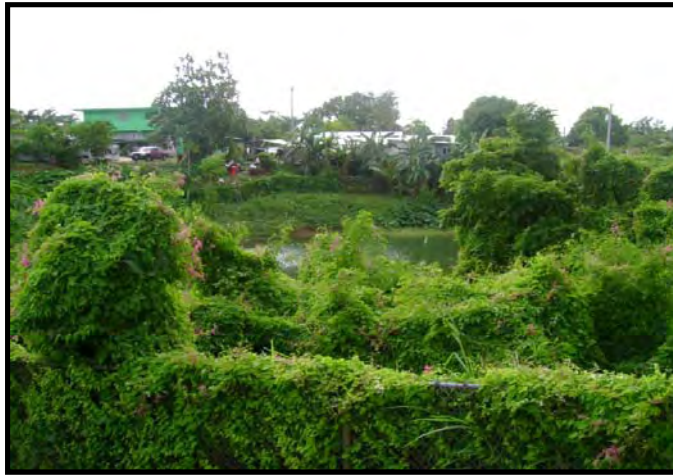
BV-110

SITE ASSESSMENT: Along Rt10 east side and south from Rt8 an infiltration basin has become a permanent wet basin. The infiltration basin is not draining the runoff anymore and has become a permanent lake and habitat for endangered species.

RECOMMENDED IMPROVEMENTS The infiltration basin along Route 10 and south of Route 8 no longer drains the runoff and has turned into a permanent lake/habitat for endangered species. This area needs a quarter acre of debris removal and approximately 1,000 cubic yards of dredging (cut). In order for the maintenance to occur, an agreement between DPW and DFW will most likely be required.

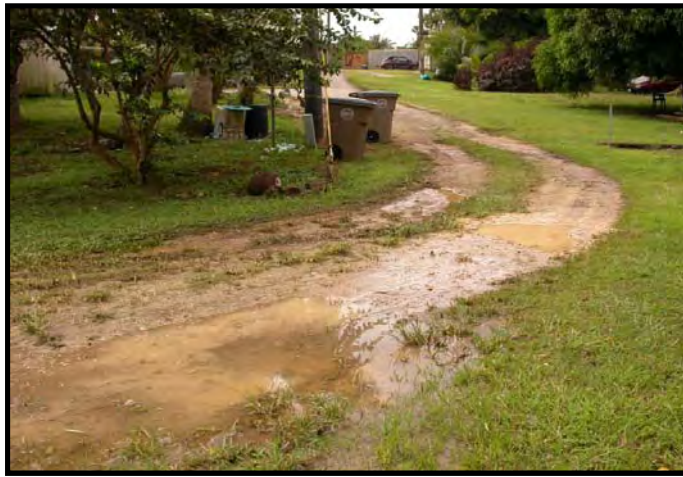
BV-113

SITE ASSESSMENT: Possible location for an infiltration basin or trench, this at a low point.

RECOMMENDED IMPROVEMENTS Recommend placement of storm drain system in Ungkulu Street to assist in flood prevention along the street, outleting to an infiltration trench (200' long) adjacent to the low point in the street. Propose intercepting roadway flow via catch basins (1 located on each side of the street) connected by 24" RCP (estimated length of 100-ft) outleting to headwall/wingwall structure and 100 SF rip rap energy dissipator located immediately upstream of proposed infiltration trench.

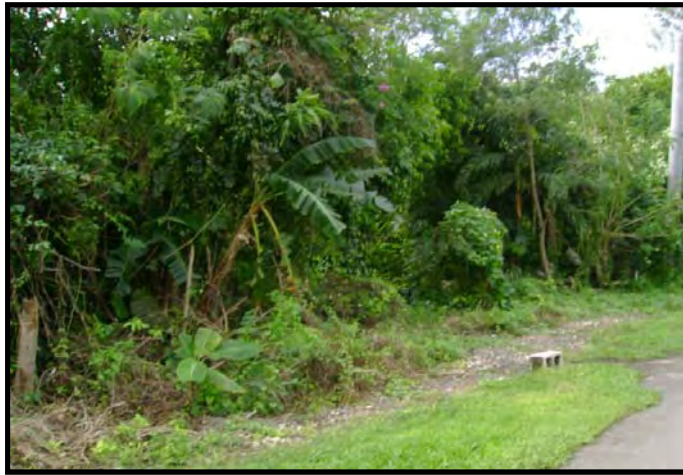
BV-115

SITE ASSESSMENT: 7 homes get flooded need to add a infiltration basin to take care of the runoff.

RECOMMENDED
IMPROVEMENTS Recommend placement of a 200'x200' infiltration basin at this site along with a drainage system along Westbrooks Street. Two catch basins should be placed at the street's low points to intercept and convey flow to a 24" RCP for 100 linear feet, outleting to a headwall/wingwall structure and a 100 square foot rip rap energy dissipator placed at the infiltration basin.

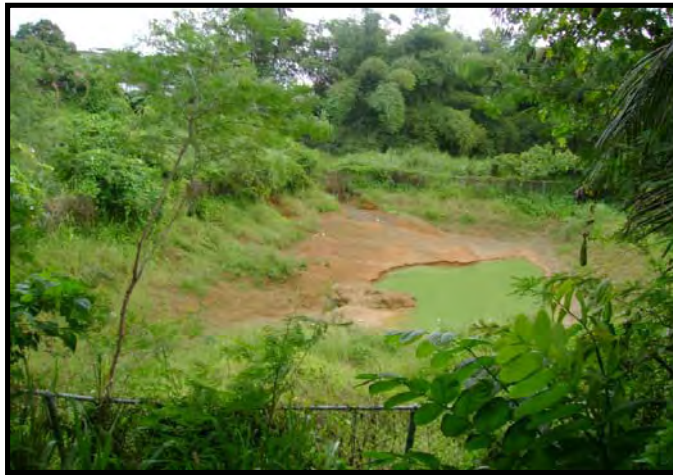
BV-116

SITE ASSESSMENT: An existing infiltration basin overtops and floods homes. Also concentrated flow entering the basin is eroding embankment next to a home. Erosion control needs to be provided to embankment next to private property, and basin needs to be resized to take care of all the runoff without flooding properties.

RECOMMENDED IMPROVEMENTS Homes at this site become flooded due to an existing infiltration basin that overtops. Recommend placement of two 200-ft long infiltration trenches (or widening of the infiltration basin by 10-ft if right of way permits) along with rip rap added to the sides of the existing basin where erosion is occurring.

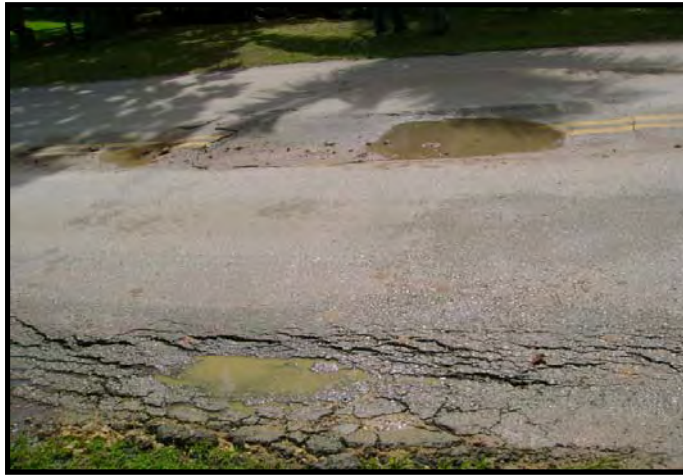
BV-119

SITE ASSESSMENT: A house on the north side of Leyang Rd, east from Manibusan Lane gets flooded due to a cross culvert that is plugged downstream. The street pavements has collapsed and there are ponding, two signs that the cross culvert has collapsed. Need to replace the cross culvert and need to replace the catch basin upstream with a grated catch basin, downstream right-of-way needs to be acquired to route the outlet through a private property.

RECOMMENDED IMPROVEMENTS A drainage conveyance system is needed along Leyang Rd to prevent future flooding of the street and surrounding private properties. Recommendations include placement of grated catch basins connected by 50 LF of 24" RCP, with runoff conveyed through an additional 50 LF of 24" RCP equipped with headwall/wingwall structure at outlet and 100 SF rip rap energy dissipator to natural flow path (easement may be required for this last segment of conveyance line).

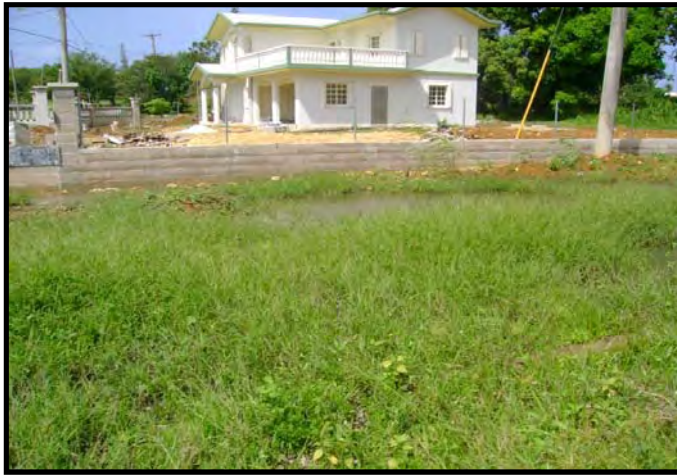
BV-121

SITE ASSESSMENT: A house gets flooded and as a temporary solution a berm was built to prevent flooding. Across the street, a wetland is located. To prevent flooding of the house, an infiltration trench should be built parallel to the berm.

RECOMMENDED IMPROVEMENTS To prevent further flooding, two 200' long infiltration trenches (one on each side of the crowned street) are recommended.

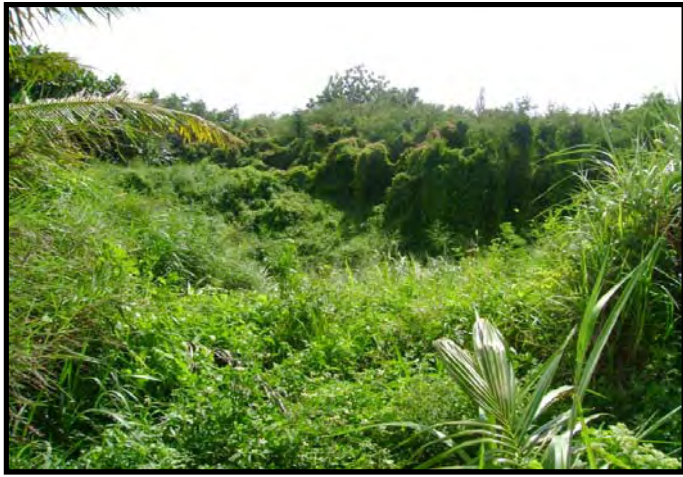
BV-122

SITE ASSESSMENT: At the end of Leon Guerrero St, an infiltration basin exists. A side of the basin has been eroded and the basin fence has collapsed - need to stabilize erosion with rip-rap.

RECOMMENDED IMPROVEMENTS: To prevent further erosion and damage to the existing infiltration basin, rip rap stabilization of approximately 1000 SF is recommended along the embankment where erosion is occurring.

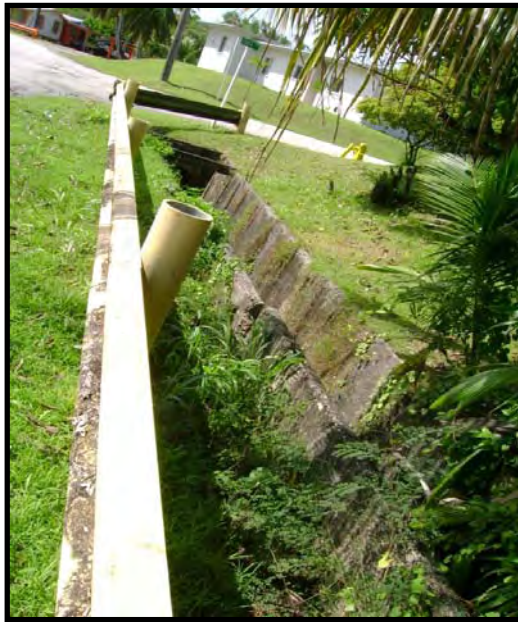
BV-124

SITE ASSESSMENT: Existing concrete lined channel needs to be re-built to keep area from flooding - the existing channel was damaged and, since sections have collapsed, is not functioning properly.

RECOMMENDED IMPROVEMENTS: To prevent further flooding of the roadway, the existing rectangular concrete lined channel at this site needs to be re-built. Recommend replacement of entire channel estimated at 10' width and 5' height for a distance of 200 linear feet.

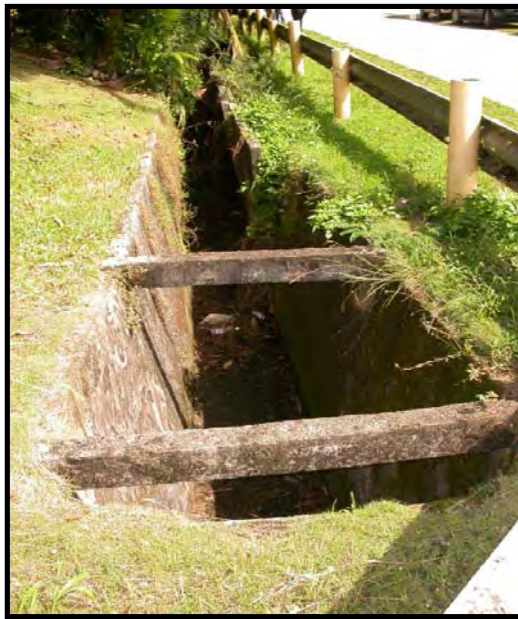
BV-125

SITE ASSESSMENT: At the intersection of Captain Reyes Way and Ungaguan Place runoff from the street is collected by a catch basin located on the private property. Runoff from this catch basin is routed to a low area behind the property, need to work on doing a land exchange in order to use that low area as a infiltration basin. Area needs significant erosion control and debris removal.

RECOMMENDED IMPROVEMENTS Recommend making existing low area into permanent infiltration basin (will require ROW through possibly a land exchange) and improve site through 1/4 acre debris removal and applying site with hydroseed and bonded fiber matrix where erosion is occurring (approximately 10,000 sq ft).

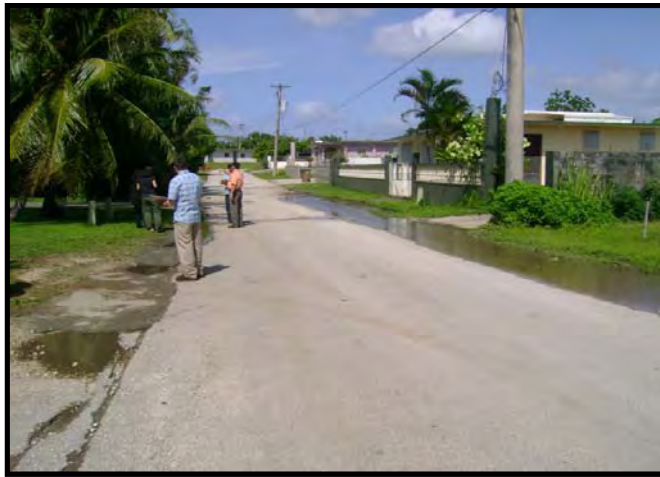
BV-126

SITE ASSESSMENT: Along the middle of Captain Reyes Way on both sides of the street, flooding exists. On the east side of the road there are existing infiltration trenches that are not working properly. Need to build new infiltration trenches along both sides of the street.

RECOMMENDED IMPROVEMENTS To prevent further flooding, two new 200' long infiltration trenches (one on each side of the crowned street) are recommended.

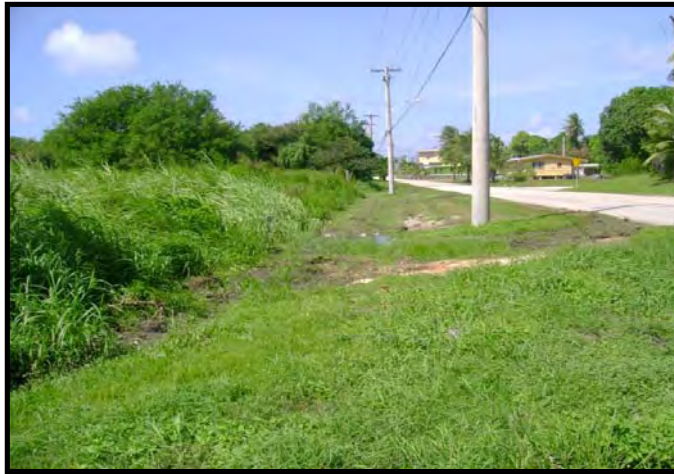
BV-127

SITE ASSESSMENT: An infiltration gallery is located where a baseball field used to be, but is not working properly and is causing flooding. New infiltration gallery needs to be built, and needs to be maintained in order to function properly.

RECOMMENDED IMPROVEMENTS To prevent further flooding, two new 200' long infiltration trenches (one on each side of the crowned street) are recommended to replace existing infiltration trench located at baseball field.

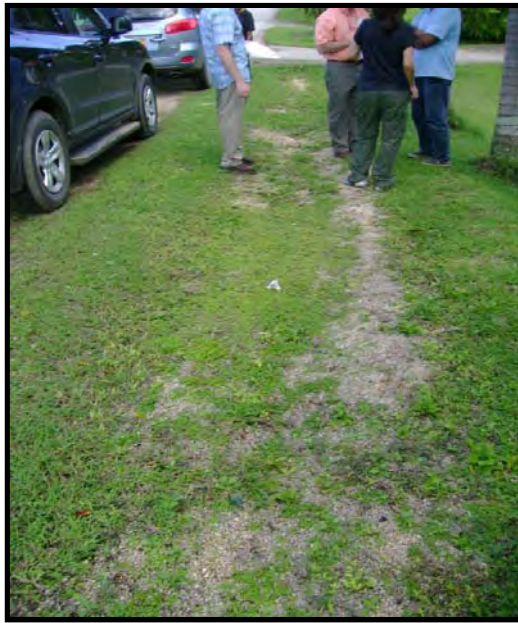
BV-133

SITE ASSESSMENT: An existing infiltration trench is not working properly and also may not be enough to take care of the street runoff. A property gets flooded. Should extend length of infiltration trench and also maintain trench.

RECOMMENDED IMPROVEMENTS Recommend placement of a 200 linear foot infiltration trench adjacent to the existing infiltration trench along with maintenance of the existing infiltration trench to enable proper infiltration.

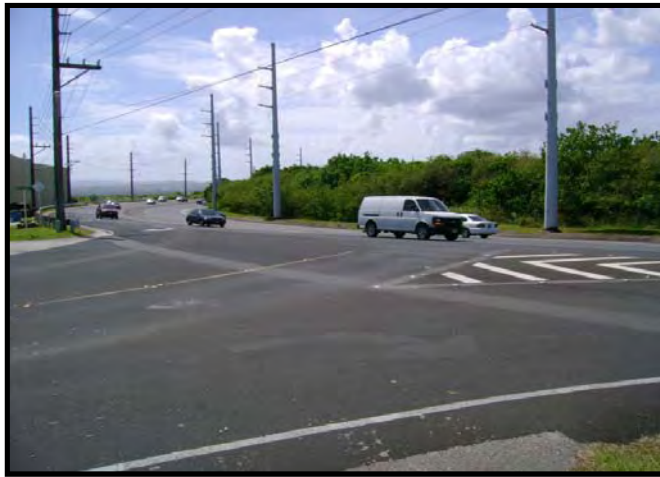
BV-134

SITE ASSESSMENT: Northeast corner of interchange shows signs of ponding. There may be enough right of way to place an infiltration trench to take care of runoff.

RECOMMENDED IMPROVEMENTS To prevent further ponding at this site, a 200 linear foot infiltration trench should be placed along the edge of pavement at the NE corner of the intersection of Rte 16 and S Sabana.

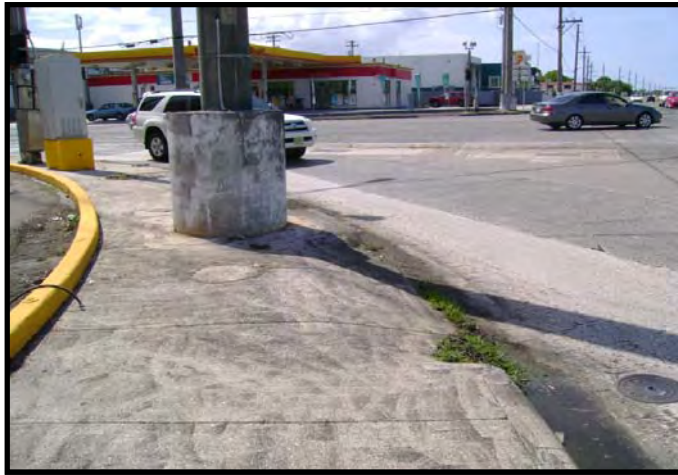
BV-137

SITE ASSESSMENT: At the southeast corner of Rt10 and Rt8 intersection there are signs of ponding(76 Gas Station) and the ponding continues south along Rt10 east side. Need to add a drainage conveyance system added along Rt10 and route it to the existing infiltration basin located next to Rt10.

RECOMMENDED IMPROVEMENTS To prevent roadway flooding, two catch basins need to be placed along the east side of Rte 10, south of Rte 8, routing flow to the existing infiltration basin located south of the 76 gas station. The catch basins will connect to a 24" RCP for 100 linear feet, routing the runoff to a headwall/wingwall structure and a 100 square foot rip rap energy dissipator located at the infiltration basin.
