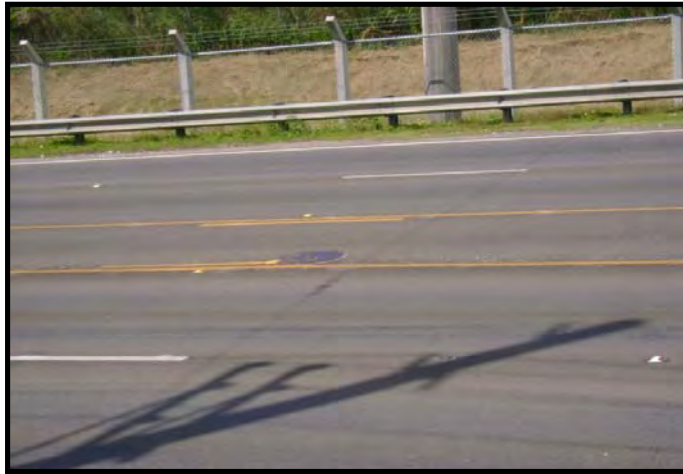
BV-138

LOCATION: RT 8 & Church of Jesus Christ of Latter Day Saints

RECOMMENDED IMPROVEMENTS: Recommend upsizing Rte 8 storm drain system in vicinity of manhole (assume 100 LF of 36" RCP to replace existing storm drain in area).

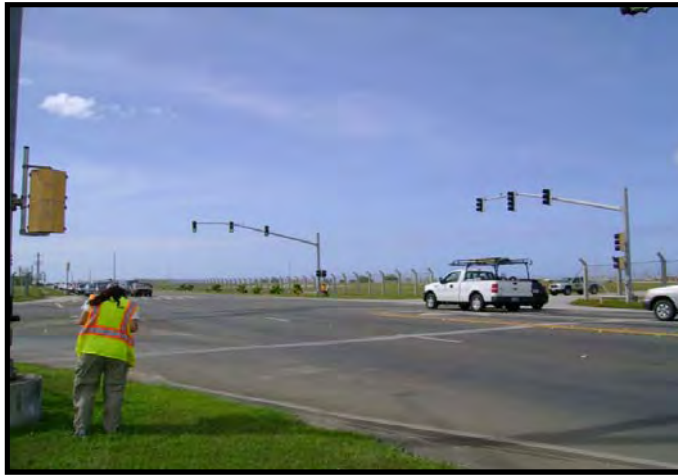
BV-139

SITE ASSESSMENT: At the interchange of Rt8 and Rt33 some of the runoff flows towards the southeast corner where this area functions as an infiltration basin. Need to add spillways along the edge of pavement to prevent ponding or re-grade area to prevent ponding.

RECOMMENDED IMPROVEMENTS To prevent further ponding at this site, one AC spillway, a 100 linear foot ditch that outlets flow through a 100 square foot rip rap energy dissipator is needed.

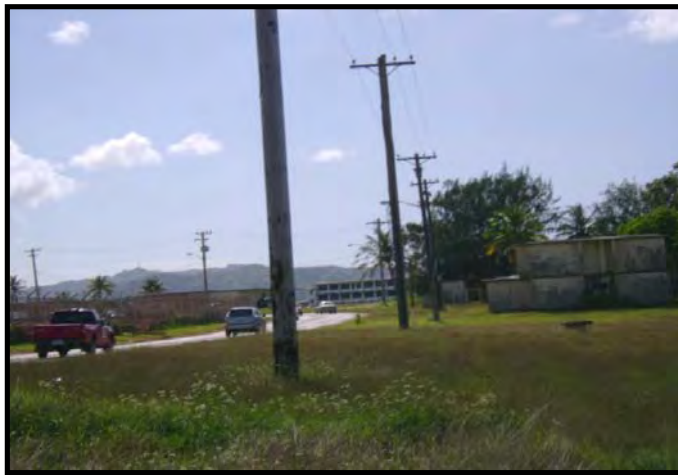
BV-140

LOCATION: Punzalan St

RECOMMENDED IMPROVEMENTS Recommend placement of a 200'x200' infiltration basin along Punzalan Street to minimize runoff that flows downstream to Tamuning Drainageway.

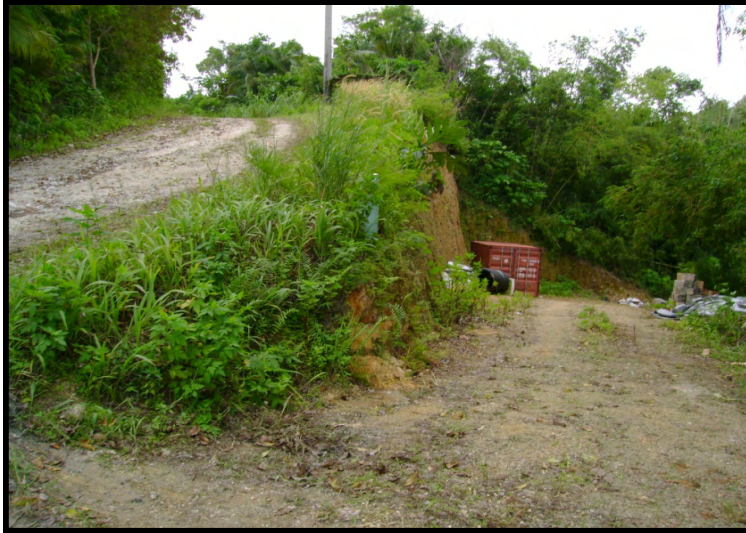
CP-101

SITE ASSESSMENT: Bridge leading to Cruz residence needs guardrail. Debris from channel along road causes flooding, this channel is tributary to Chaot river. Road is eroded is not paved, need right-of-way to add drainage conveyance systems along road.

RECOMMENDED IMPROVEMENTS Recommend storm drain system along Leo Place at Ch Famha, routing flow to channel adjacent to Ch Famha. Recommend swale along Leo Palace (400 LF total) routing flow to double 24" RCP. The double 24" RCP should be equipped with headwall/ wingwall structures (upstream and downstream) and convey the flow for approximately 500 LF to channel adjacent to Ch Famha. Channel will require 1/4 acre debris removal and 200 sq feet of rip rap placed at the pipeline outlet for erosion control.

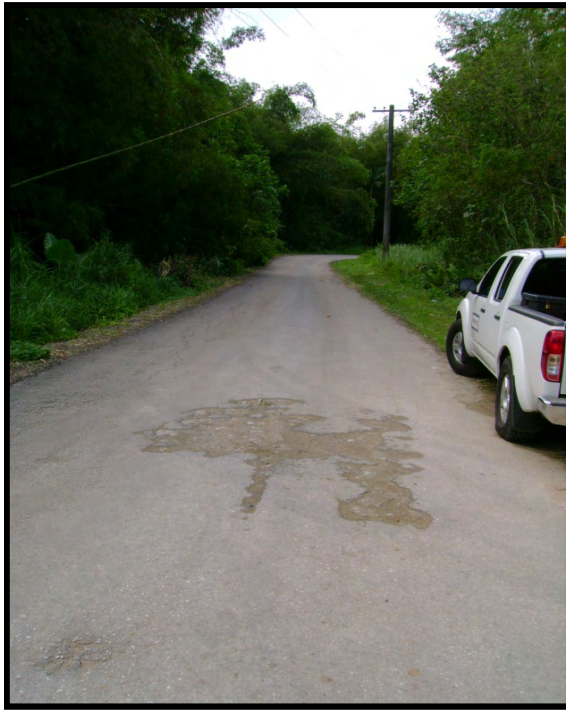
CP-102

LOCATION: Victoriano Road & Dero Road

RECOMMENDED IMPROVEMENTS Recommend placement of a storm drain system along Victoriano Road with a ditch on both sides (200' on each side) of the street routing flow to grated catch basins placed on both sides of street at the street's low point. The two catch basins will connect to a 24" RCP for 100 linear feet conveying flow to the end of the road, outleting through a headwall/wingwall structure to a 100 square foot rip rap energy dissipator.

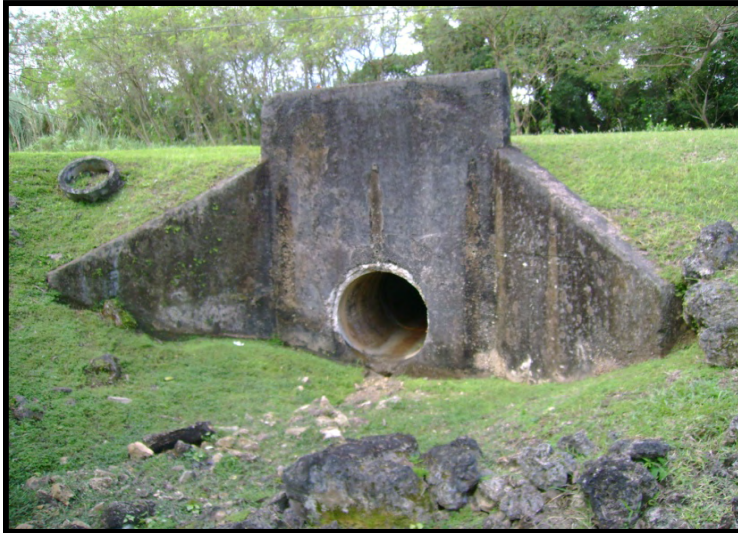
CP-103

LOCATION: Ramirez Drive & Judge Sablan St

RECOMMENDED IMPROVEMENTS Recommend storm drain improvements at Ramirez Drive including placement of 400 LF of ditch placed along the north of Ramirez Drive with placement of two catch basins (one at Judge Sablan Street cross-culvert and one connecting to culvert located along the school (where the culvert has been plugged), connected by 500' of 24" RCP. Also, place 1 headwall/wingwall structure and 100 SF rip rap at the existing school culvert inlet to control erosion that was observed at the upstream side of the culvert.

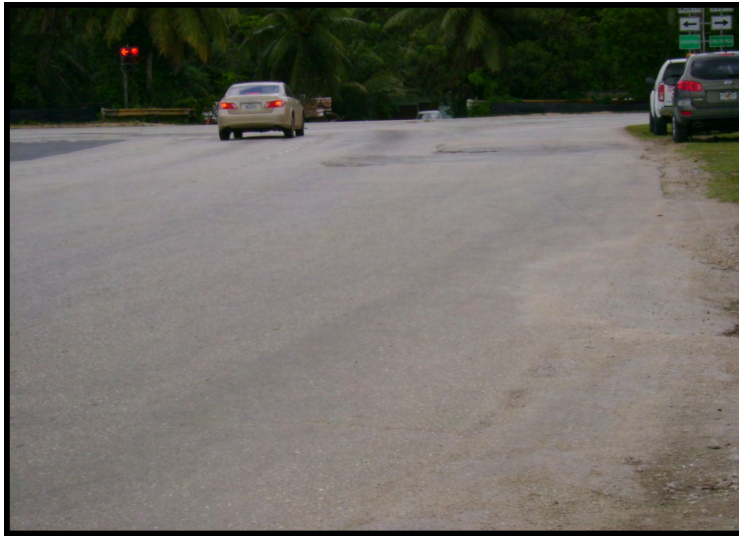
CP-104

LOCATION: Dero Rd & RT 4

RECOMMENDED IMPROVEMENTS The intersection of Dero Road and Route 4 gets flooded. This site needs a drainage conveyance system. A quarter acre of debris needs to be removed, 2 catch basins should be place at the street's low points to capture flow that will travel through a 24" RCP for 100 linear feet, leading to one headwall/wingwall structure, outleting through a 100 square foot rip rap to a 400 linear foot ditch.

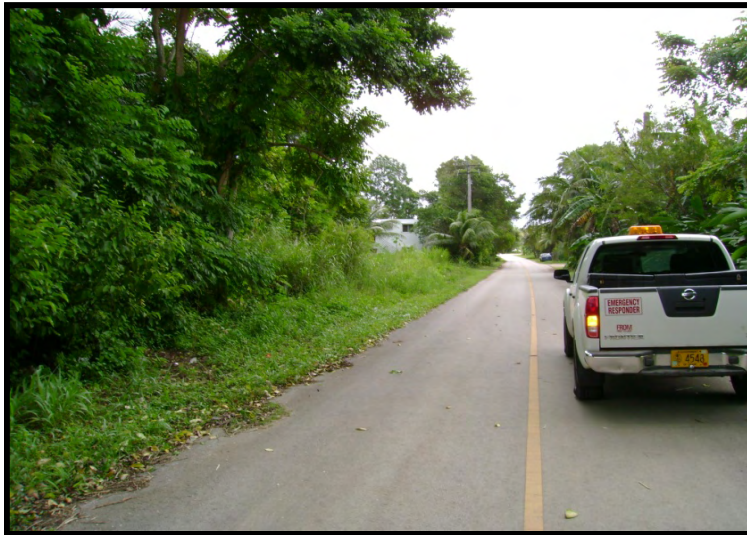
CP-105

LOCATION: Gogue Drive

RECOMMENDED IMPROVEMENTS Recommend placement of a storm drain system in Gogue Drive to intercept and convey flow to Chaot river. Place ditches along both sides of the crowned road (200 LF each side) conveying flow to two grated catch basins located at the low point in the road, connecting 600 linear feet of 24" / 36" pipeline. The new pipeline should route flow to a headwall/wingwall structure outleting to a 100 square foot rip rap energy dissipator at the Chaot River.

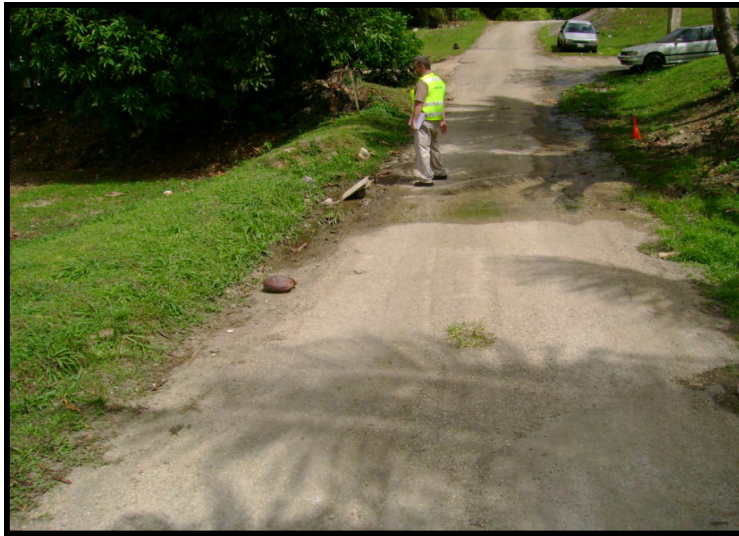
CP-106

LOCATION: Chalan Totot & RT 4

RECOMMENDED IMPROVEMENTS Recommend placement of a storm drain system along Chalon Totot St with a ditch on both sides (200' on each side) of the street routing flow to grated catch basins placed on both sides of street at the street's low point. The two catch basins will connect to a 24" RCP for 100 linear feet and a 36" RCP for 500 linear feet, placed along the right of way between 2 properties (may require easement if one does not exist already) conveying flow to Nakie Street. Along Nakie, the pipe will connect to an existing ditch via an outlet equipped with a headwall/wingwall structure and a 100 square foot rip rap energy dissipator.

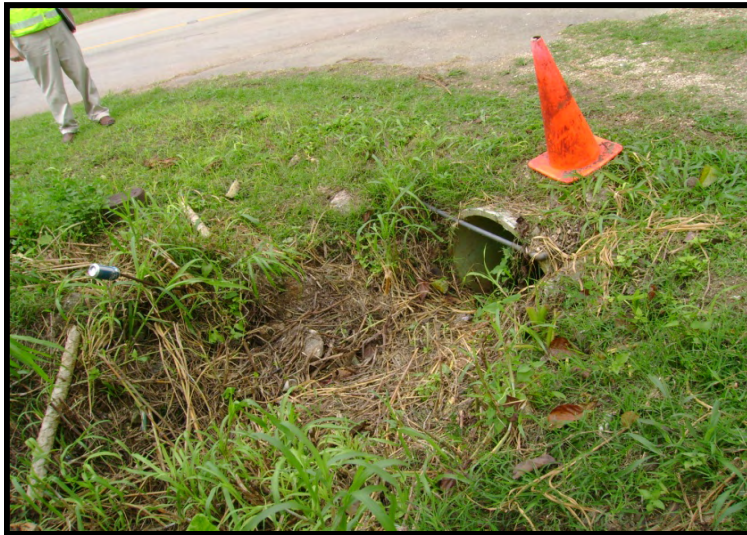
CP-107

LOCATION: Nakie St & RT 4

RECOMMENDED IMPROVEMENTS Recommend improvement of the storm drain system along Nakie Street including placement of ditches (approximately 50-ft each) on both sides of the street to intercept and convey roadway runoff to 2 grated catch basins located at the street's low point (on both sides of the street). The catch basins should connect to a new, 100'x 36" RCP storm drain placed in the street that outlets to a concrete channel located at the downstream side of the existing 36" RCP culvert. The channel will route the flow along Nakie to an existing channel located immediately upstream of the Apusento Garden Development. 100 SF of rip rap should be placed at the outlet to the existing channel (which runs perpendicular to Nakie Street).

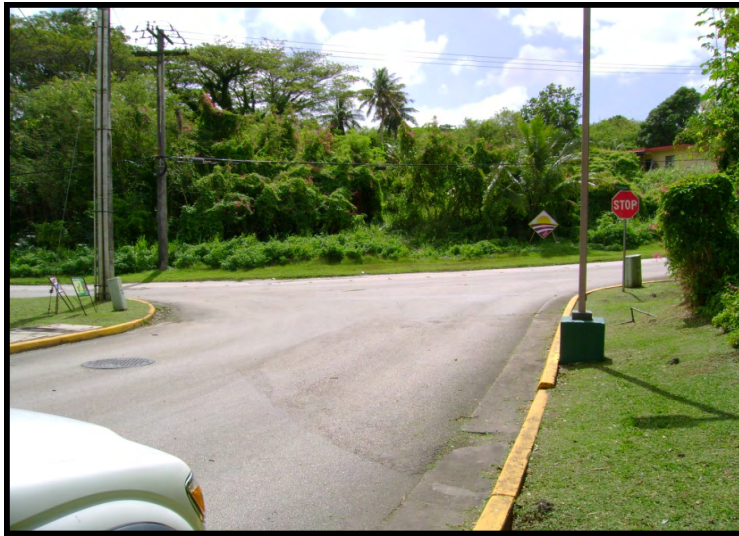
CP-108

LOCATION: Chalan Apusento & Maimai St

RECOMMENDED IMPROVEMENTS The natural flow from the Nakie Street drainage system is being blocked by the Apusento Garden development slightly downstream of the existing channel outlet for the Nakie Street drainage system (see CP-107). A drainage system needs to be built to carry the runoff from Nakie to a discharge point at Route 15. Recommend the following improvements to the drainage conveyance system at Apusento Garden Development: 1) placement of a 100 linear foot concrete channel routing runoff from Nakie Street to a 48" RCP (equipped with headwall/ wingwall structure) located at the upper limits of the Apusento Garden Development, 2) placement of 500'x 48" RCP storm drain system along edge of right of way for Apusento Garden Development (may require easement) routing flow to Rte 15 and across Rte 15 to natural flow path, 3) placement of 2 catch basins connecting to proposed 48" pipeline crossing Rte 15 approximately at the entrance to the Apusento Garden Development, 4) placement of 50' ditch routing flow along Rte 15 to proposed grated catch basins, and 5) placement of 100-SF rip rap energy dissipator at outlet of 48-inch pipeline.

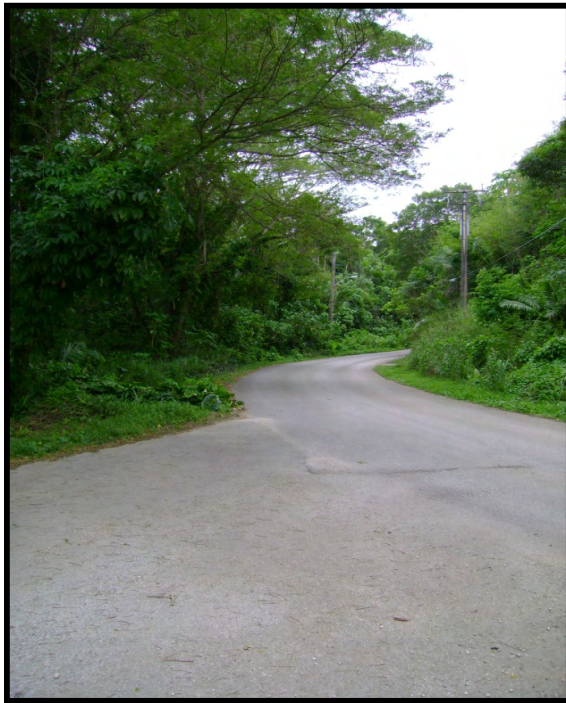
CP-109

LOCATION: Kongga Rd

RECOMMENDED IMPROVEMENTS Recommend placement of a storm drain system in Kongga Rd to stop roadway flooding. Place ditches along both sides of the crowned road (200 LF each side) conveying flow to two grated catch basins located at the low point in the road, connecting to 100 linear feet of 24" pipeline. The new pipeline should route flow to a headwall/wingwall structure outleting to a 100 square foot rip rap energy dissipator. One quarter ac debris removal is also necessary.

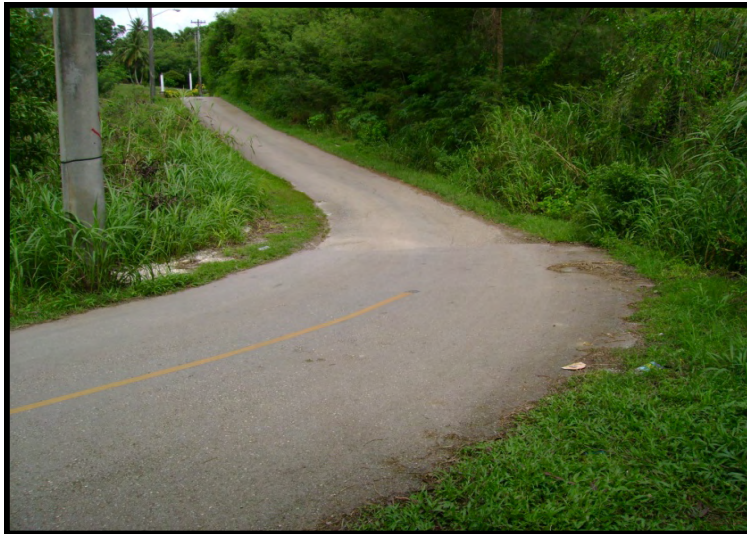
CP-110

LOCATION: Chalan Okso & Santa Cruz Dr

RECOMMENDED IMPROVEMENTS Recommend placement of a storm drain system along Ch Okso with a ditch on both sides (200' on each side) of the street routing flow to grated catch basins located at Juan Bernardo Court. The two catch basins will connect to a 24" RCP for 100 linear feet, equipped with headwall/wingwall structure at the outlet to a new 100' conc channel conveying flow to a tributary of Pago River, outleting through a 100 square foot rip rap energy dissipator. A quarter acre of debris removal is also needed.

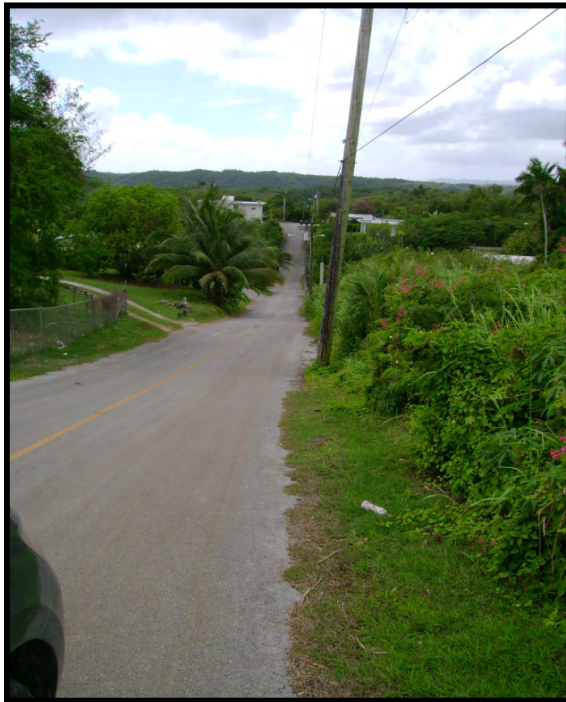
CP-111

SITE ASSESSMENT: Runoff from road cascades into private properties. Need to add curb road and add catch basins. Sections of the road pavement is failing, probably from runoff undermining.

RECOMMENDED IMPROVEMENTS Recommend improvements to the storm drain system in Manibusan Lane including placement of ditches along both sides of the crowned road (200 LF each side) conveying flow to two grated catch basins located at the low point in the road, connecting to a 24" RCP for 100 linear feet. The new pipeline should route flow to a headwall/wingwall structure outleting to a 100 square foot rip rap energy dissipator.

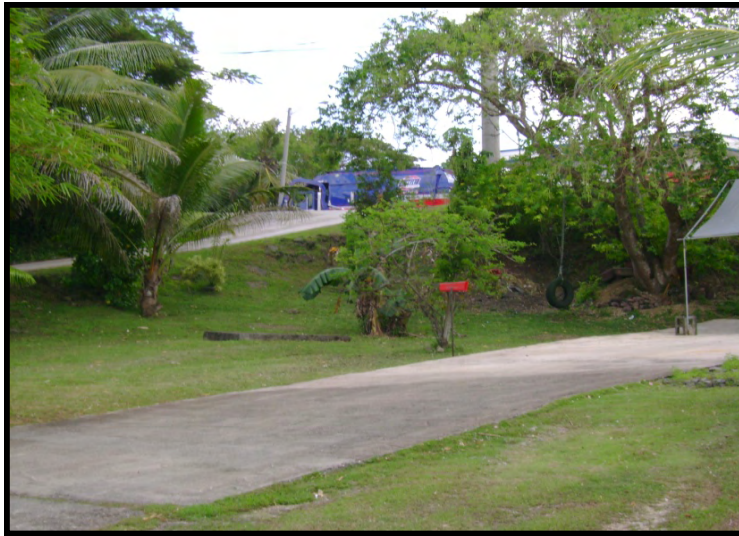
CP-112

SITE ASSESSMENT: Runoff from Rt10 floods three properties along Chalan Chirik. Need to add conveyance systems along Rt10 to prevent runoff from entering Chalan Chirik. Place Infiltration trenches along Rt10.

RECOMMENDED IMPROVEMENTS Three properties flood along Chalan Chirik due to the runoff from Route 10. A drainage conveyance system along route 10 to prevent runoff from entering Chalan Chirik is needed. Recommend 400 ft ditch placed upgradient of Chalan Chirik (to capture roadway runoff), placement of two grated catch basins (one at end of ditch and one immediately downgradient of Chalan Chirik along Rte 10). Connect via a 24" RCP for 100 linear feet and outlet to a headwall/wingwall structure and 100 square foot rip rap energy dissipator. A quarter acre of debris removal will be needed.

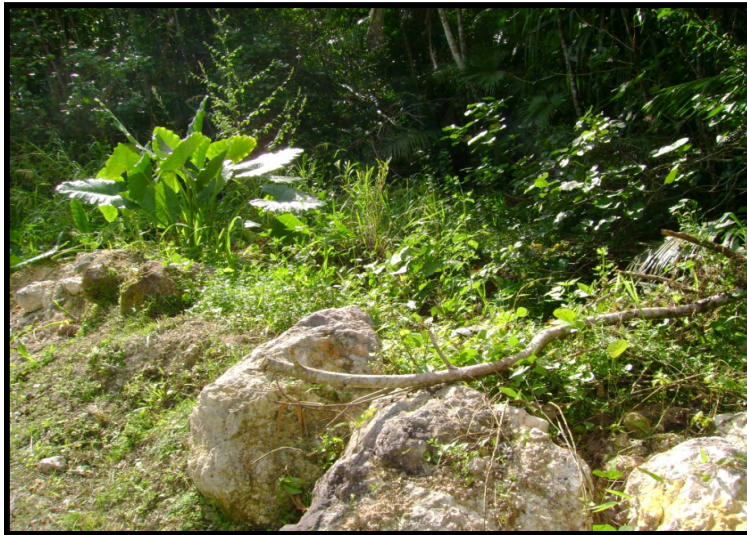
CP-114

LOCATION: Chalan Nganga & Leo Palace

RECOMMENDED IMPROVEMENTS Recommend replacement of existing culvert with 100'x 5'x5' RCB, a quarter acre of debris removal (upstream and downstream), placement of 1,000 square feet of gabions along embankments upstream and downstream of culvert for a distance of 50-ft (approximately 5' high), placement of rip rap at base of gabions (400 square feet total), and placement of headwall/wingwall structures at both ends of culvert.

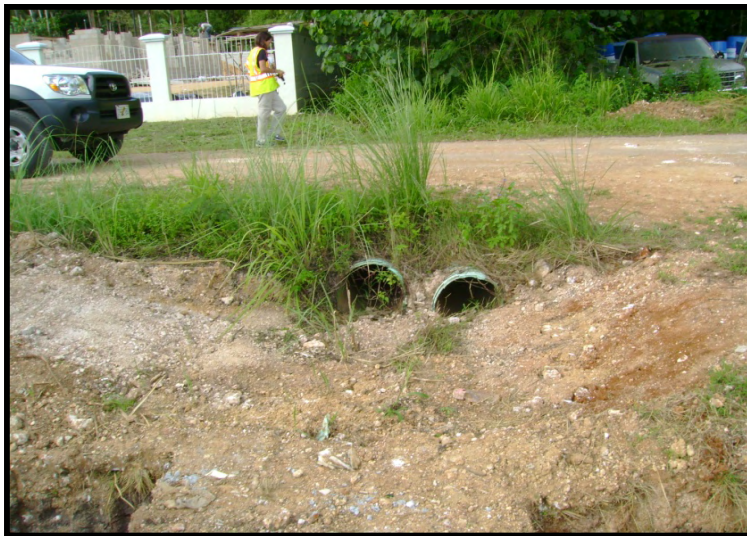
CP-115

SITE ASSESSMENT: On a street off Chalan Famha, existing 2-18" PVC cross culverts that were outleting to a low area were plugged. The property has been developed and the ground raised, now an adjacent property floods. The 2-18" PVC culverts should be replaced with 2-24" RCP or an RCB. Need to get an easement through private property to route these pipes to the existing earthen channel behind the property where all the runoff used to naturally flow.

RECOMMENDED IMPROVEMENTS Recommend replacement of existing culvert with 100'x 2-24" RCP equipped with upstream and downstream headwall/wingwall structures, outleting to a new concrete channel, 100-feet long, routing flow along the right-of way of 2 properties (may require easement) to the natural flow path located at the back of the property. A 100 SF rip rap energy dissipator should be placed at the outlet of the channel.

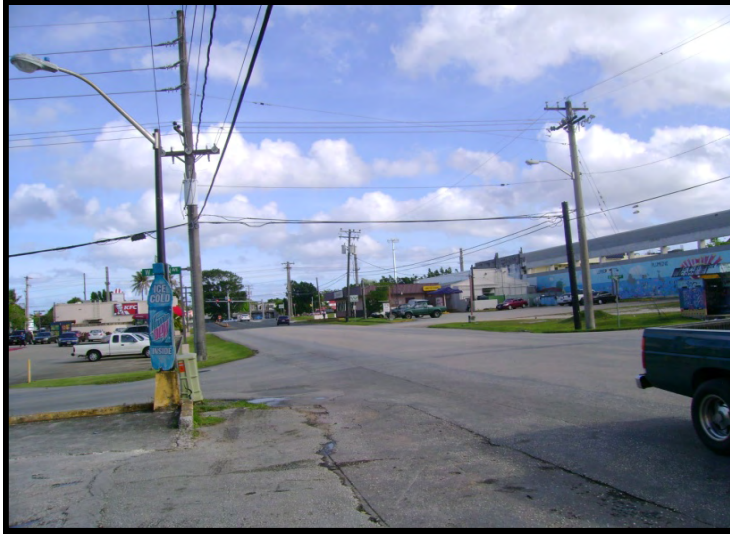
DE-101

LOCATION: RT 26 & RT 1

RECOMMENDED IMPROVEMENTS To prevent further flooding along Route 26 at the low point, two catch basins are proposed along Rte 1 and 2 additional catch basins are proposed at the low point in Rte 26. The catch basins along Rte 26 should be routed to the system at Rte 1, connecting to the system with approximately 200 LF of 24" RCP and two manholes. Ditches are also proposed along Rte 26 to route the pavement flow to the catch basins at the low point (approximately 400 LF total).

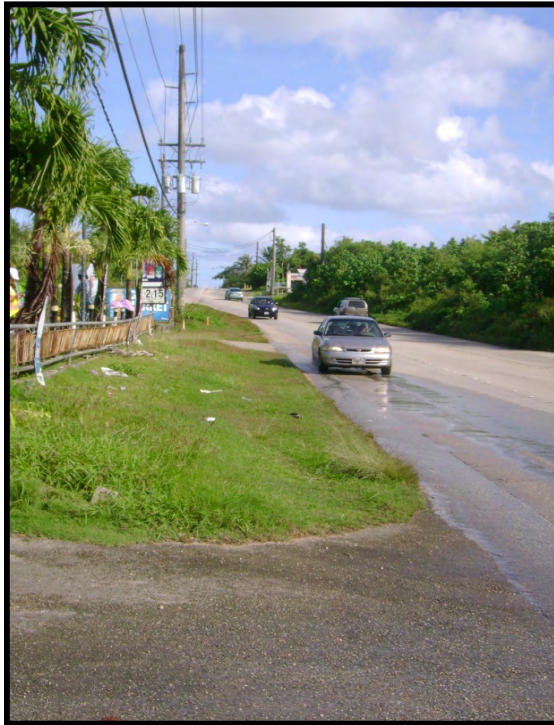
DE-102

SITE ASSESSMENT: This is a low point along Route 26, where ponding is created and possibly flooding one commercial property. There are no existing drainage systems at this location. Possible solution will be to add a drainage system that can route the flow to an existing infiltration basin near by.

RECOMMENDED IMPROVEMENTS To prevent further ponding and possible flooding of one commercial property at the low point of this site, two catch basins connecting to a 24" RCP for 100 linear feet leading to one headwall/wingwall structure outleting flow to a 100 square foot rip rap energy dissipator is needed at this site to improve the storm drain system.

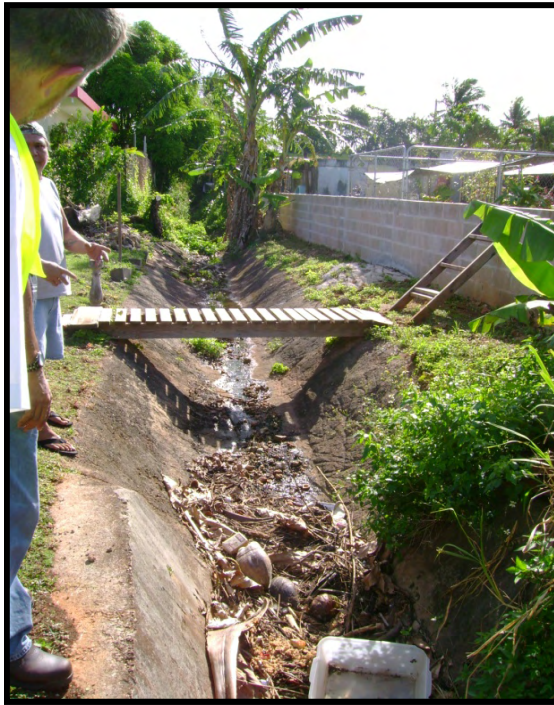
DE-103

LOCATION: Salisbury St

RECOMMENDED IMPROVEMENTS Recommend the following improvements to the existing storm drain system at the site: 1) remove a quarter acre of debris, 2) remove box culvert at site and extend existing channel to edge of Salisbury Street (this will improve maintainability) which will require approximately 100-feet of open concrete trapezoidal channel, and 3) connect to 2 new catch basin structures at Salisbury that connect to existing culvert in street.

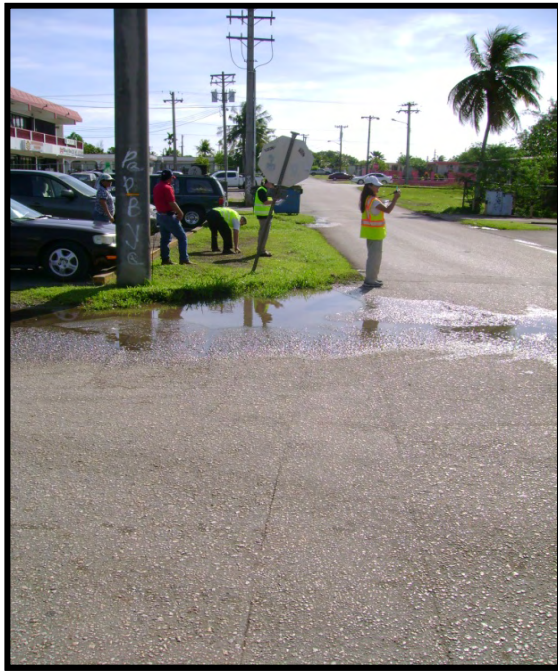
DE-104

SITE ASSESSMENT: At the intersection of these two streets, three infiltration trenches exist. These trenches are not sufficient to take care of all runoff and ponding is created, thus flooding one commercial property and three residential. An existing infiltration basin exists along E. Sta Barbara Ave, about 100 feet away from intersection. A possible solution is to add a drainage system and discharge to the existing infiltration basin.

RECOMMENDED IMPROVEMENTS: Recommend the addition of a storm drain system along Loreta Street including 2 catch basins connecting to a 24" RCP for 200 linear feet outletting to a headwall/wingwall structure and a 100 square foot rip rap energy dissipator located at the existing infiltration basin at E Santa Barbara Ave.

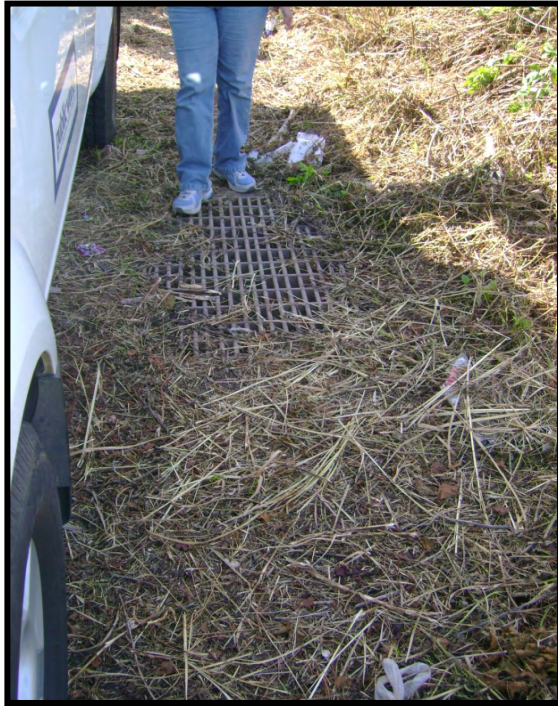
DE-105

SITE ASSESSMENT: An existing grated inlet gets clogged with debris, and this causes flooding of about three to four private properties in the area. A possible solution is to add a debris/trash rack that will take care of debris/trash and thus solve the flooding issue.

RECOMMENDED IMPROVEMENTS Maintenance to the storm drain system at this site is needed to prevent further flooding of private properties in the area. 1,000 square feet of debris removal is needed to unclog the existing grated inlet, a 100 square foot apron and 1-ft high trash rack should be placed around the inlet to prevent further clogging.

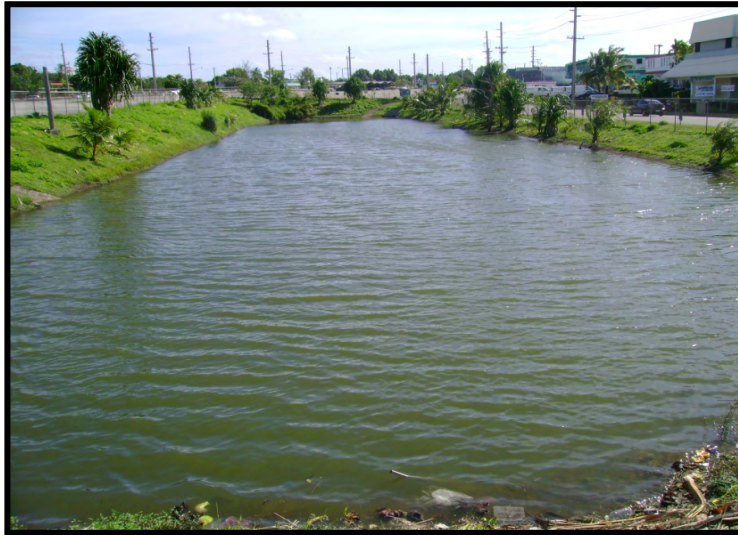
DE-106

SITE ASSESSMENT: An existing infiltration basin exist south from Route 1 and east of Route 27. Water is not infiltrating anymore, the basin needs to be dredged and all vegetation cleared. This situation creates major flooding around the perimeter of this basin, which in this area is mainly commercial properties.

RECOMMENDED IMPROVEMENTS To prevent the continuation of major flooding around the perimeter of this basin, recommend roadway storm drain improvements along with improvements to the existing infiltration basin. Storm drain improvements include placement of two catch basins connecting to approximately 100 linear feet of 24" RCP that will convey the street runoff along Rte 27 and along the roadway south of the infiltration basin to the infiltration basin. Recommend the outlet to the infiltration basin be equipped with one headwall/wingwall structure and a 100 square foot rip rap energy dissipator. Improvements to the existing basin (which has been silted up and has limited infiltration capacity because of it) include dredging the bottom of the basin (approximately 4000 CY of sediment removal) along with approximately one acre of debris removal.

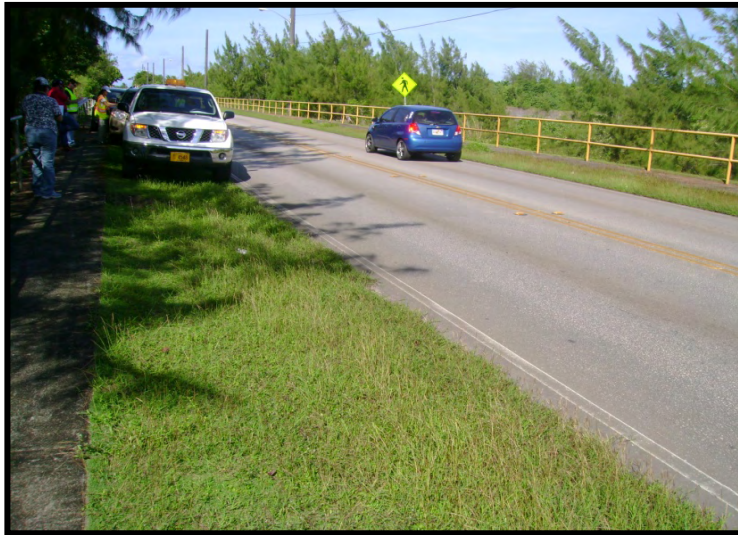
DE-107

SITE ASSESSMENT: At this location there is a low point on Route 27A , where the roadway runoff is discharged to the south to a private property. No apparent flooding or ponding occurs. There is an existing infiltration basin on the north side of this location. In order to route the runoff to the infiltration basin, a drainage system needs to be built.

RECOMMENDED IMPROVEMENTS There is a low point on Route 27A where the runoff is discharged to the south of a private property. There are no signs of flooding or ponding, however improvements to the current storm drain system are needed. The runoff needs to be re-routed to the infiltration basin located on the north side of this property. Two catch basins need to be placed at the low points on the street, connecting to a 24" RCP, outleting to a headwall/wingwall structure with a downstream 100 square foot rip rap energy dissipator located at the infiltration basin.

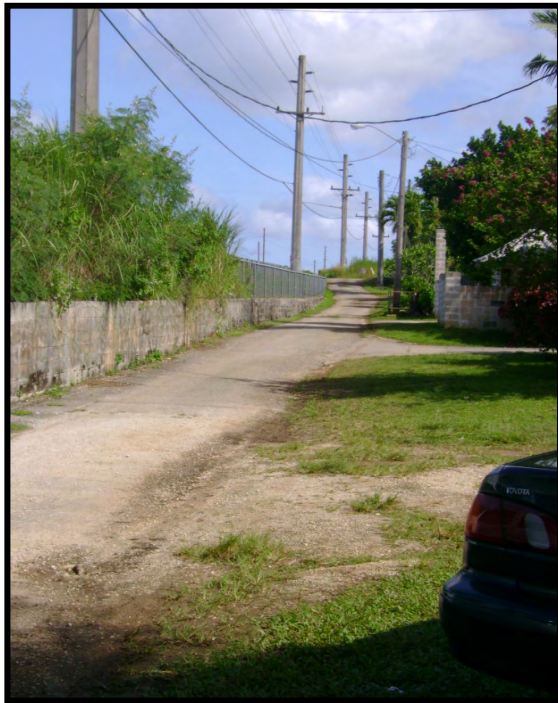
DE-108

SITE ASSESSMENT: Runoff from Route 3 roadway flows offsite to the adjacent properties on the east side. Where the low point is located and ponding occurs thus flooding two properties. One of these properties home is already abandon due to flooding. A solution will be to have an infiltration basin where this house is located.

RECOMMENDED IMPROVEMENTS To prevent further ponding and property flooding, a new infiltration basin is needed at the location of the abandoned house or adjacent to the house within public right of way (though some right of way will most likely be required). A 200'x200' infiltration basin is proposed at this location as an outlet for a storm drain system along Rte 3 including two catch basins connecting to a 24" RCP for 100 linear feet, outleting to a 100 square foot rip rap energy dissipator at the infiltration basin.

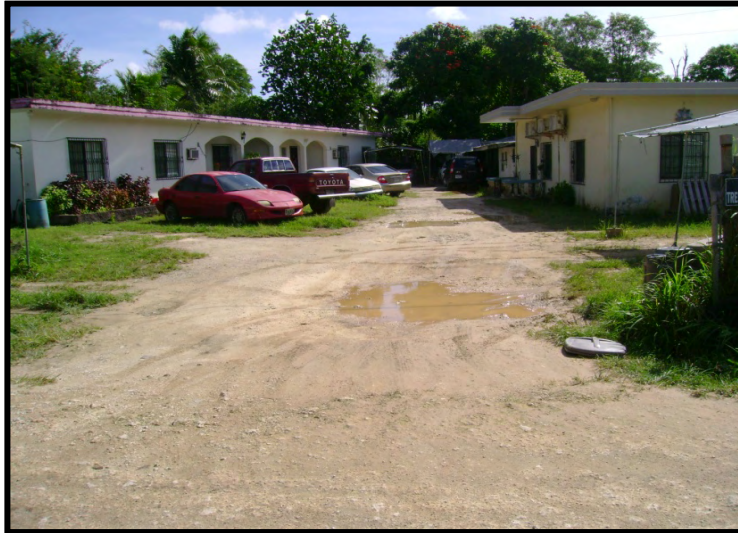
DE-109

LOCATION: Ukudo St

RECOMMENDED IMPROVEMENTS Recommend placement of a 100' x 100' infiltration basin with 3 injection wells for outleting flow generated along Ukudo Street. The infiltration basin can be placed within public right of way. Recommend placement of bioswales adjacent to the road to pre-treat runoff prior to outleting to injection wells/ infiltration basin (200 linear ft total). Bioswale will outlet to proposed infiltration basin through small 24" culvert (approximately 10-ft in length equipped with headwall upstream and downstream) and outleting to infiltration basin through a 100 square foot rip rap energy dissipator.

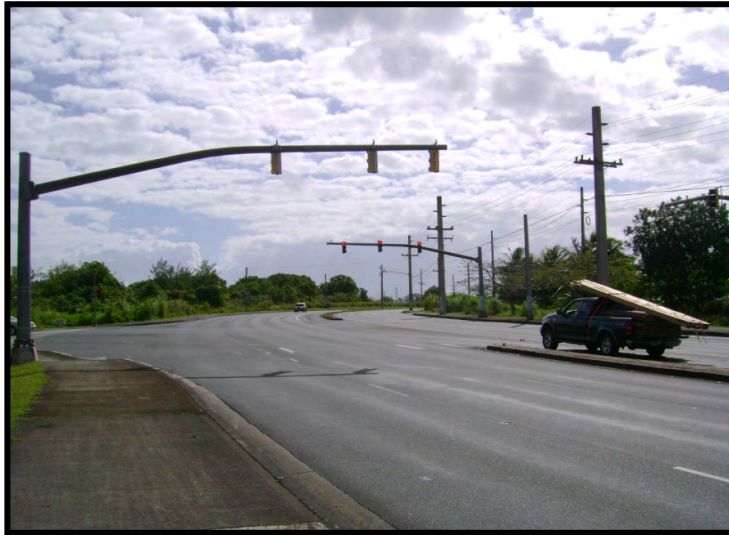
DE-110

LOCATION: RT 3 & RT 1

RECOMMENDED IMPROVEMENTS: Low points are located on both sides of the road along Route 3. Recommend placement of a storm drain system along Rte 3 that will connect to existing storm drain system along Rte 1. Storm drain system will include two catch basins connecting to 100 linear ft of 24" RCP conveying flow to a new manhole connecting to the Rte 1 drainage system. Roadside ditches should be placed upstream of each catch basin (approximately 100 LF in length each).

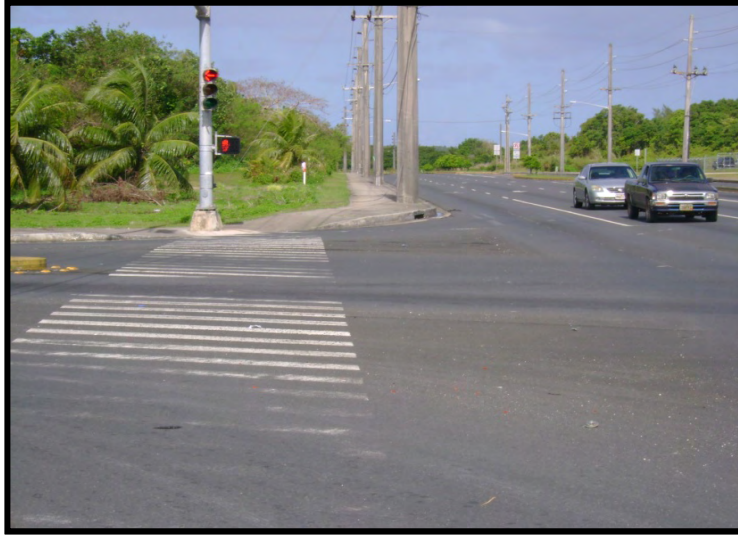
DE-111

LOCATION: RT 27A & RT 1

RECOMMENDED IMPROVEMENTS To avoid further ponding at the intersection of Route 1 and Route 27A, recommend placing one catch basin at the southeast corner of the intersection, connecting to a 24" RCP for 100 linear feet, connecting to the existing storm drain system located across the street via a manhole structure.

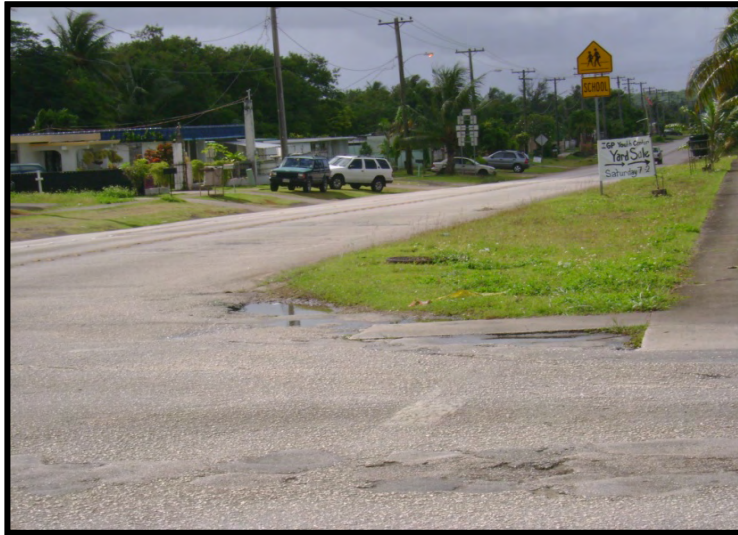
DE-112

LOCATION: RT 27A & RT 28

RECOMMENDED IMPROVEMENTS Recommend improvements to the storm drain system at this intersection including placement of 4 catch basins connecting to a 24" RCP for 100 linear feet, routing flow to an outlet equipped with a headwall/wingwall structure and a 100 square foot rip rap energy dissipator.

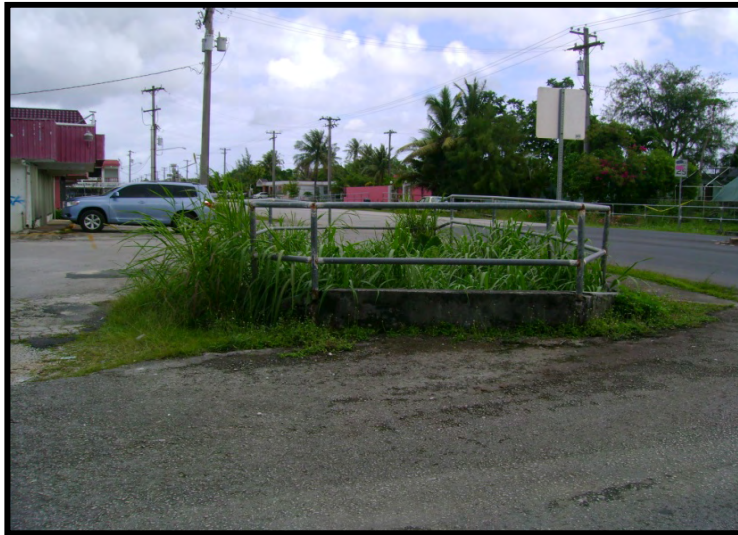
DE-113

SITE ASSESSMENT: There is an existing Infiltration Basin at the north West Intersection of Route 28 and Route 1, it needs maintenance(vegetation clearance), runoff from both route discharge directly to the basin but due to overgrown vegetation runoff is ponding on street. West from Route 28 along Buena Vista Ave an existing catch basin at the low point of the street is on the sidewalk, should be on street and an additional catch basin added.

RECOMMENDED IMPROVEMENTS Recommend 1/4 acre debris removal at the infiltration basin located at the north west corner at Route 28 and Route 1. Also recommend improvements to the storm drain system along Buena Vista Ave which will require two new catch basins connecting to a 24" RCP for 100 linear feet, outleting to a headwall/wingwall structure and a 100 square foot rip rap energy dissipator located at the infiltration basin. Roadside ditches will be required to convey flow to the new catch basins (estimated at approximately 400 LF in total length).

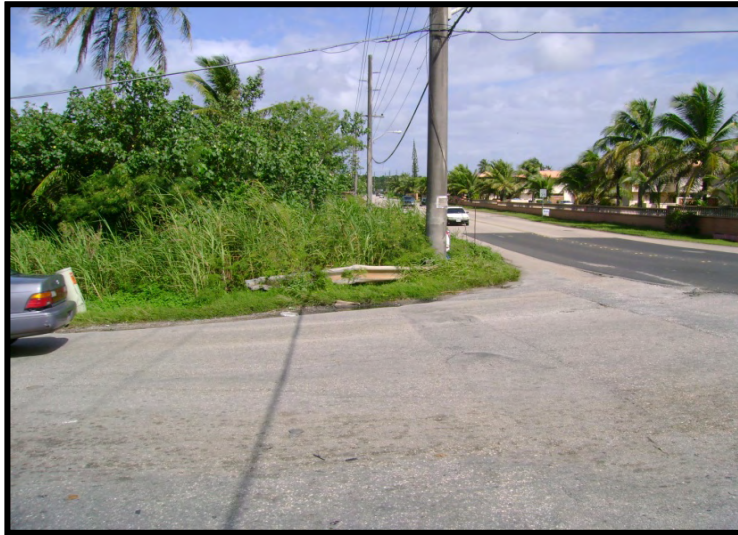
DE-114

SITE ASSESSMENT: This intersection possibly floods. Along Rt26 on the southwest of the intersection a concrete lined channel routes runoff from Rt26 from the south and ends at the intersection where possibly an inlet exists but is not visible under a pile of debris. The property across the street at the northwest corner of the intersection could be possible an existing infiltration basin, overgrown vegetation in that property makes it hard to verify. A double 18" RCP cross culverts discharge to the possible infiltration basin location, these cross culverts run under Rt26 and carry flow from the northeast corner of the intersection. A solution will be to clear vegetation in the possible infiltration basin, add catch basins along the north west corner along Route 26 and clear debris from existing concrete lined channel.

RECOMMENDED IMPROVEMENTS To prevent further flooding at this site, debris first needs to be removed from the existing concrete lined channel and infiltration basin. A quarter acre of debris will need to be removed. A new storm drain system including two catch basins will need to be added at the northwest corner of Rte 26 and Rte 25, connecting to a 24" RCP (for approximately 100 linear feet). This system should route flow to the infiltration basin through a headwall/wingwall structure and a 100 square foot rip rap energy dissipator.

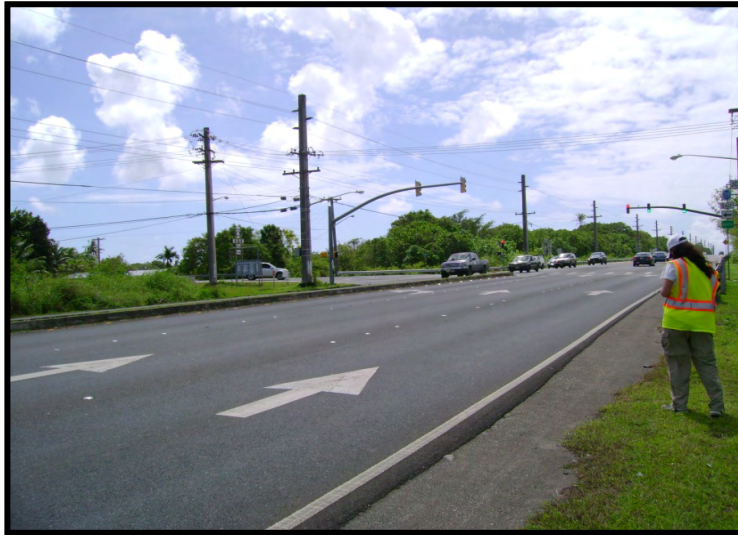
DE-118

SITE ASSESSMENT: Ponding at the northeast corner of Rt3 and Rt28. Need to re-grade corner and add an infiltration trench along Rt3 where the runoff can be routed.

RECOMMENDED IMPROVEMENTS Recommend improvements to the storm drain system at the corner of Rte 3 and Rte 28 including two catch basins along Rte 3 connecting to a 24" RCP for 100 linear feet conveying the flow to an outlet structure consisting of a 100 square foot rip rap energy dissipator equipped with an upstream headwall/wingwall structure and a downstream bioswale (100 ft length) or a downstream infiltration trench.

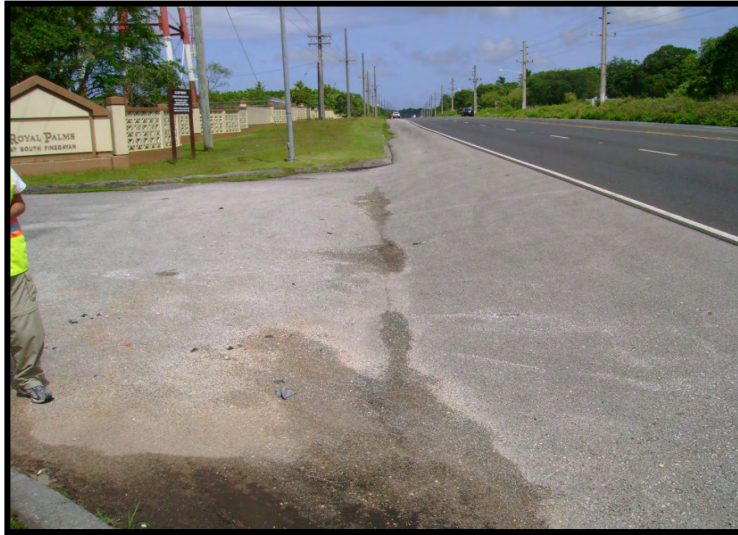
DE-119

SITE ASSESSMENT: At the intersection of Rt3 and Royal Palm, ponding occurs. A solution is to build a cross gutter at Royal Palm Drive to continue runoff down Rt3. Another solution is to add a catch basin on Royal Palm Drive and route the flow via a cross culvert under Rt3 to the east where there may be room to build an infiltration trench.

RECOMMENDED IMPROVEMENTS To prevent further ponding at this site, recommend placement of a catch basin on Royal Palm Drive (at the intersection with Rte 3), connecting to 100'x 24" RCP storm drain routing flow under Rte 3 to a 200 LF bioswale (or infiltration trench). The outlet of the storm drain system should consist of a headwall/wingwall structure with a downstream energy dissipator (100 sq ft rip rap pad).

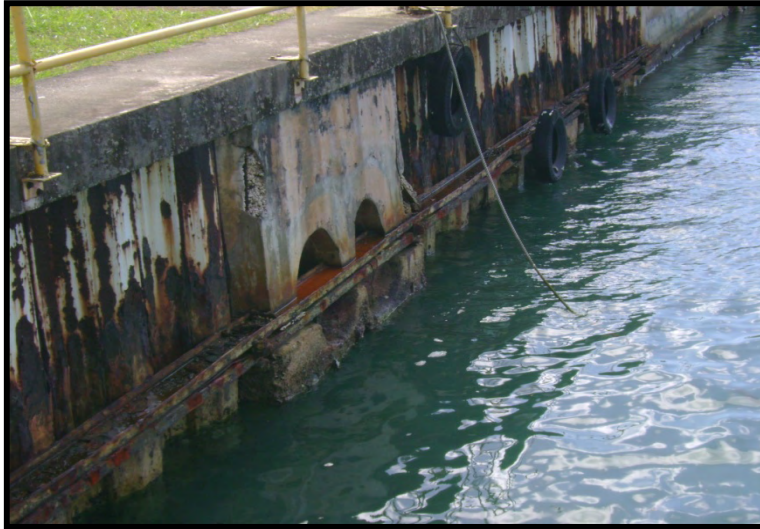
HA-120

SITE ASSESSMENT: Two 36" RCP cross culverts discharge to the Marina docking area, these culverts probably carry flow from Rt1. Headwall for the cross culverts need to be replaced, and a trash rack also added. Per the Flood Control Document, this RCB is to be increased in size to a 4'x4' RCB.

RECOMMENDED IMPROVEMENTS The RCB at this site needs to be increased in size to a 4'x4' RCB for 200 linear feet (as per the Flood Control Document) routing flow from Rte 1 to the Marina. A new headwall located at the Marina is also required

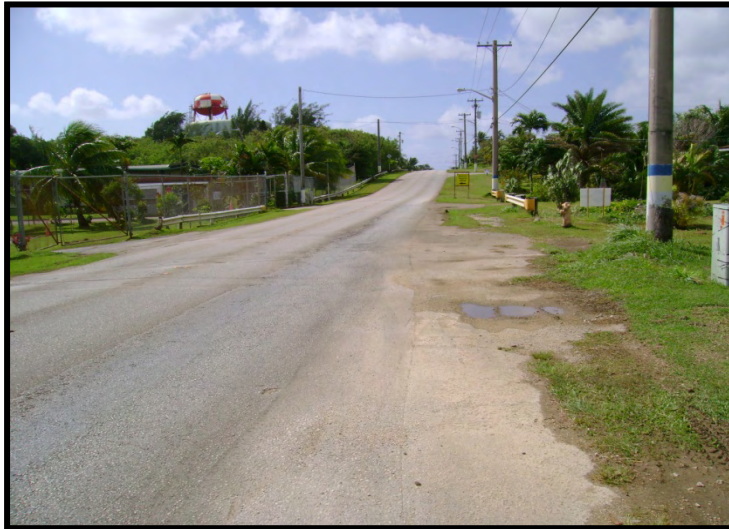
IV-102

SITE ASSESSMENT: Inarajan Mayor placed infiltration trenches along Rt4 at low point close to Ates St, but they are not working properly. Infiltration trenches were not built per standards - need to be rebuilt.

RECOMMENDED IMPROVEMENTS Infiltration trenches at this site were not constructed properly and need to be re-built. Recommend replacement with 2 standard infiltration trenches (200 LF each).

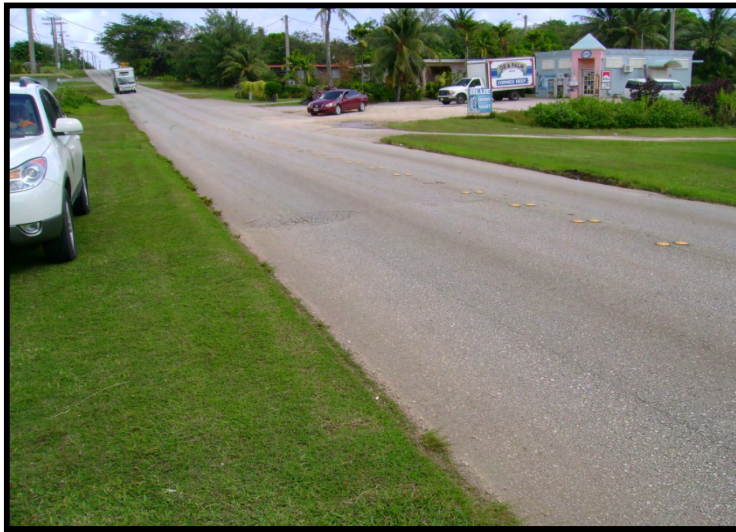
IV-103

SITE ASSESSMENT: At this location, infiltration trenches can be built on both sides of Rt4 to take care of runoff and prevent flooding and ponding.

RECOMMENDED IMPROVEMENTS To prevent future flooding at this site, placement of two 200 ft infiltration trenches are recommend along Rte 4 (both sides of road) at this site.

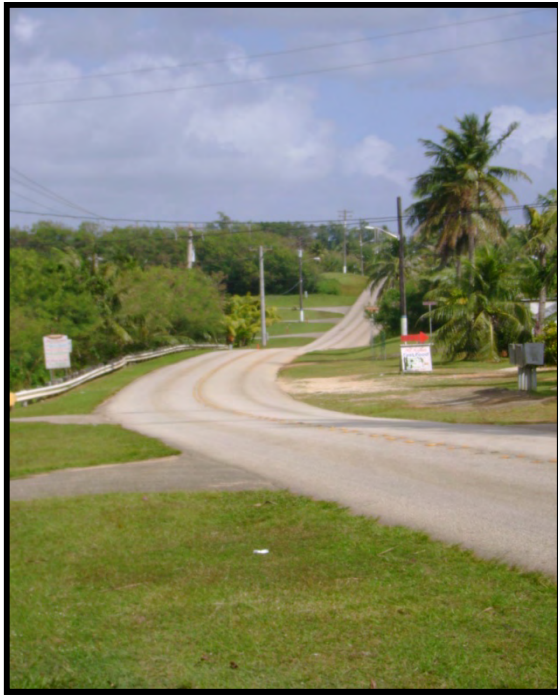
IV-104

SITE ASSESSMENT: At low point add an infiltration trench on both sides of road.

RECOMMENDED IMPROVEMENTS To prevent future flooding at this site, placement of two 200 ft infiltration trenches are recommend along Rte 4 (both sides of road) at this site.

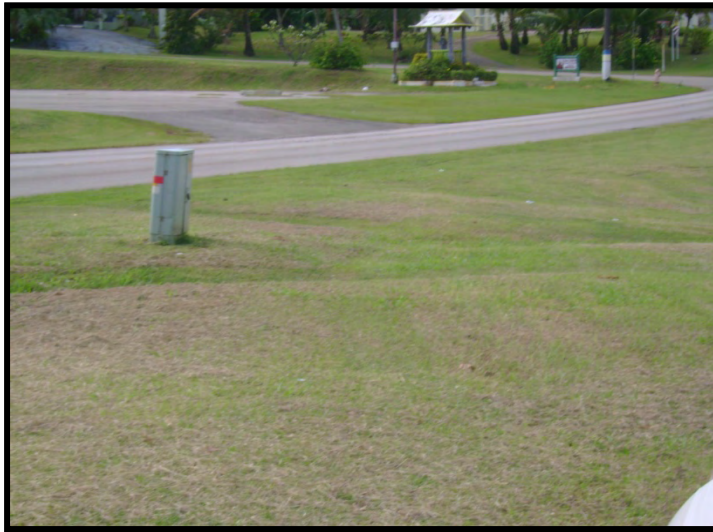
IV-105

SITE ASSESSMENT: Opposite side of Mayor's office - need to build an infiltration trench to prevent runoff from flooding private property.

RECOMMENDED IMPROVEMENTS: To prevent further flooding, recommend placement of a 200 linear foot infiltration trench along road.

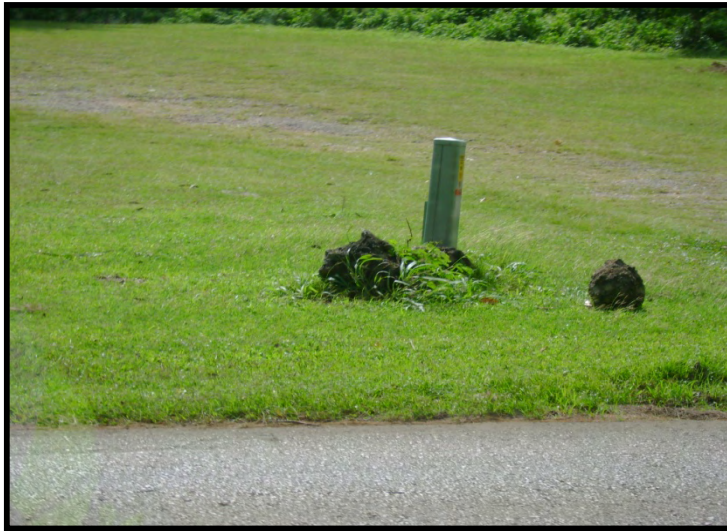
IV-106

SITE ASSESSMENT: Add infiltration trenches along Rt4 to capture runoff.

RECOMMENDED IMPROVEMENTS: To prevent future flooding at this site, placement of two 200 ft infiltration trenches are recommend along Rte 4 (both sides of road) at this site.

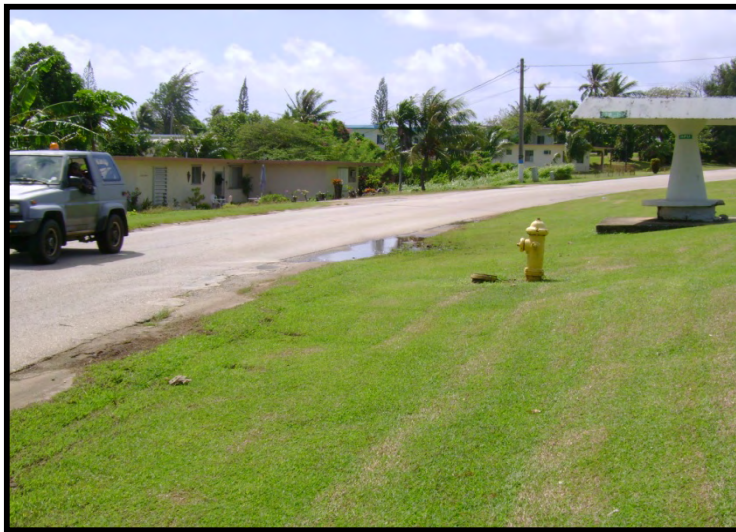
IV-111

SITE ASSESSMENT: Along Rt4 between Tinago River and Apman Dr, a low point is located where ponding is created. Need to build an infiltration trench to prevent ponding.

RECOMMENDED IMPROVEMENTS To avoid ponding at the low point at this site, recommend installation of a 200 linear foot infiltration trench adjacent to Rte 4.
