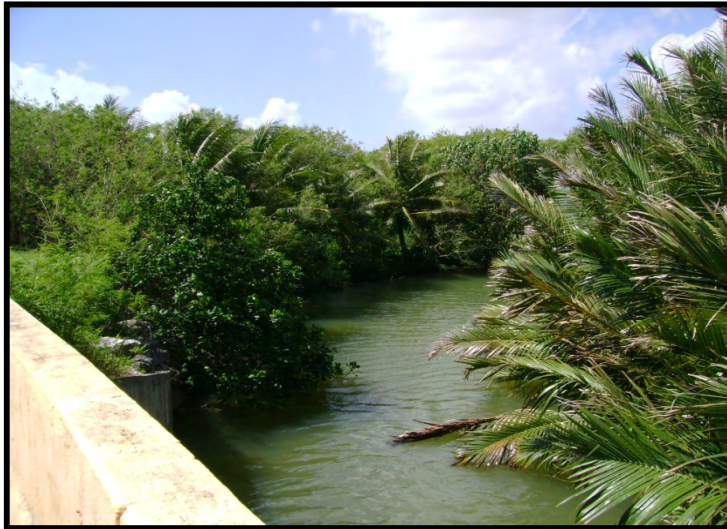
IV-112

SITE ASSESSMENT: At this location along Rt4 a bridge crosses the Agfayan River. There are Nipa trees on both the upstream and downstream of the river, these are protected trees. These trees grow in the water and cause debris to accumulate, a permit is needed to remove these trees. There is erosion on both the upstream of the river, need embankment stabilization (riprap). There is undermining of the Rt4 at the approach slabs of the bridge, need to stabilized the road embankment with riprap.

RECOMMENDED IMPROVEMENTS Erosion control and maintenance is needed at this site. Remove one quarter acre of debris. Place 1,000 square feet of rip rap for embankment stabilization adjacent to the roadside approach slabs for a distance of 25 feet upstream and 25 feet downstream of bridge.

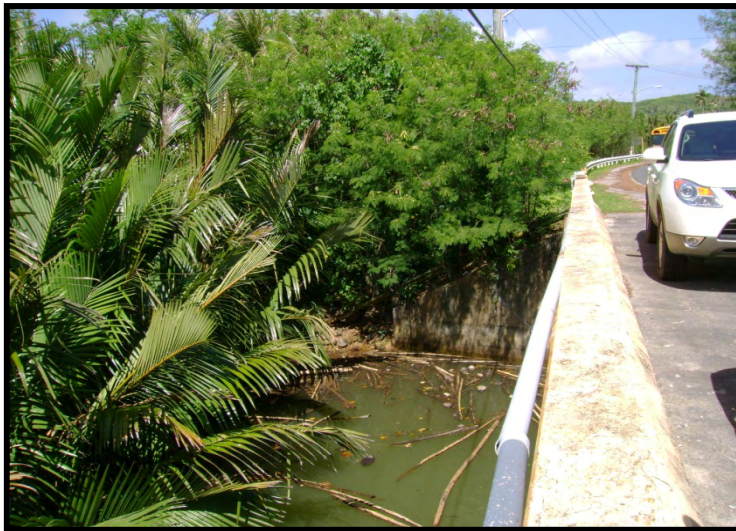
IV-113

SITE ASSESSMENT: Rt4 crosses two branches of the Inarajan River. On the north branch there are Nipa trees on both the upstream and downstream of the river, these are protected trees. These trees grow in the water and cause debris to accumulate, a permit is needed to remove these trees. There is erosion on both the upstream of the river, need embankment stabilization (riprap) also to stop the undermining of Rt4.

RECOMMENDED IMPROVEMENTS Erosion control and maintenance is needed at this site. Remove one half acre of debris. Place 2,000 square feet of rip rap for channel stabilization for a distance of 50 feet upstream and 50 feet downstream of bridge

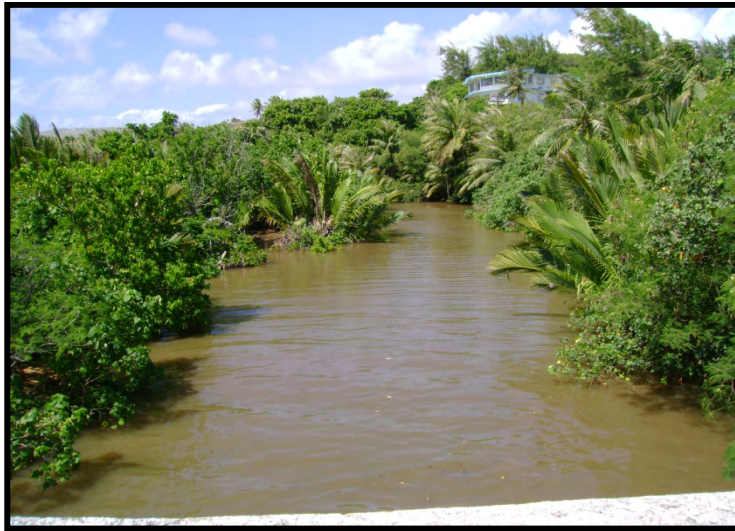
IV-114

LOCATION:	RT 4 & Inarajan River (South)
MITIGATION TYPE:	Erosion Control, Conveyance Maintenance
SITE ASSESSMENT:	Rt4 crosses two branches of the Inarajan River. On the south branch there are Nipa trees on both the upstream and downstream of the river, these are protected trees. These trees grow in the water and cause debris to accumulate, a permit is needed to remove these trees. There is erosion on both the upstream of the river, need embankment stabilization (riprap) also to stop the undermining of Rt4.
RECOMMENDED IMPROVEMENTS	Erosion control and maintenance is needed at this site. Remove one half acre of debris. Place 2,000 square feet of rip rap for channel stabilization for a distance of 50 feet upstream and 50 feet downstream of bridge
COST:	\$285,000

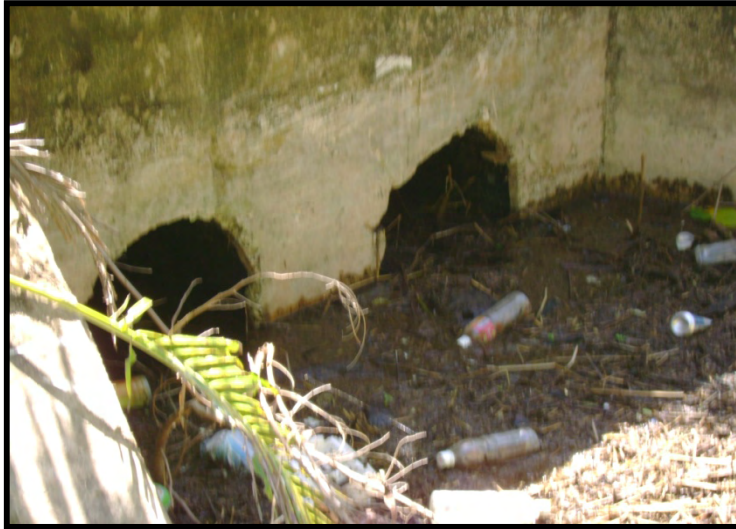
IV-118

SITE ASSESSMENT: At this location 2-24" RCP cross culverts run under Rt4. These culverts are partially clogged with sediment and trash. There is embankment erosion on both sides of the culverts and ponding along the sides of the road. Downstream bottom needs to be dredged, embankments need to be stabilized with riprap, cross culverts replaced with a 6'x3' RCB with wingwalls on both ends.

RECOMMENDED IMPROVEMENTS To prevent further erosion of the embankment and to unclog the culverts at this site, improvements and maintenance will need to be made to the drainage conveyance system. Recommend replacing existing culvert with 100'x3'x6' RCB equipped with upstream and downstream headwall/wingwall structures, and 100 SF rip rap energy dissipators placed upstream and downstream of the culvert. A quarter acre of debris removal along with some sediment removal to promote proper drainage will be required.

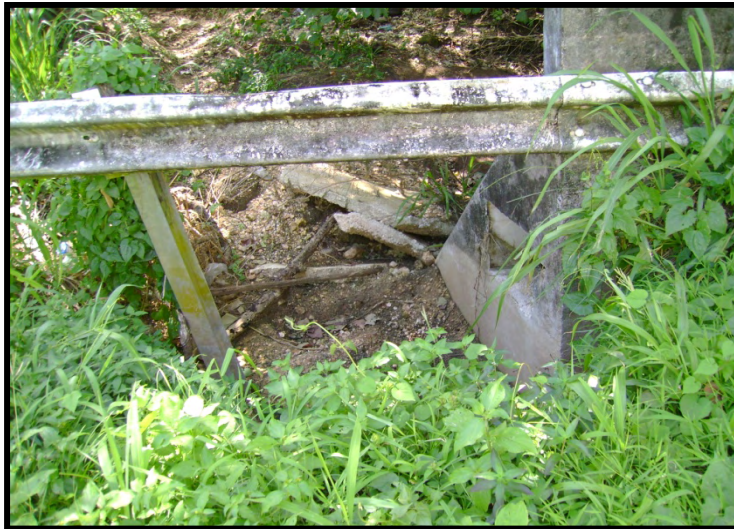
IV-119

SITE ASSESSMENT: Existing 3-24" RCP cross culverts with headwall and wingwalls cross Rt4. There is ponding along roadway adjacent to cross culverts, also significant debris/trash/sediment accumulated both upstream and downstream, culverts are clogged and erosion around headwalls. Need to replace cross culverts with a 6'x3' RCB cross culvert with wingwalls, need to dredge upstream and downstream channel, clear vegetation, add rip rap on channel embankments for erosion control, and add an infiltration trench along Rt4 to prevent ponding.

RECOMMENDED IMPROVEMENTS Erosion control is needed at this site and measures need to be taken to prevent future ponding along roadway. Recommend replacement of existing culvert with 100'x6'x3' RCB equipped with upstream and downstream headwall/wingwall structures and 100 sq ft rip rap energy dissipators at the culvert inlet and outlet. Also recommend placement of a 200 linear foot infiltration trench along Rte 4 and a quarter acre of debris removal throughout area.

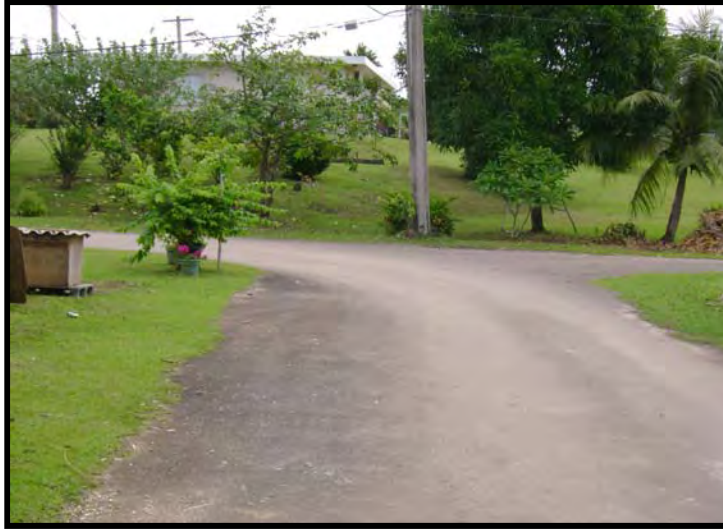
MO-104

SITE ASSESSMENT: At this location, a low point along the street exists. This creates ponding, thus flooding of about three properties. Also, this is known to be a location for mosquito breeding due to the stagnant water. A possible solution is to add a drainage conveyance system that can route flow downstream at the end of this street where an infiltration basin can be built at the lowest location.

RECOMMENDED IMPROVEMENTS Recommend placement of a 50'x400' infiltration basin with 900' of fencing at the end of the street along with grading the edge of pavement along Chargualaf Street to drain toward the basin Also recommend 1 AC of debris removal throughout area.

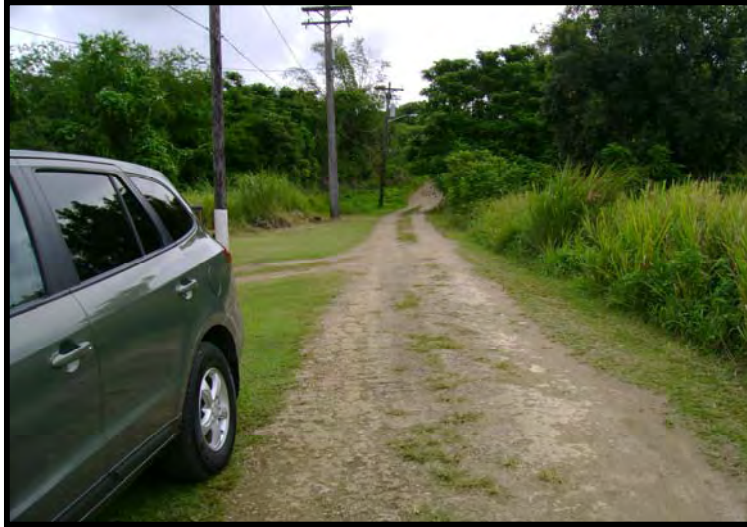
MO-105

SITE ASSESSMENT: This is the end of the street and is also the lowest point along the street. At this location, there is ponding and flooding of one property. Here, an infiltration basin can be built within an existing city easement - all runoff from this street and from Kotpus Street can be routed to this infiltration basin.

RECOMMENDED IMPROVEMENTS Recommend placement of a 200'x200' infiltration basin (with 800 LF of fencing) at the end of Chargualaf Street. Also recommend placement of a storm drain system in Chargualaf consisting of two catch basins connecting to 100 linear feet of 24" RCP storm drain and a quarter acre of debris removal. The pipeline should route the runoff to the proposed infiltration basin.

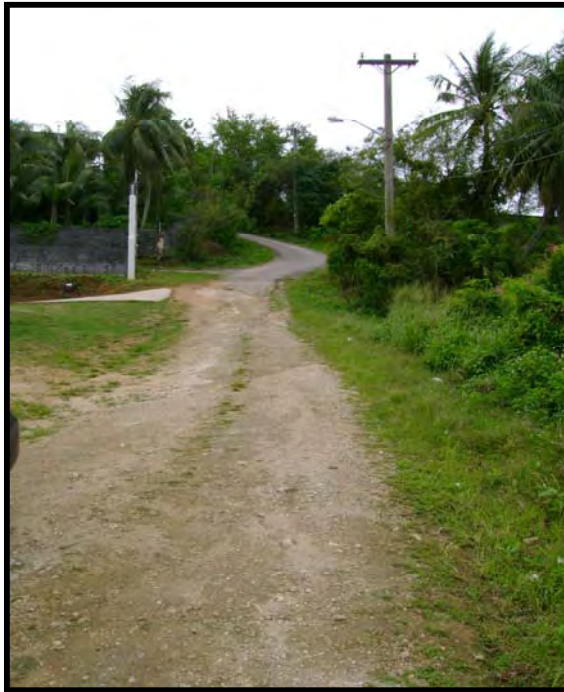
MO-106

SITE ASSESSMENT: This is a low point along Tangerine Lane where significant runoff has created in the past significant ponding and thus flooding approximately six properties at this location, including properties along Manderine Lane (parallel street to tangerine). There is no existing drainage conveyance system at this location. A possible solution is to build an infiltration basin with about eight injection wells at the end of the street in an empty lot. This basin will take care also of runoff from Manderine Lane, and it is possible that the basin can also be accessible from Manderine Lane.

RECOMMENDED IMPROVEMENTS: Recommend placement of a 200'x200' infiltration basin with 800 linear feet of fencing 8 injection wells toll improve the current drainage problems in the area. Recommend grading along the edge of pavement along Tangerine Lane to drain to infiltration basin.

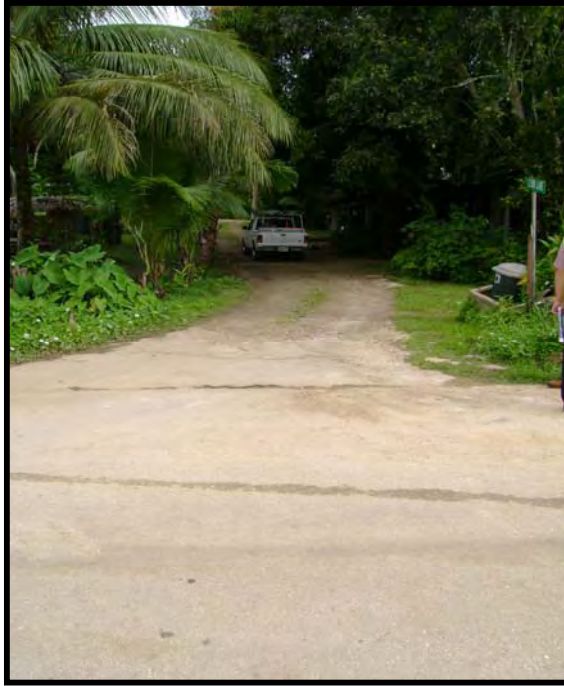
MO-108

SITE ASSESSMENT: There is a low point at this interchange. There is no existing drainage conveyance system and therefore ponding occurs and thus flooding of four properties. A possible solution will be to add a drainage conveyance system which can outlet to the proposed infiltration basin at Tangerine Lane.

RECOMMENDED IMPROVEMENTS To avoid future flooding of the properties in the area a drainage conveyance system along Lemon Lane needs to be constructed. Recommend placement of two catch basins connecting to 100 linear feet of 24" RCP storm drain outleting to the proposed infiltration basin along Tangerine (MO-106). The outlet should be equipped with a headwall/wingwall structure and a 100 square foot rip rap energy dissipator. Also recommend placement of roadside ditches (200 LF total) to route runoff to catch basins.

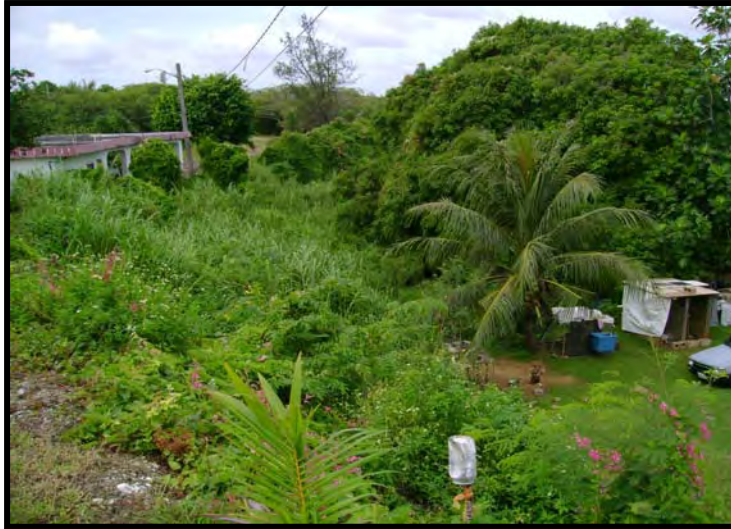
MO-110

SITE ASSESSMENT: At this end of this street a natural local depression exists within private properties where all runoff from the street drains to. There is no flooding of properties, since the lowest point is not developed and water infiltrates without causing permanent ponding or flooding of adjacent properties. There is significant erosion within the perimeter of this depression, which happens within private properties. A possible solution to stop erosion is to build a retaining wall and a concrete lined channel.

RECOMMENDED IMPROVEMENTS To prevent further erosion from occurring it is recommended that an 8000 SF retaining wall (approximately 20 feet tall by 400 feet long) be placed along the eroding hillside with a 1,000 linear foot concrete channel placed at the road edge, immediately adjacent to the wall. The conc channel will route flow to the existing sink located at the downstream side of the property. A quarter acre of debris removal throughout the area will also be needed along with placement of hydromulch and bonded fiber matrix placed along the embankments devoid of vegetation (estimated at approximately 1000 square feet).

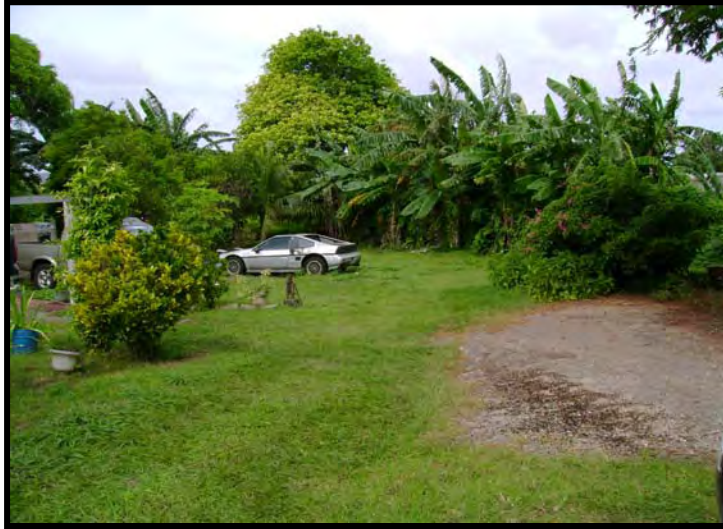
MO-111

SITE ASSESSMENT: Significant runoff from Route 10 flows to this street and creates flooding of possibly three homes. There is no existing drainage conveyance system along this street. A solution is to add drainage conveyance system along Route 10 to prevent runoff from Route 10 from entering Manha Lane, and adding infiltration trenches at the lowest point of the street to capture just street runoff.

RECOMMENDED IMPROVEMENTS To prevent further flooding at this site, recommend interception of Rte 10 flows upstream of Manha Lane and placement of an infiltration trench at the low point in Manha Lane. Along Rte 10, recommend placement of one catch basin placed immediately upgradient of Manha Lane, connecting to 100 linear feet of 24" RCP conveying flow past Manha Lane and outleting flow to a headwall/wingwall structure and a 100 square foot rip rap energy dissipator along Rte 10. Also recommend placement of a 200 linear foot infiltration trench along Manha Lane with roadway ditches (200 LF total) routing flow to infiltration trench.

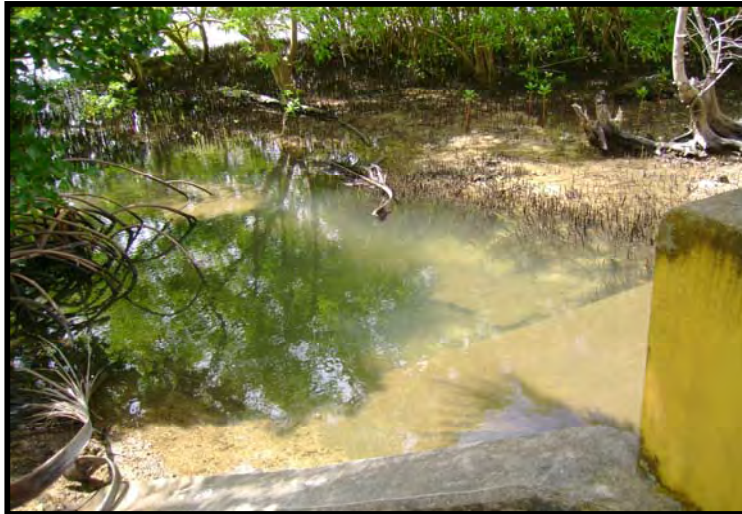
ME-108

SITE ASSESSMENT: Un-named tributary at this location. Standing water observed on the upstream side. Downstream side needs bank stabilization along the culvert and roadway. Along Route 4 there are 4 cross culverts with un-named tributaries that need bank stabilization on the upstream and downstream sides.

SITE IMPROVEMENTS: Erosion control and maintenance is needed at this site. Remove one half acre of debris and place 250 square feet rip rap for channel stabilization for a distance of 25 feet upstream and 25 feet downstream of 4 culverts (2,000 square feet total).

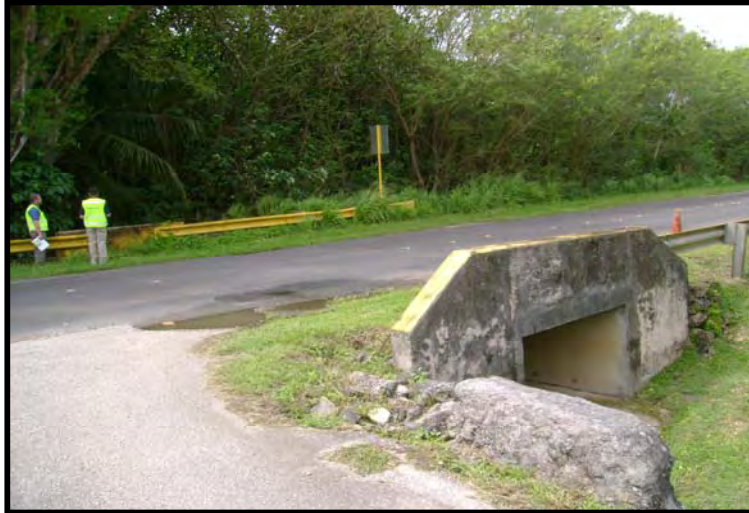
ME-112

SITE ASSESSMENT: A 6'x4' RCB cross culvert under Rt4, just south of Juan Babauta St. The RCB is in good condition, there is erosion around the upstream headwall. Need to extend headwall (or add rip rap) upstream to include a 36" RCP that is discharging to the side of the headwall, and also need to add riprap for erosion control.

SITE IMPROVEMENTS: Erosion control and maintenance is needed at this site. Remove one quarter acre of debris and place 1,000 square feet of rip rap for channel stabilization for a distance of 50 feet upstream of existing culvert and around 36" RCP culvert outlet located immediately upstream of cross culvert.

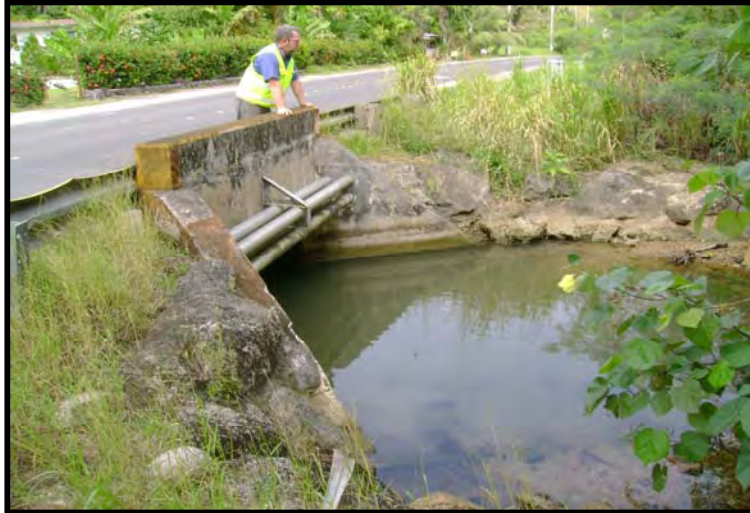
ME-116

LOCATION: RT 4 & Achang River

SITE IMPROVEMENTS: Erosion control and maintenance is needed at this site. Remove one quarter acre of debris. Place 1,000 square feet of rip rap for channel stabilization for a distance of 25 feet upstream and 25 feet downstream of culvert.

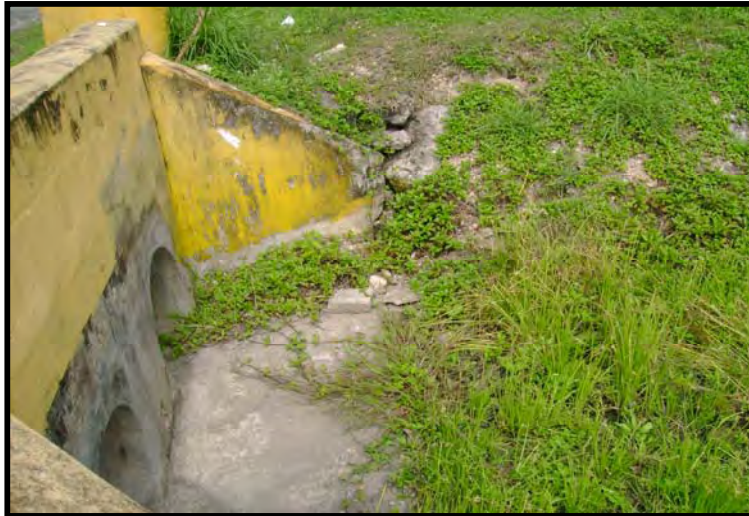
ME-117

SITE ASSESSMENT: A double 24" RCP cross culvert under Rt4 just south of Geus river. Upstream channel is in good condition except for vegetation clearing, downstream channel needs debris/sediment removal and enbankment stabilization.

SITE IMPROVEMENTS: Erosion control and maintenance is needed at this site. Remove one quarter acre of debris and place 1,000 square feet of rip rap for channel stabilization for a distance of 50 feet downstream of existing culvert.

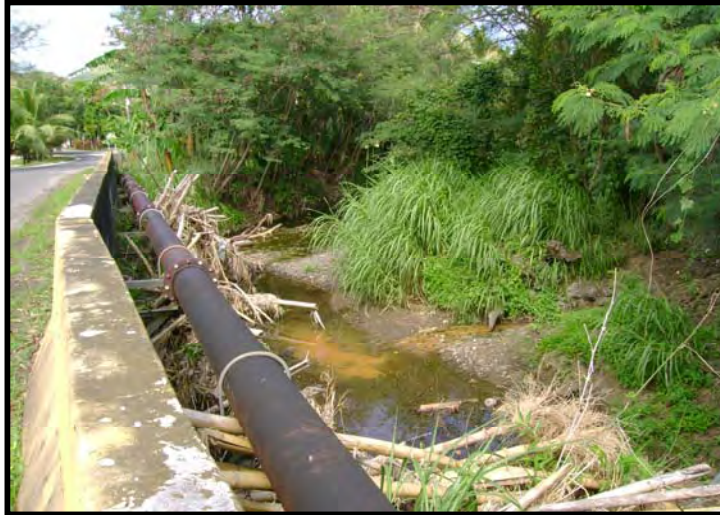
ME-118

LOCATION: RT 4 & Geus river

SITE IMPROVEMENTS: Erosion control and maintenance is needed at this site. Remove one half acre of debris. Place 2,000 square feet of rip rap for channel stabilization for a distance of 50 feet upstream and 50 feet downstream of culvert.

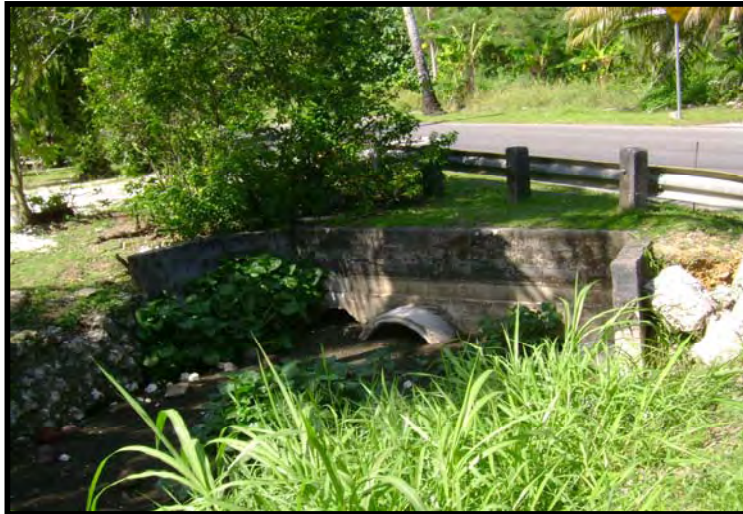
ME-119

LOCATION: RT 4 & south of Benny Espinoza Ave

SITE IMPROVEMENTS: Maintenance and channel stabilization for the area adjacent to and upstream of the house is required. Remove one quarter acre of debris. Place 1,000 square feet of rip rap for channel stabilization for a distance of 50 feet upstream and 50 feet downstream of culvert.

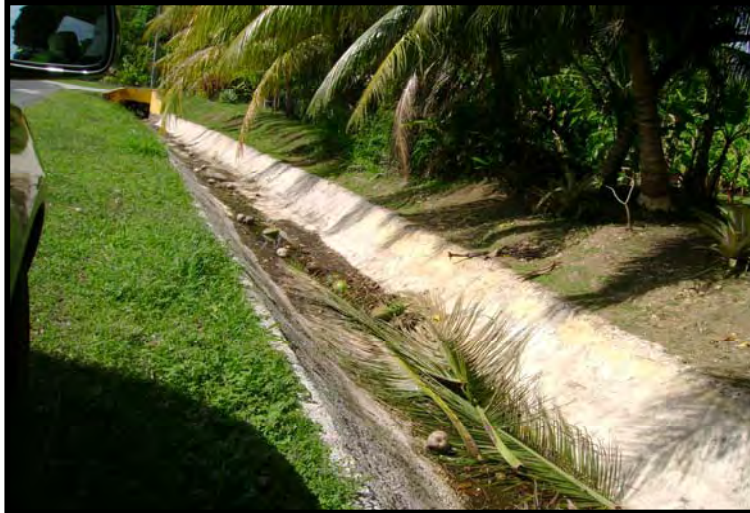
ME-120

LOCATION: RT 4 & Benny Espinoza Ave

SITE IMPROVEMENTS: Maintenance is needed at this site. Remove one quarter acre of debris and sediment from channel.

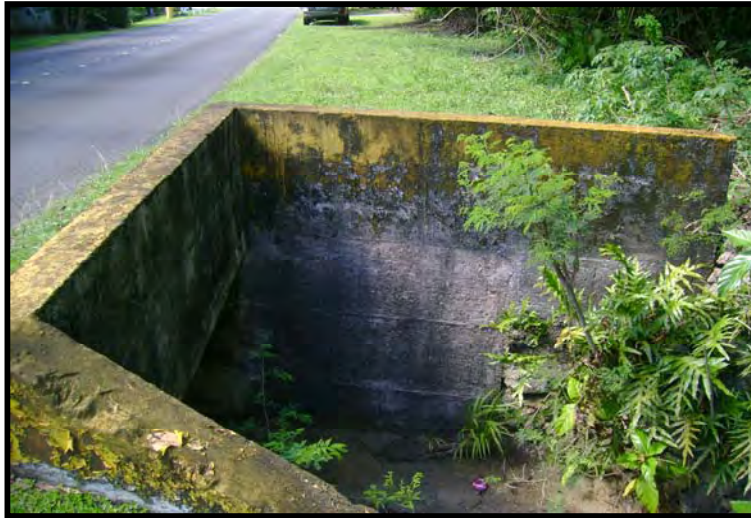
ME-121

LOCATION: RT 4 & north of Benny Espinoza Ave

SITE IMPROVEMENTS: To prevent further erosion, maintenance including 1/4 acre of debris removal and erosion control including 1,000 square feet of rip rap channel stabilization for a distance of 50 feet upstream and 50 feet downstream of the

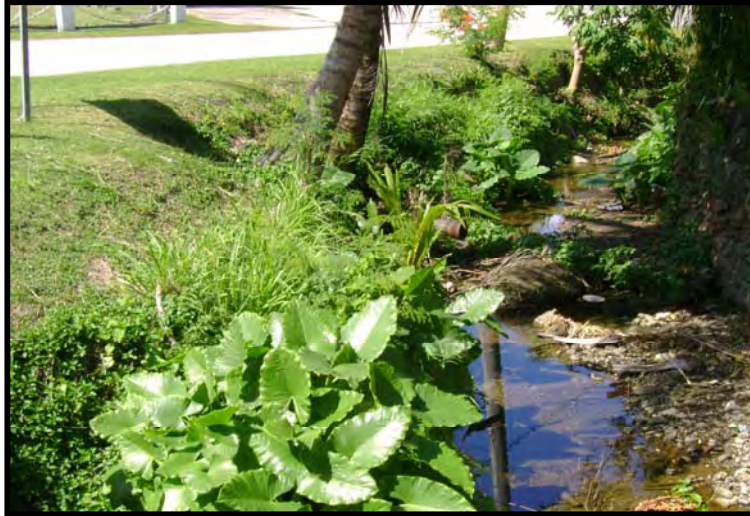
ME-122

SITE ASSESSMENT: 10'x5' RCB cross culvert under Rt4, just south of Chalan Joseph A. Cruz. This RCB routes runoff from a channel along the south side of Chalan Joseph A. Cruz. The RCB is in good condition, upstream channel needs debris/sediment removal and enbankment stabilization.

SITE IMPROVEMENTS: Erosion control and maintenance is needed at this site. Remove one quarter acre of debris and place 1,000 square feet of rip rap for channel stabilization for a distance of 50 feet upstream of existing culvert.

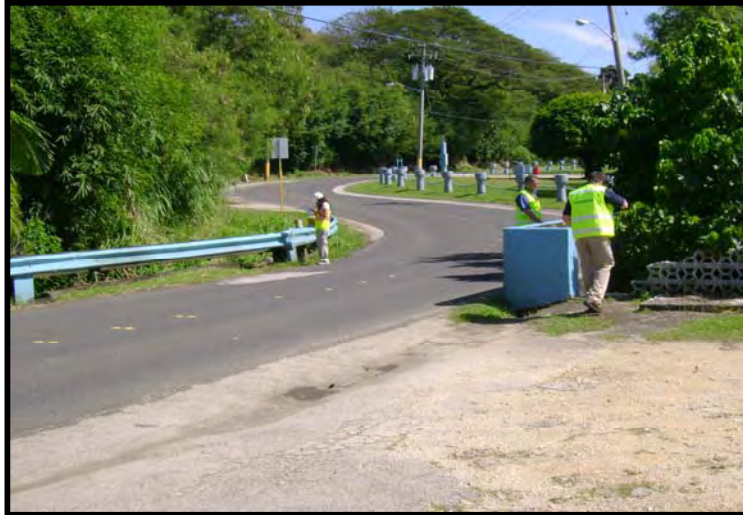
ME-124

SITE ASSESSMENT: A mixed of cross culverts cross Rt4 south of Merizo Catholic Cementary. The upstream side consits of 4-36" RCP and 4-24" RCP cross culverts, the 4-24" cross culverts sit on top of the 4-36" cross culverts. The upstream side is a RCB cross culvert. This system should be replaced with a 12'x6' RCB cross culvert with wingwalls on both ends. The upstream and downstream channels need debris/sediment/vegetation removal, and enbankment stabilization(riprap) to stop the undermining of Rt4.

SITE IMPROVEMENTS: To stop the undermining of Route 4, the placement of approximately 100 linear feet of 12'x6' RCB, with two headwall/wingwall structures (one upstream and one downstream), and 1,000 square feet of channel stabilization are required.

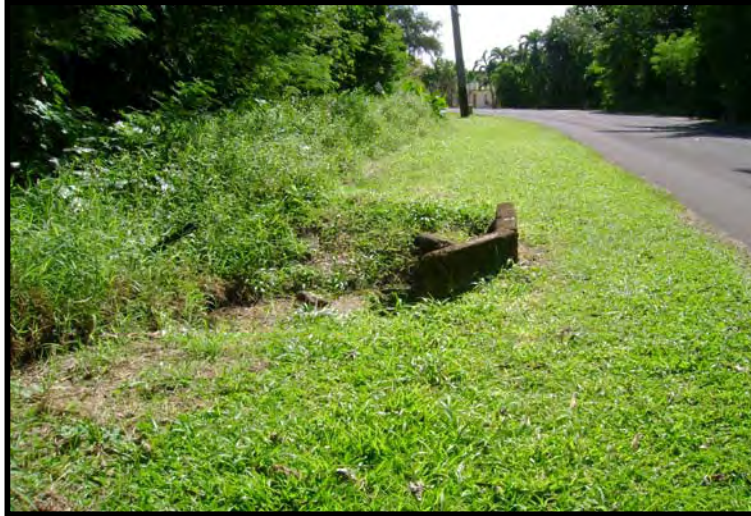
ME-125

LOCATION: RT 4 & north of Merizo Catholic Cemetary

SITE IMPROVEMENTS: To prevent further erosion, maintenance including 1/4 acre of debris and sediment removal and erosion control including 1,000 square feet of rip rap channel stabilization for a distance of 50 feet downstream of the culvert is required. Add apron and trash rack to existing catch basin at the site.

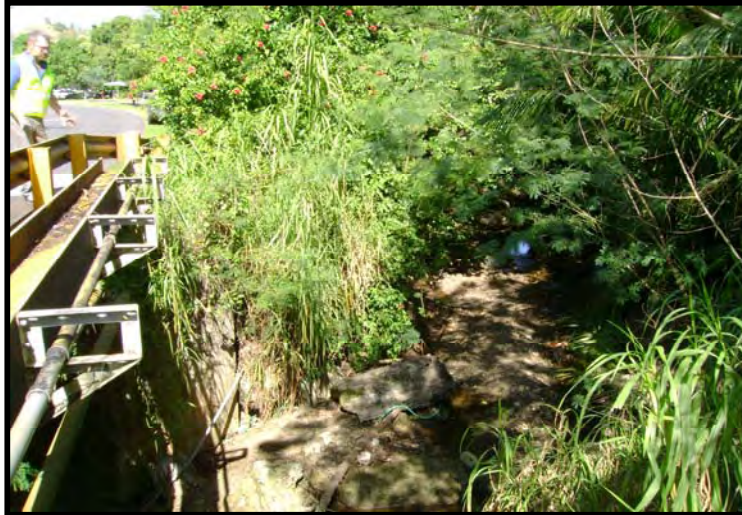
ME-126

LOCATION: RT 4 & Pigua river

SITE IMPROVEMENTS: The cross culvert at this site needs to be widened, and embankment stabilization is needed upstream and downstream. Recommended improvements include 100 cubic yard of excavation, placement of 100 square feet of rip rap stabilization along the base (10 feet upstream and 10 feet downstream of the culvert), 800 square feet of gabions placed along the embankments (400 sq ft upstream and 400 sq ft downstream of culvert), and placement of a 100'x6'x12' RCB.

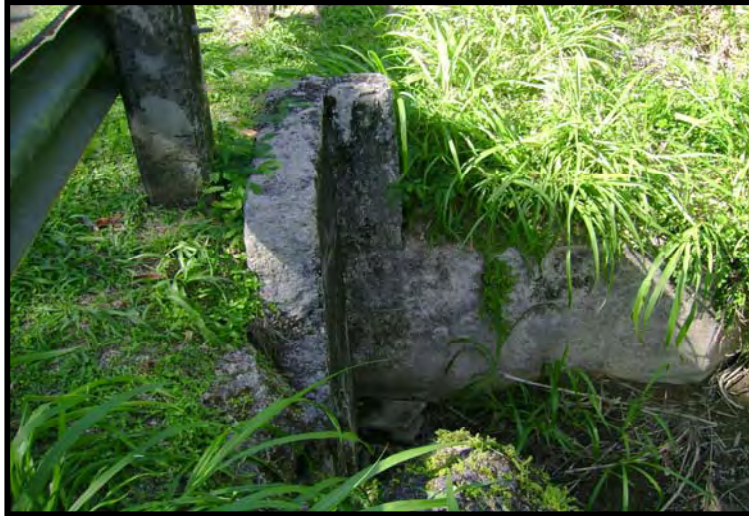
ME-128

SITE ASSESSMENT: A single 36" RCP cross culvert runs under Rt4 north of Bile river. This cross culvert should be replaced with a 5'x3' RCB with wingwalls, and the upstream and downstream channels need debris/vegetation removal and enbankment stabilization(riprap).

SITE IMPROVEMENTS: The cross culvert at this site needs to be replaced with 100 linear feet of 5'x3' RCB , a headwall/wingwall structure with 100 sq ft rip rap stabilization upstream and downstream of the culvert, excavation of approximately 20 cubic yards and maintenance including a quarter acre of debris removal.

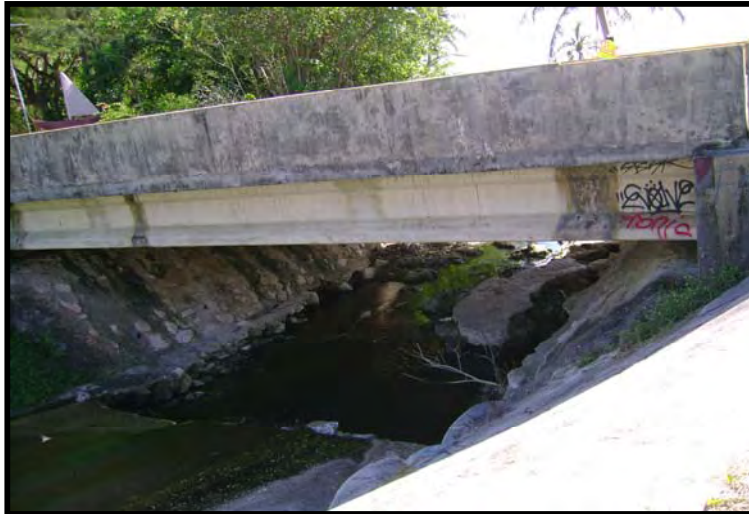
ME-129

SITE ASSESSMENT: Bridge along Rt4 over Toguan river. The upstream river is routed along a trapezoidal concrete lined channel, this channel ends with the bridge. Portions of the upstream concrete embankment are broken and need to be fixed. Bottom of the concrete channel needs to extend under bridge and downstream to stop the undermining of the bridge abutments. Need to add embankment stabilization(riprap) along the approach slabs, and also need to add riprap downstream base of river to stop erosion.

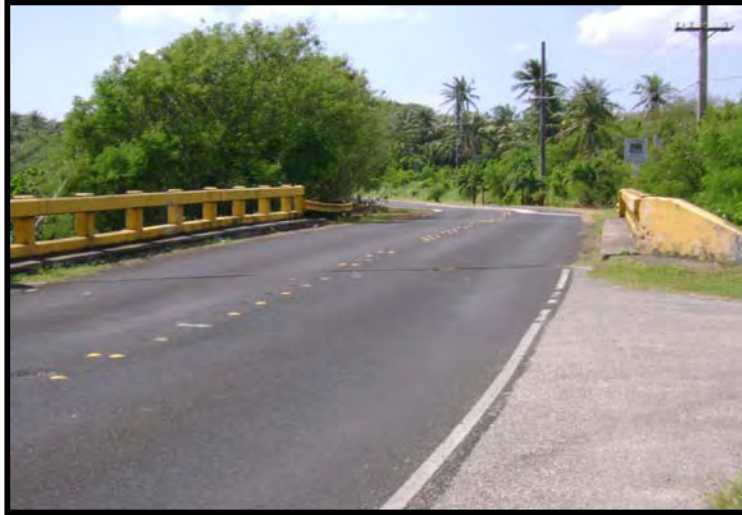
ME-130

LOCATION: RT 4 & Ajayan river

SITE IMPROVEMENTS: To prevent further undermining of the approach slabs, maintenance consisting of a quarter acre of debris removal along with installation of 1,000 square feet rip rap channel stabilization is recommended.

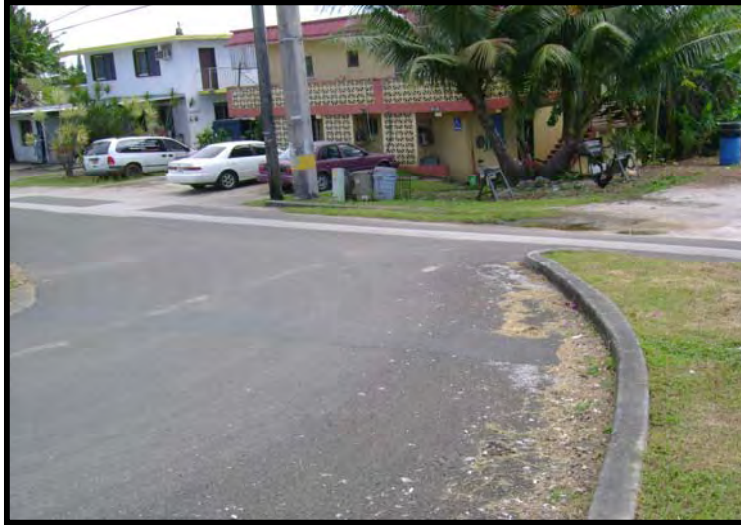
MM-101

SITE ASSESSMENT: Concentrated flow from Route 8 on and off ramps discharge to Rt33 at a location where the apartment complex at 105 Roy T. Damian is located. Building gets flooded from runoff. Need to add catch basins with a pipe outletting to the Hagatna river, which is located behind this apartment complex. Need to add underground infiltration chamber or media filter to system (assume underground infiltration chamber @ \$500,000)

RECOMMENDED IMPROVEMENTS To prevent the continuation of flooding at 105 Roy T. Damian, improvements to the storm drain system need to be made to the Rte 8/ Rte 33 intersection. The proposed improvements are to add 2 catch basins connected by 200'x24" RCP, conveying flow from Rte-8 to the east side of Rte 33, across Rte 33 to the west side where it can outlet to an existing drainage flow path along the Agana River. In order to treat the runoff, it is recommended that an underground infiltration vault be constructed under Rte 33 to accomodate the water quality volume of the roadway runoff. It is apparent that sufficient right of way is unavailable for placement of a bioswale downstream of the proposed drainage network. The outlet of the drainage system will consist of a headwall/wingwall structure, leading flow to a 100 square foot rip rap energy dissipator.

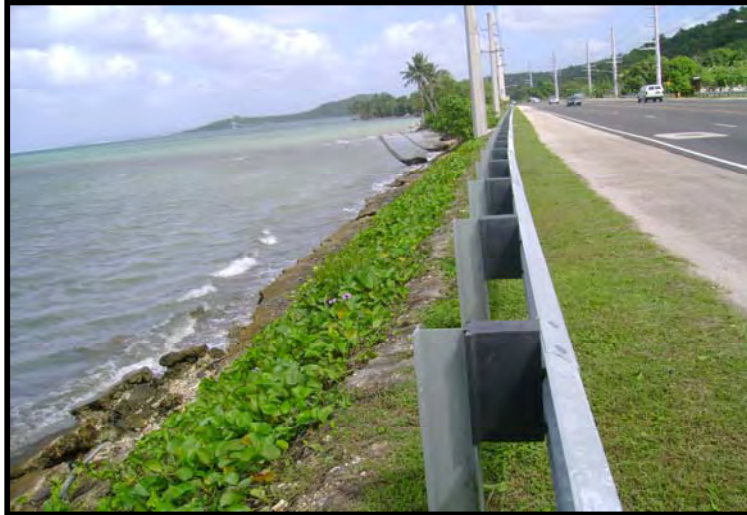
PI-101

LOCATION: RT 1 & Masso River to 1000' North

RECOMMENDED IMPROVEMENTS To prevent further shoreline erosion, maintenance including 1 acre of debris removal and placement of 10,000 square feet of rip rap coastal stabilization (approximately 10-ft in width along the shoreline) from Masso River to 1000 feet north of the river is recommended.

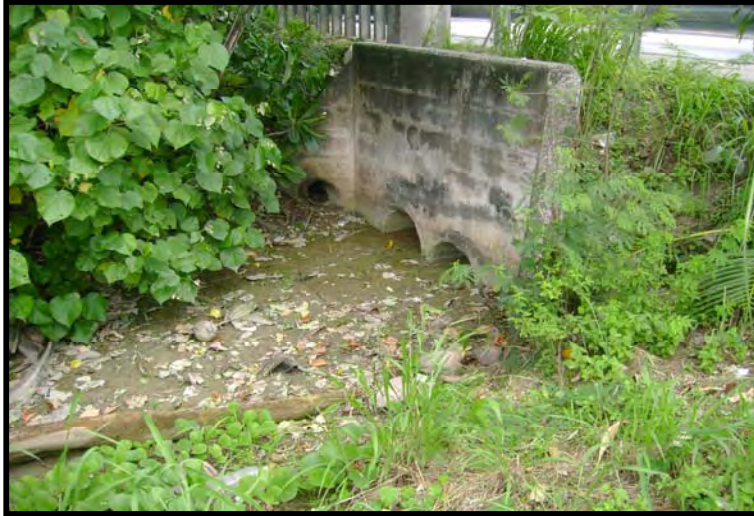
PI-102

SITE ASSESSMENT: A double 36" cross culverts runs under Route 1 and outlets on the north side of Pedro Santos Park. These culverts are under sized and there is significant sediment blocking the downstream end, they carry runoff from the south side of Route 1 from Mary Pling St. This double cross culvert should be replaced with a RCB with wingwalls, downstream debris and sediment should be removed also.

RECOMMENDED IMPROVEMENTS In order to provide sufficient conveyance capacity, the existing culvert should be replaced with 200 linear feet of a 3'x5' RCB equipped with headwall/wingwall structures on the upstream and downstream sides of the culvert. To prevent further erosion, maintenance including 1/4 acre of debris removal and erosion control including 1,000 square feet of rip rap channel stabilization for a distance of 25 feet upstream and 25 feet downstream of the culvert is required.

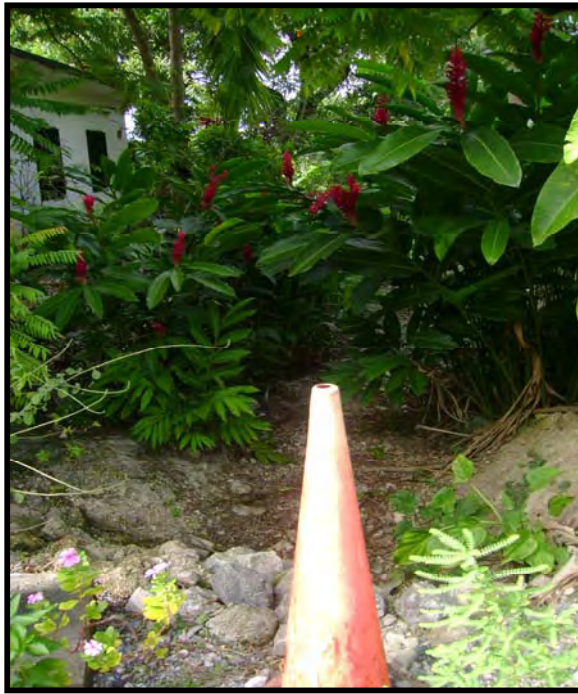
PI-103

SITE ASSESSMENT: This area flows to the 2-36" cross culverts at Rt1. A 24" RCP cross culverts carries from from the area to the 2-36" RCP cross culverts. Homes have encroached into the earthen swales. Need to improve the drainage system in order to prevent the flooding of homes, also this area is in the flooding zone. Need to clear earthen channel of debris and vegetation and replace the 24" RCP cross culvert with a double 36" cross culverts with headwalls on both ends.

RECOMMENDED IMPROVEMENTS In order to provide sufficient conveyance capacity, the existing 24" culvert should be replaced with 100 linear feet of double 36" RCP culvert with headwall/wingwall structures on the upstream and downstream sides of the culvert. To prevent further erosion, maintenance including 1/4 acre of debris removal and erosion control including a 200 sq ft energy dissipator located at the downstream side of the culvert is recommended.

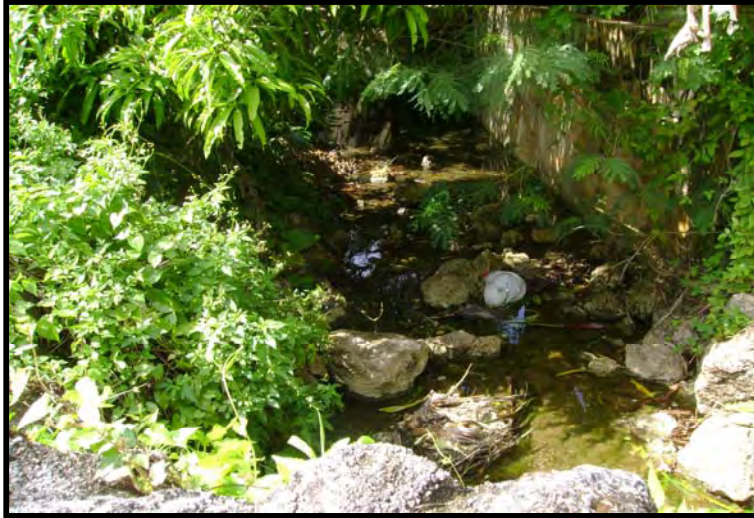
PI-104

LOCATION: A Quenga St & Assumption Drive

RECOMMENDED IMPROVEMENTS To prevent further erosion, maintenance including 1/4 acre of debris removal and erosion control including 1,000 square feet of rip rap stabilization for a distance of 25 feet upstream and 25 feet downstream of the culvert is recommended.

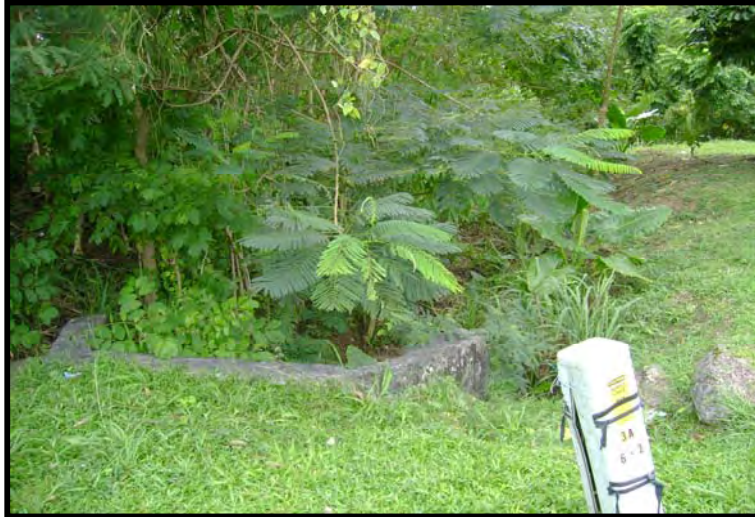
PI-105

LOCATION: Assumption Drive

RECOMMENDED IMPROVEMENTS To prevent further erosion, maintenance including 1/4 acre of debris removal and erosion control including 1,000 square feet of rip rap stabilization for a distance of 25 feet upstream and 25 feet downstream of the culvert is recommended.

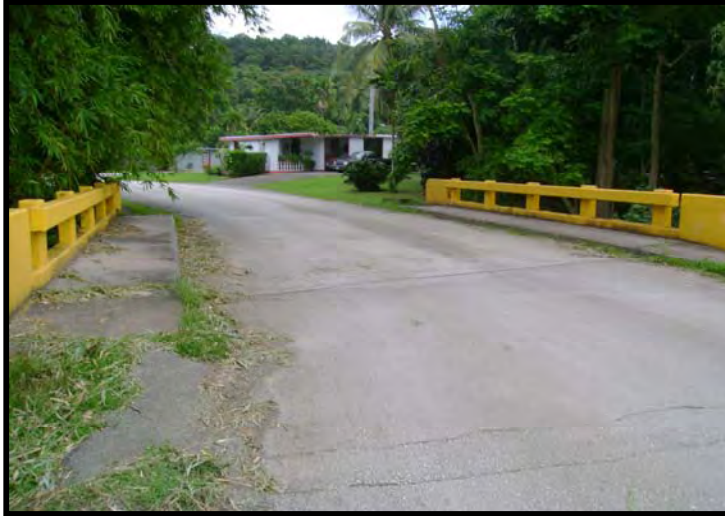
PI-106

LOCATION: Assumption Drive & Masso River

RECOMMENDED IMPROVEMENTS To prevent further erosion, maintenance including 1/4 acre of debris removal and erosion control including 1,000 square feet of rip rap channel stabilization for a distance of 25 feet upstream and 25 feet downstream of the bridge is required.

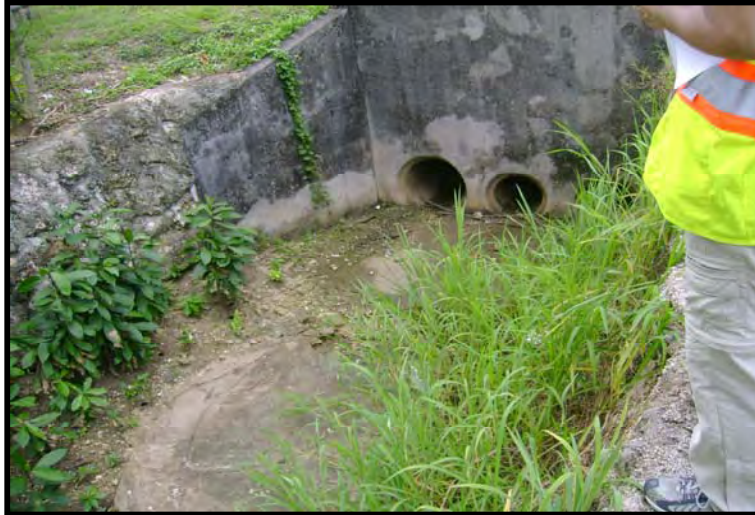
PI-107

SITE ASSESSMENT: A concrete/rock channel along Chalan Soling discharges into a triple cross culverts 18"-24" which runs under Rt1 and discharges to the Tepungan Beach. The outlet at the beach is covered with sediment. These cross-culverts should be replaced with a RCB with headwall and wingwalls at both upstream and downstream, and riprap at the downstream end to prevent erosion. Neighboring homes get flooded especially during high tides.

RECOMMENDED IMPROVEMENTS In order to provide sufficient conveyance capacity, the existing culvert should be replaced with 100 linear feet of 3'x3' RCB equipped with headwall/wingwall structures on the upstream and downstream sides of the culvert. To prevent further erosion, maintenance including 1/4 acre of debris removal and erosion control including a 200 sq ft energy dissipator located at the downstream side of the culvert is recommended.

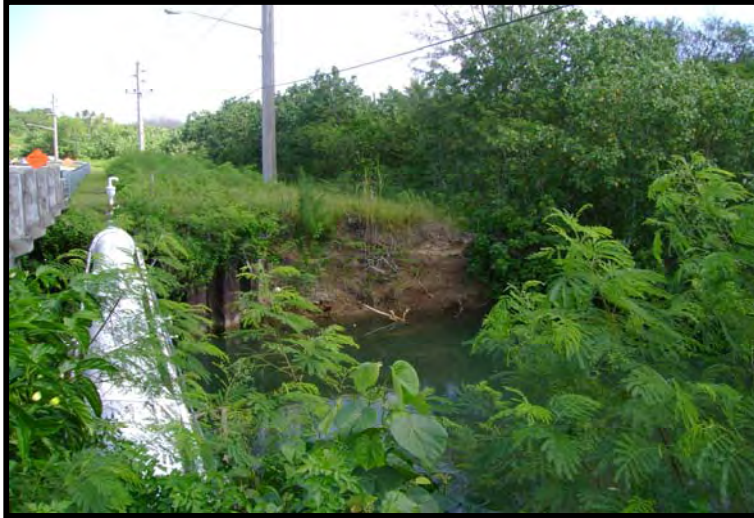
PI-108

SITE ASSESSMENT: Bridge along Rt1 over Atantano river. Approach slabs are sinking, there is erosion at approach slabs, and parts of wingwalls missing. Upstream of channel there is significant erosion along embankment. Need to add erosion control(riprap) along upstream embankment and wingwalls.

RECOMMENDED IMPROVEMENTS To prevent further erosion, maintenance including 1/4 acre of debris removal and erosion control including 1,000 square feet of rip rap channel stabilization for a distance of 50 feet upstream of the bridge is required.

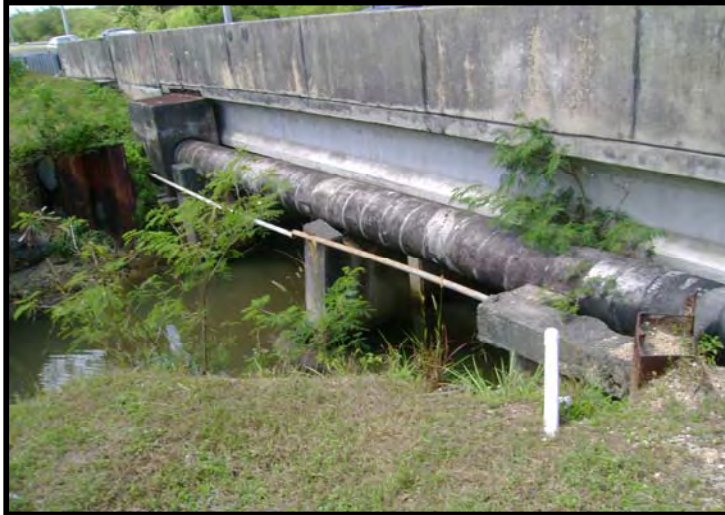
PI-109

LOCATION: RT 1 & Sasa River

RECOMMENDED IMPROVEMENTS To prevent further erosion, maintenance including 1/4 acre of debris removal and erosion control including 1,000 square feet of rip rap channel stabilization for a distance of 25 feet upstream and 25 feet downstream of the bridge is required.

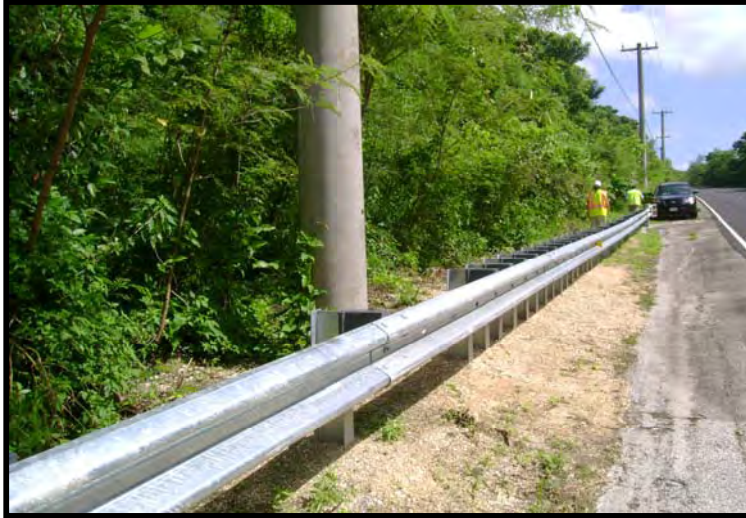
PI-110

LOCATION: RT 6 & Masso River

RECOMMENDED IMPROVEMENTS To prevent further erosion, maintenance including 1/4 acre of debris removal and erosion control including 1,000 square feet of rip rap channel stabilization for a distance of 25 feet upstream and 25 feet downstream of the bridge is required.

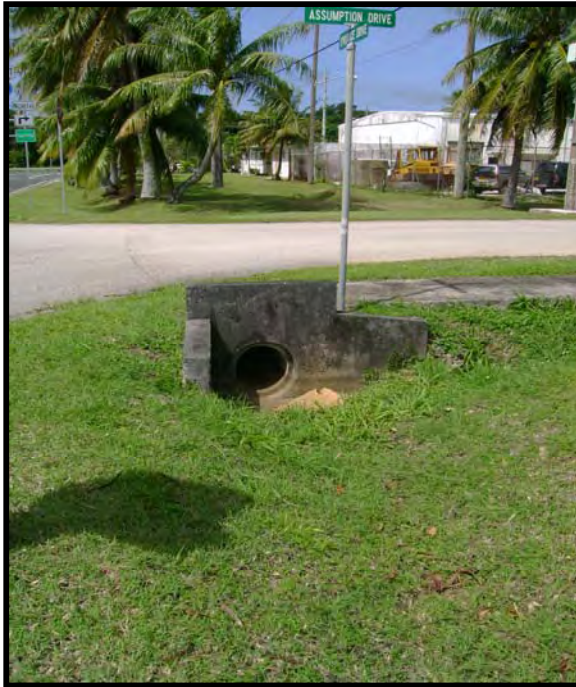
PI-111

SITE ASSESSMENT: At the intersection of Rt6 and Assumption Drive there is a 18" cross culvert that runs parrallel to Rt6 under Assumption Drive. This cross culvert carries flows from Assumption Drive and from Rt6. This culvert should be replaced with a 2'x3' minimum RCB to handle the flow. The runoff from the culvert and a swale from Assumption Drive are collected by a double 18" cross culverts at the interchange of Rt6 and Rt1(northeast corner), the entrance has a straight headwall it needs wingwalls added and debris removal.

RECOMMENDED IMPROVEMENTS In order to provide sufficient conveyance capacity, the existing culvert should be replaced with 100 linear feet of 24" RCP equipped with headwall/wingwall structures on the upstream and downstream sides of the culvert. To prevent further erosion, maintenance including 1/4 acre of debris removal and erosion control including 1,000 square feet of rip rap channel stabilization for a distance of 25 feet upstream and 25 feet downstream of the culvert is required.

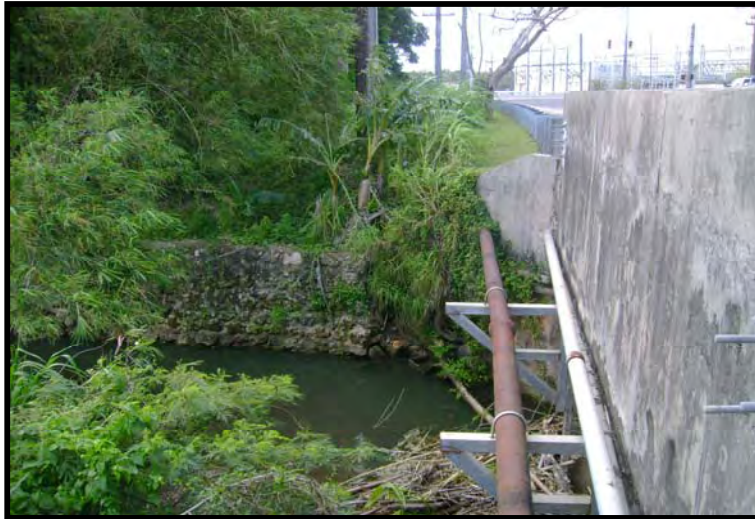
PI-112

LOCATION: RT 1 & Masso River

RECOMMENDED IMPROVEMENTS To prevent further erosion, maintenance including 1/4 acre of debris removal and erosion control including 1,000 square feet of rip rap channel stabilization for a distance of 25 feet upstream and 25 feet downstream of the bridge is required.

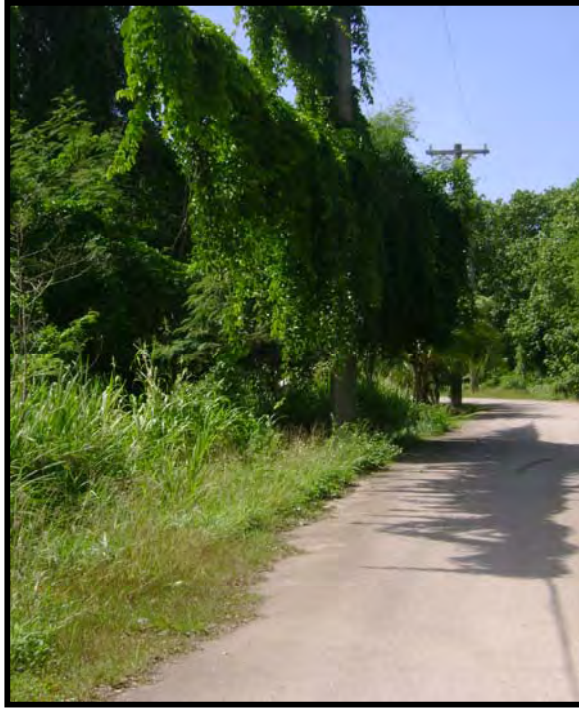
PI-113

LOCATION: A Quanga St

RECOMMENDED IMPROVEMENTS To prevent further erosion, maintenance including 1/4 acre of debris removal and erosion control including 1,000 square feet of rip rap stabilization for a distance of 25 feet upstream and 25 feet downstream of the culvert is recommended.
