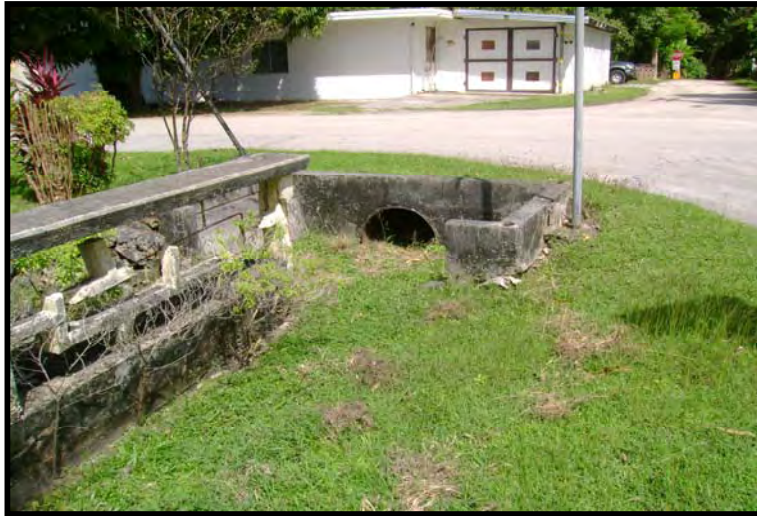
PI-114

LOCATION: J.C. Santos & J.M. Tuncap St

RECOMMENDED IMPROVEMENTS In order to provide sufficient conveyance capacity, the existing 24" culvert should be replaced with 100 linear feet of 36" RCP culvert with headwall/wingwall structures on the upstream and downstream sides of the culvert. To prevent further erosion, maintenance including 1/4 acre of debris/ sediment removal (and removal of the patio in the flow path) along with erosion control including 1000 sq ft of rip rap channel stabilization placed 50 feet upstream and 50 feet downstream of the culvert is recommended.

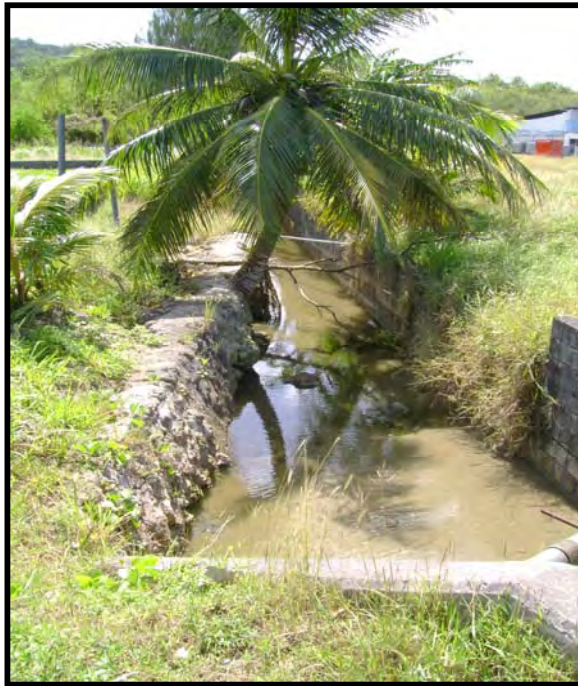
PI-115

SITE ASSESSMENT: Cross culvert RCB under Rt1, this is possibly the Taguag river. RCB in good shape, downstream channel needs to remove a palm tree that is growing on the side of the concrete/rock embankment and repair the embankment.

RECOMMENDED IMPROVEMENTS To prevent further erosion, maintenance including 1/4 acre of debris removal and erosion control including 1,000 square feet of rip rap stabilization for a distance of 25 feet upstream and 25 feet downstream of the culvert is recommended.

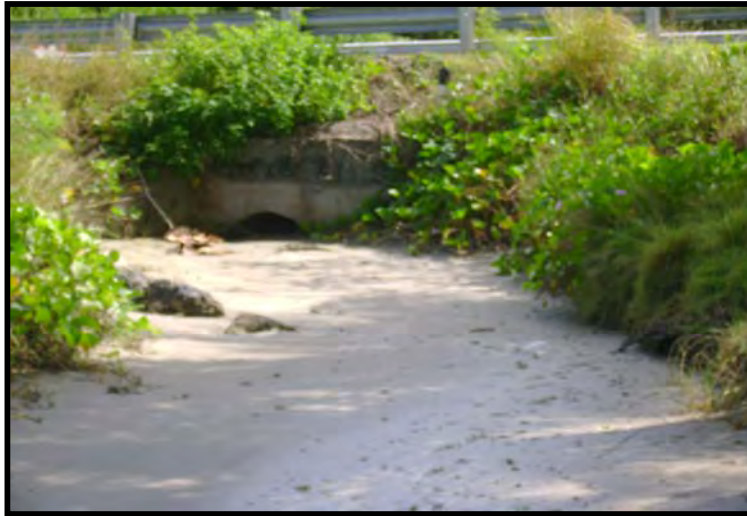
PI-116

LOCATION: RT 1 & Tepungan Beach Park

RECOMMENDED IMPROVEMENTS Maintenance and improvements need to be made to the existing drainage conveyance system to allow for the flow to be adequately conveyed to the shore. Maintenance including one quarter acre of debris and sediment removal is required. Replacement of the double 36-inch pipes under the parking lot may be required (approximately 100 linear feet of 2 - 36" RCP) and upstream and downstream headwall/wingwall structures with a 200 square foot rip rap outlet energy dissipator is recommended.

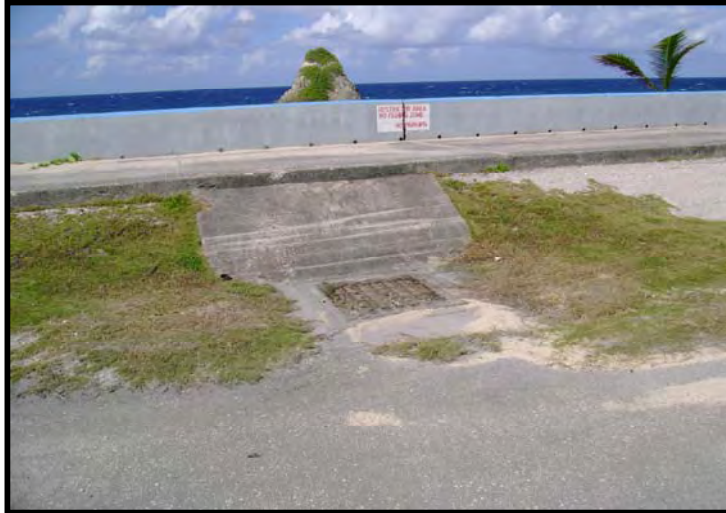
PI-118

LOCATION: RT 11 & Commercial Port

RECOMMENDED IMPROVEMENTS In order to mitigate water quality concerns along the road, 2-100 linear foot bioswales are proposed for conveyance of runoff along the west side of the road to a grated inlet with a 100 square foot apron located at the low point of the road. The bioswales will be located on both sides of the inlet.

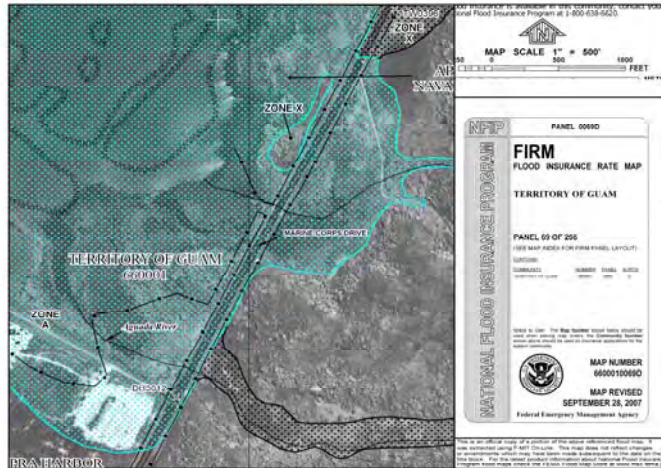
PI-119

LOCATION: RT 1 & Polaris Point

RECOMMENDED IMPROVEMENTS Raise Rt1 over Sasa, Laguas, Agueda and Atantano River flood plains for a total distance of 13,000 feet (raise 1 ft for a distance of 4000' at Sasa River, raise 2' for a distance of 4000' at Atantano River and raise 2' for a distance of 5000' at Agueda and Laguas Rivers). Place gabions along the edge of right-of-way where necessary to raise roadway elevation (estimated 13,000 CY). Replace an estimated 30,000 SY of pavement along entire length. Add rip rap stabilization of channels for a distance of 50' upstream and downstream of each crossing (estimated 1200 CY of rip rap). Construct storm drain network along raised portion of roadway (estimated 22 catch basins and 6500' of 24" RCP). Where roadway flow is not concentrated, place biostrips along edges of pavement for treatment. Where flow enters storm drain system, add media filters at outlets to treat runoff prior to outleting into offsite waterways (estimated 8 media filters). Bioswales may be an option instead of media filters if right of way is available. Cost estimate assumes media filters.

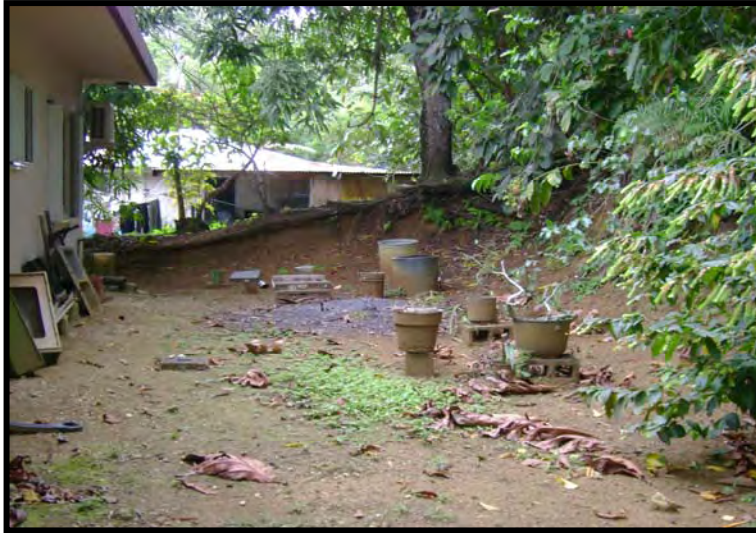
SR-101

LOCATION: #746 Obispo Olano(RT 12) & Pale Medina St

RECOMMENDED IMPROVEMENTS: This property will require approximately 200 linear feet of concrete trapezoidal channel to convey flow from what appears to be overflow from a spring located at the back of the property to the front of the property along the edge of right of way. Approximately 1000 SF of rip rap stabilization is also needed at this site for erosion control.

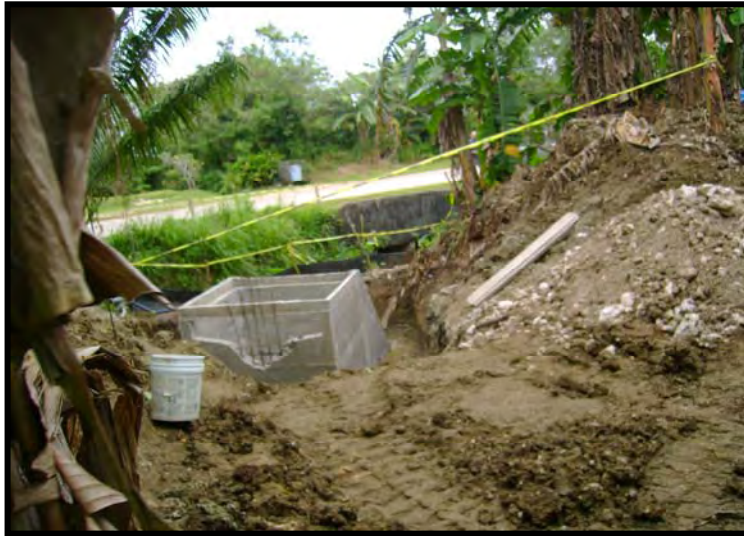
SR-102

LOCATION: Obispo Olano(RT 12) & Pale Medina St

RECOMMENDED IMPROVEMENTS: Recommend placement of 20' high gabion walls on each side of the culvert outlet for a distance of 50 feet downstream along with 1000 cubic feet of rip rap placed at the channel bottom for the same distance for erosion control at the site. One quarter acre of debris removal is also needed at this site.

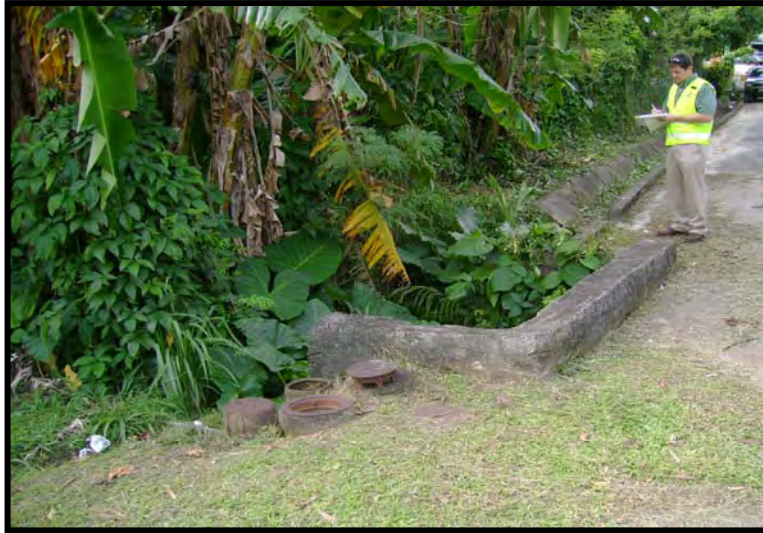
SR-103

SITE ASSESSMENT: A 2-36" cross culvert under Pale Ramon St carry the flow from Obispo Olane. These culverts should be replaced with a 8'x5' RCB, and upstream and downstream needs embankment stabilization (riprap or gabions for about 200') and debris/vegetation removal.

RECOMMENDED IMPROVEMENTS The double 36" RCP cross culvert at this site needs to be replaced with 100 linear feet of 8'x5' RCB and a headwall/wingwall structure with 2000 sq ft rip rap stabilization along the channel bottom and 1000 sq ft gabion placement along the channel sides for a distance of 200 feet upstream and downstream of the culvert. One quarter acre of debris removal is also needed at this site for maintenance and approximately 1000 sq ft of hydromulch with bonded fiber matrix is recommended at the top of the channel.

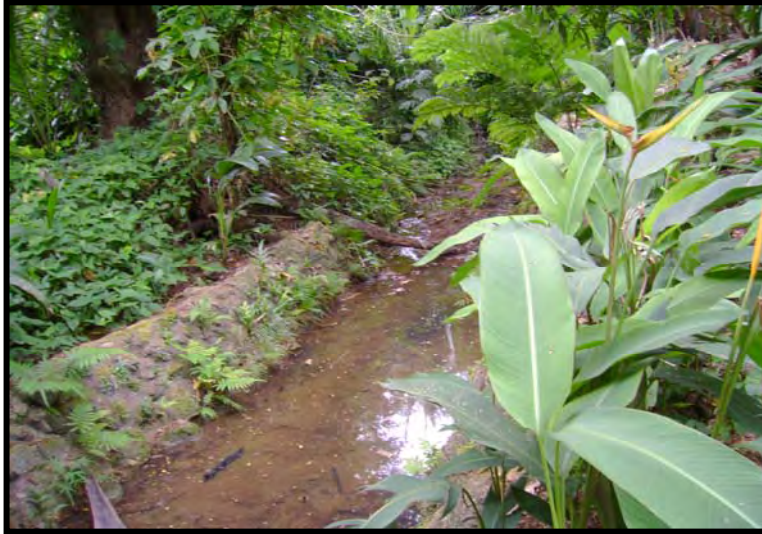
SR-105

LOCATION: Namo Falls Park & Obispo Olano(RT 12)

RECOMMENDED IMPROVEMENTS Recommend placement of 100 linear feet of 36" RCP adjacent to existing cross-culvert in order to improve conveyance capacity across roadway at this location. The new cross-culvert should be equipped with new headwall/wingwall structures upstream and downstream of the culvert. Namo Falls Road should also have a storm drain conveyance system consisting of 3 grated catch basins connecting to 100 linear feet of 24" RCP that will connect to the cross-culvert in Namo Falls Road. Channel stabilization of approximately 500 sq ft of rip rap is recommended upstream and downstream of the culvert crossing.

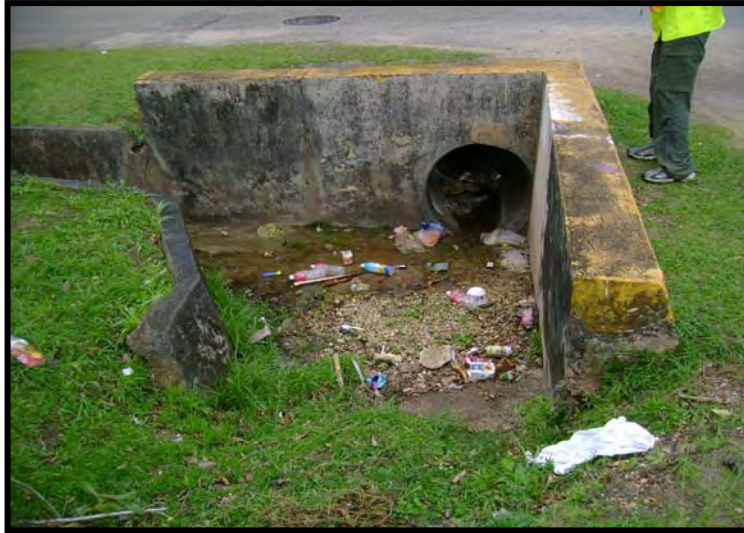
SR-106

LOCATION: Chalan Pale Duenas Haya & Sgt. Quenga St

RECOMMENDED IMPROVEMENTS The cross culvert at this site needs to be replaced with 100 linear feet of 5'x3' RCB and a headwall/wingwall structure with 100 sq ft rip rap stabilization upstream and downstream of the culvert.

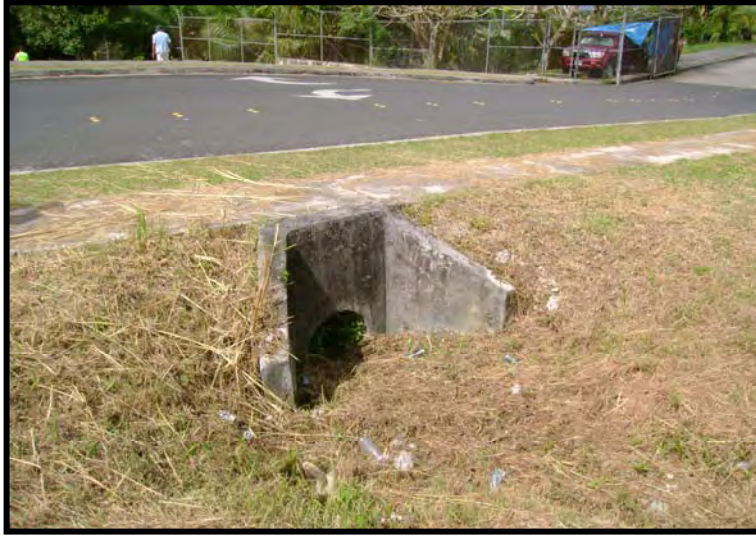
SR-107

LOCATION: Pale Ferdinand Way(RT 12A) & High School

SITE ASSESSMENT: An onsite drainage system within the school discharges to a dry well that is not handling all the runoff and excess runoff flows to football field. The drainage system consists of a 24" RCP cross culvert that runs under a driveway, then outlets to a concrete lined channel which discharges to the dry well at the southwest corner of the highschool. The solution is to replace the concrete channel to a grass swale and outlet it to a grated catch basin which can connect via a 36" RCP culvert to a City system along Pale Ferdinand Way.

RECOMMENDED IMPROVEMENTS: Recommend maintenance at the site including one quarter acre of debris removal, placement of a headwall/wingwall structure with a 100 sq ft rip rap energy dissipator located at the existing 24" RCP outlet, replacement of the existing concrete channel with a swale, placement of a 100-sq ft energy dissipater at the downstream end of the swale connecting to a new double 5'x3.5' RCB approximately 100' in length (sized per the Flood Control Document) and equipped with a headwall/wingwall structure. The new culvert will connect to the City system in Pale Ferdinand Way.

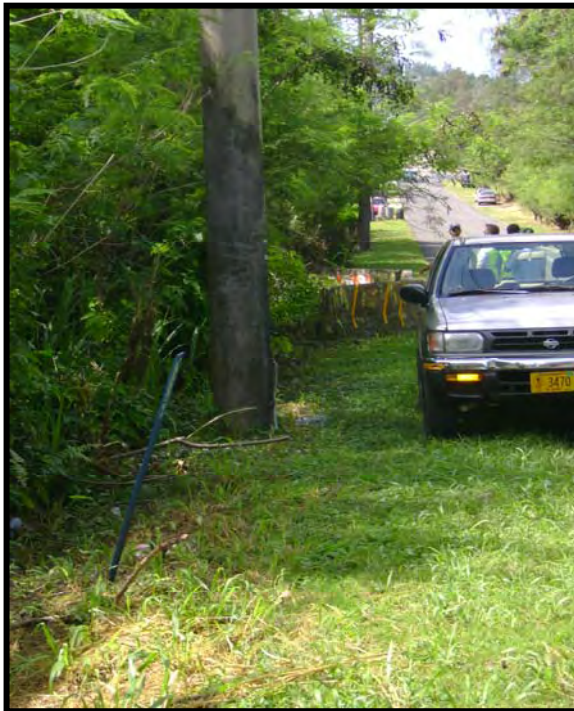
**SR-108**

LOCATION: Sumay Memorial St (RT 12A)

SITE ASSESSMENT: An existing 24" RCP cross culvert runs at an angle under Sumay Memorial St. This cross culvert is broken and is causing the roadway to collapse, also due to the alignment of the culvert the upstream headwall does not seem to be capturing all the runoff and the downstream end is covered with excessive debris and trash. Cross culvert should be replaced with a double 36" RCP cross culvert and aligned perpendicular to road and add a new headwalls upstream and downstream also with embankment stabilization both upstream and downstream.

RECOMMENDED IMPROVEMENTS The cross culvert at this site needs to be replaced with 100 linear feet of 36" RCP, a headwall/wingwall structure with 500 sq ft rip rap stabilization (approximately 25 feet in length) upstream and downstream of the culvert and maintenance including a quarter acre of debris removal.

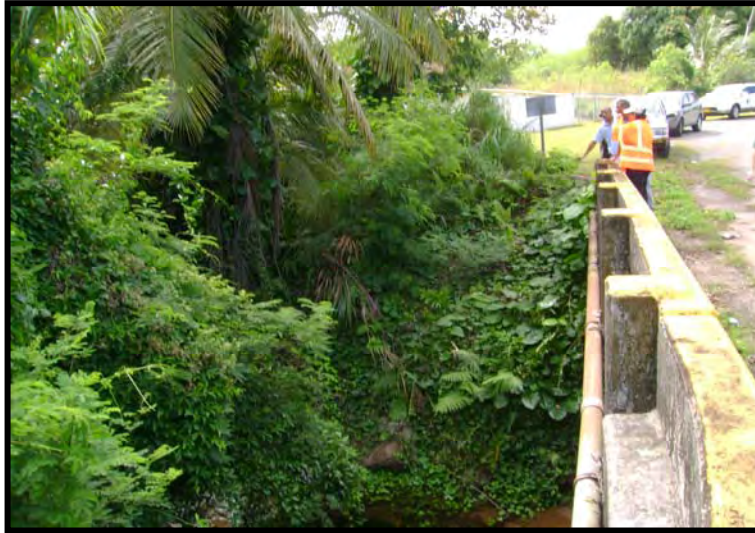
SR-109

LOCATION: RT 17 & Aplacho River

RECOMMENDED IMPROVEMENTS To prevent further undermining of approach slabs and ponding, placement of 2 overside drains is recommended along with one quarter acre of debris removal upstream and downstream of the bridge and 1,000 square feet of rip rap channel stabilization placed a distance of 50 feet upstream and downstream of the bridge.

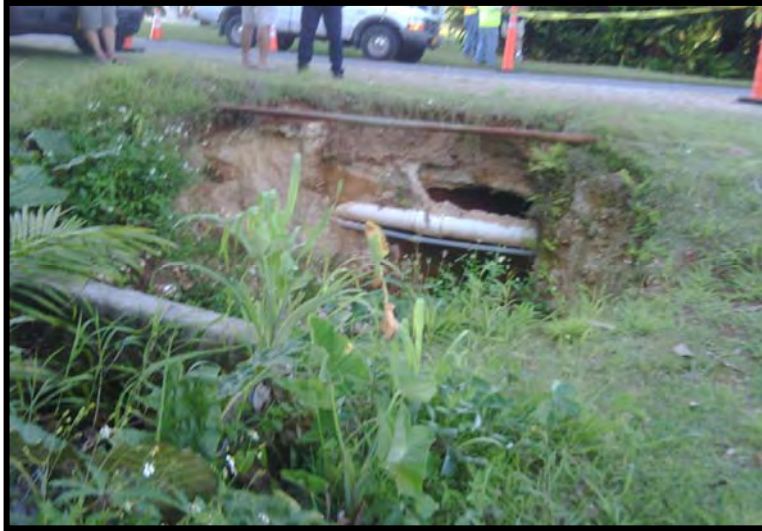
SR-110

LOCATION: RT 17

SITE ASSESSMENT: All existing CMP cross culverts under Rt17 need to be replaced with RCP cross culverts.

RECOMMENDED IMPROVEMENTS: An estimated 5 CMP cross-culverts along Rte 17 (North of Aplacho River) from Iseke Street to Bishop FC Flores Street within the Village of Santa Rita must be replaced with RCP. Each crossing will require the addition of headwalls upstream and downstream of the culverts and an estimated 100-ft of culvert. For cost estimating purposes, all cross-culverts are assumed to be 36-inch RCP (totaling 500 linear feet of 36" RCP).

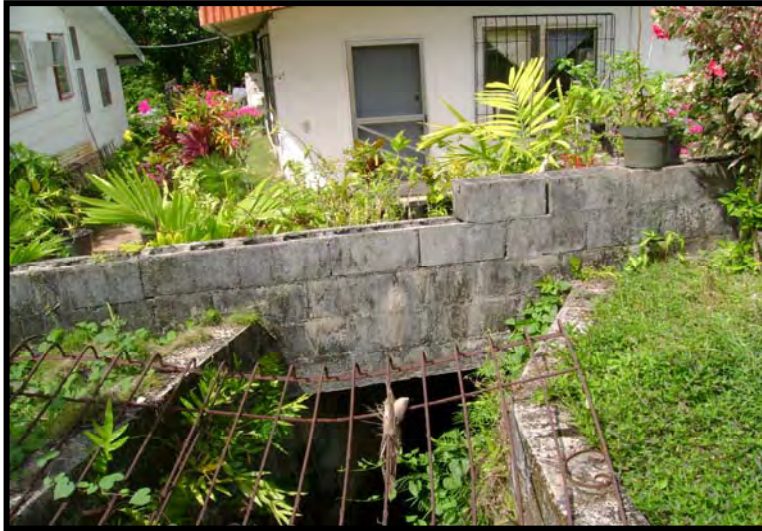
SR-111

LOCATION: Vicente S Borja Dr & RT 17

SITE ASSESSMENT: An existing double 12" cross culvert routes flow under Vicente S. Borja Dr and discharges to an RCB that runs under a house, which outlets to Aplacho river. Upstream, a concrete ditch was enclosed and now is functioning as an RCB. The double 12" cross culverts should be replaced with a 4'x4' RCB and existing swales along the street need to be improved in order to function properly.

RECOMMENDED IMPROVEMENTS The dual 12" RCP cross culvert at this site needs to be replaced with 100 linear feet of 4'x4' RCB equipped with a headwall and 100 sq ft rip rap channel stabilization at the upstream and downstream ends.

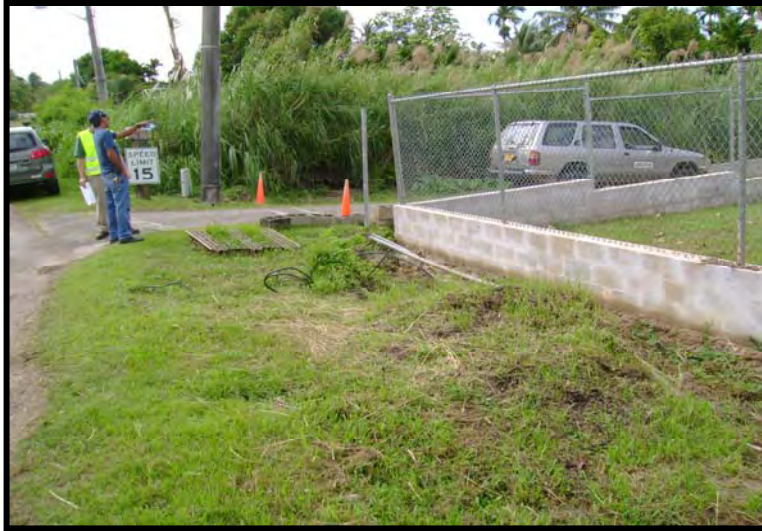
SR-112

LOCATION: Felix T Pangelinan Dr & RT 17

RECOMMENDED IMPROVEMENTS: The 36" RCP cross culvert at this site needs to be replaced with 100 linear feet of 6'x4' RCB (sized in accordance with the Flood Control Document) equipped with a headwall/wingwall structure at the upstream and downstream ends. Recommend an 18" rectangular concrete ditch (estimated at 500 feet in length) be placed between the existing retaining wall structures that will convey the flow to the upstream side of the 6'x4' RCB.

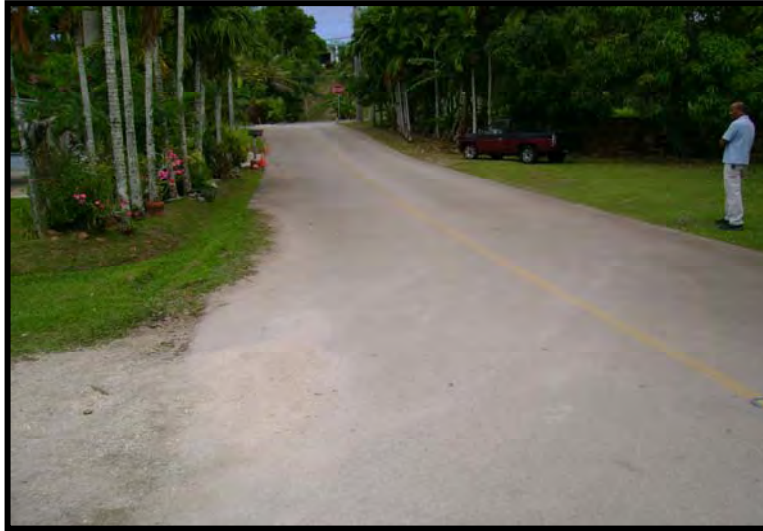
SR-113

LOCATION: Felix T Dydasco Dr & RT 17

RECOMMENDED IMPROVEMENTS Place a storm drain system along Felix Dydasco Dr consisting of 100' of concrete ditch, 100 linear feet of a 6'x4' RCB (per Flood Control Document) with a headwall/wingwall structure upstream and downstream of the culvert.

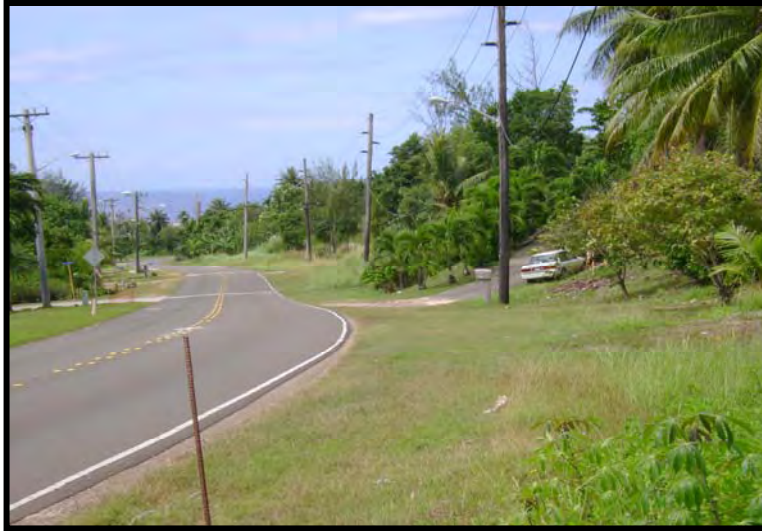
SR-114

LOCATION: RT 17 & Felix T Dydasco Dr

RECOMMENDED IMPROVEMENTS: Recommend grading a 1,000 linear foot ditch along Rte 17 to convey flow downstream of Felix T. Dydasco Drive toward Felix T. Pangelinan Dr. Recommend placing a 36" culvert under Felix T. Dydasco Drive to convey flow upstream of the road to the ditch downstream of the road. The culvert should include approximately 100'x36" RCP and headwalls with 100 sq ft rip rap stabilization placed upstream and downstream of the culvert.

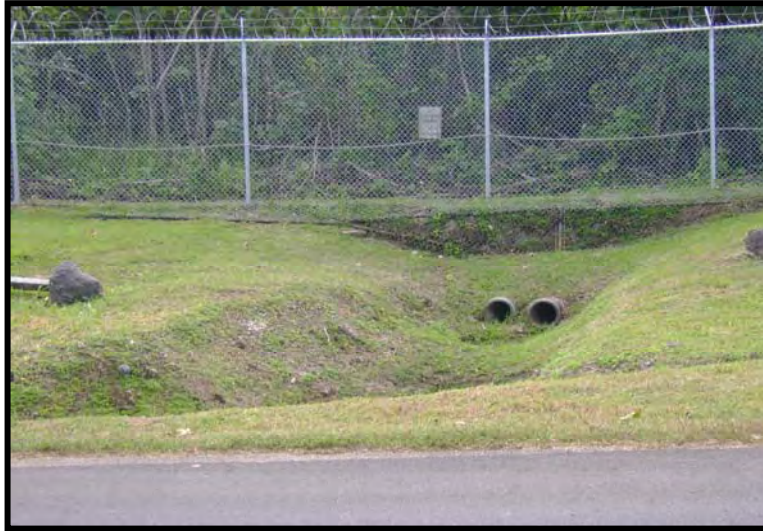
SR-115

LOCATION: RT 12 & Navy

RECOMMENDED IMPROVEMENTS Recommend adding headwall/wingwall structures with 100 sq ft rip rap energy dissipators to the upstream and downstream ends of the existing cross culverts at Rte 12. A storm drain system connecting to these cross culverts is needed along Rte 12 consisting of a 200 linear foot ditch adjacent to both sides of the crowned road conveying flow to a catch basin located at the low point on both sides of the road. The catch basins will connected to a new 24" RCP in the road that will route flow to the cross culvert.

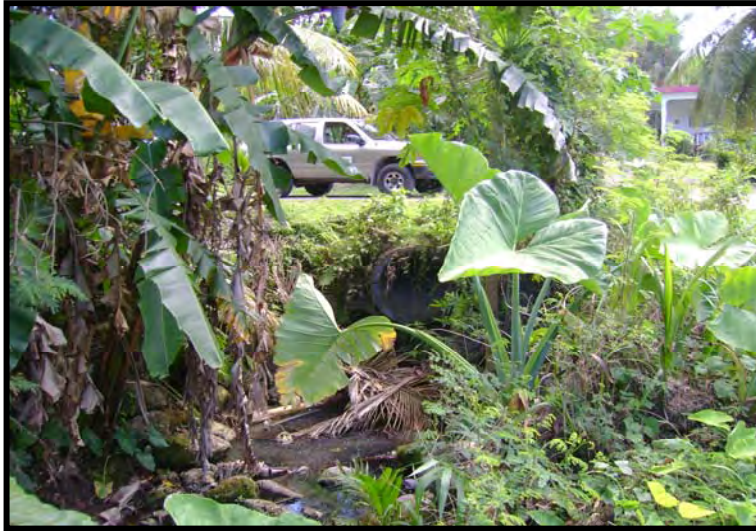
SR-117

LOCATION: Juan P Sarmiento Dr & Pedro Roberto Dr (Rt12)

SITE ASSESSMENT: Two 48" RCP cross culverts run under Juan P. Sarmiento Dr. These two culverts are on top of each other there is significant embankment erosion both upstream and downstream. Replace cross culverts with a 8'x5' RCB cross culvert with headwall and wingwalls both upstream and downstream. Need also to clear debris and vegetation upstream and downstream.

RECOMMENDED IMPROVEMENTS The double 48" RCP cross culvert at this site needs to be replaced with 100 linear feet of 8'x5' RCB and a headwall/wingwall structure with 500 sq ft rip rap stabilization upstream and downstream of the culvert. One quarter acre of debris removal is also needed at this site.

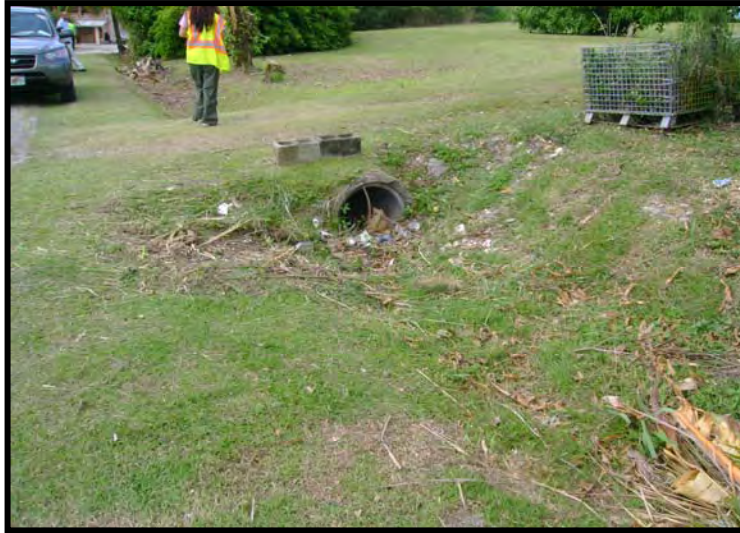
SR-118

LOCATION: Vicente D. Lizama Dr & Pedro Roberto Dr (RT 12)

RECOMMENDED IMPROVEMENTS In order to provide sufficient erosion control, the channel located upstream of Route 12 (along the north side of Vicente D. Lizama Drive) should be stabilized with 500 sq ft of rip rap for a distance of approximately 25 feet and the channel located downstream of the structure should be stabilized for a distance of 25 feet with 500 sq ft of rip rap A quarter acre of debris removal, and placement of two headwalls with wingwalls (one upstream of Rte 12 and one downstream of Rte 12) are also recommended.

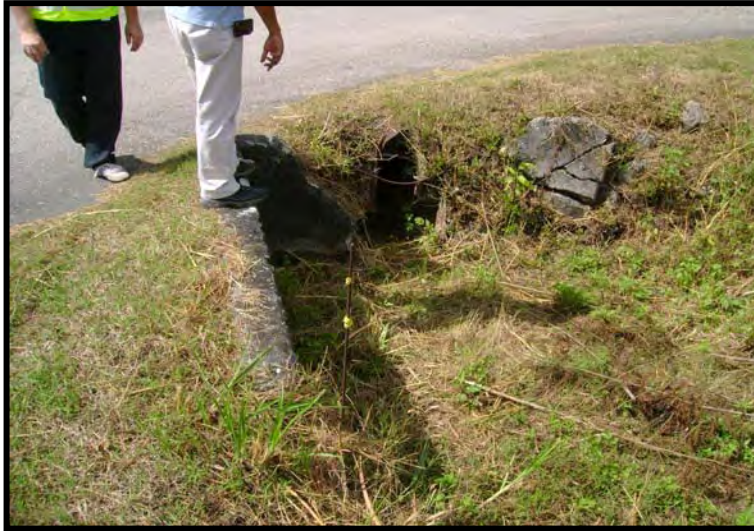
SR-119

LOCATION: Pedro Roberto Dr (Rt12) & RT 17 & RT 5

SITE ASSESSMENT: A 36" CMP under Rt17 routes flow from an upstream channel along Pedro Roberto Dr and discharges to another channel downstream. This 36" CMP cross culvert needs to be replaced with a 33'x3' RCB along with the upstream headwall. Both upstream and downstream channels need debris and vegetation removal and embankment stabilization.

RECOMMENDED IMPROVEMENTS The 36" CMP cross culvert at this site needs to be replaced with 100 linear feet of 3'x3' RCB equipped with a headwall/wingwall structure and 500 sq ft rip rap channel stabilization at the upstream and downstream ends.

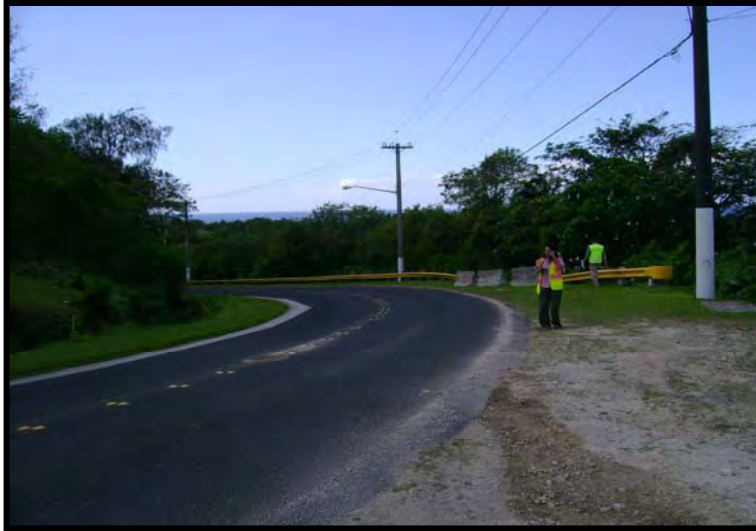
SR-120

LOCATION: Obispo Olano(RT 12) & Namo Falls Park

RECOMMENDED IMPROVEMENTS Recommend placement of an AC Spillway along Rte 12 at this location and 2,000 square feet of rip rap stabilization for erosion control. Maintenance in the form of one quarter acre debris removal is also needed.

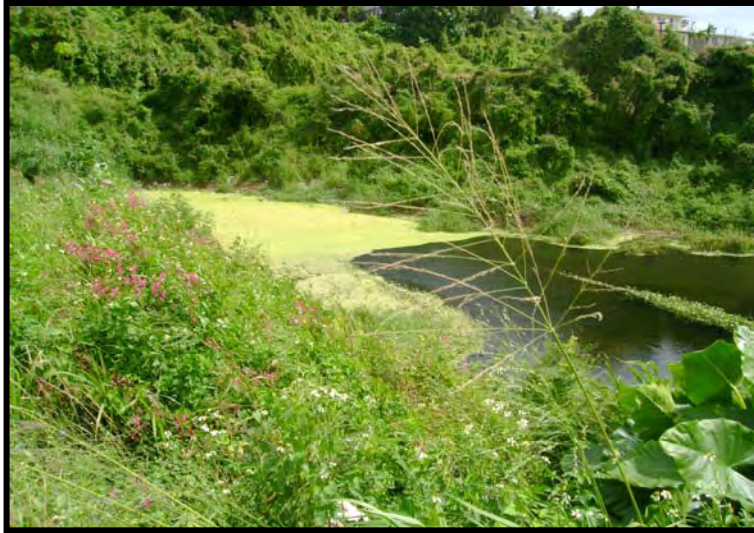
SV-101

LOCATION: Chalan Gumayuus & Pipino Ct

SITE ASSESSMENT: Infiltration basin where runoff entering the basin from the street has been eroding adjacent property. Need to stabilize basin embankment next to the private property with gabions.

RECOMMENDED IMPROVEMENTS To prevent further erosion of infiltration basin embankment and to the adjacent property at this site, a quarter acre of debris removal followed by placement of 400 SF of gabions along the infiltration basin embankment and placement of approximately 100 square feet of rip rap at the bottom of the gabions is recommended.

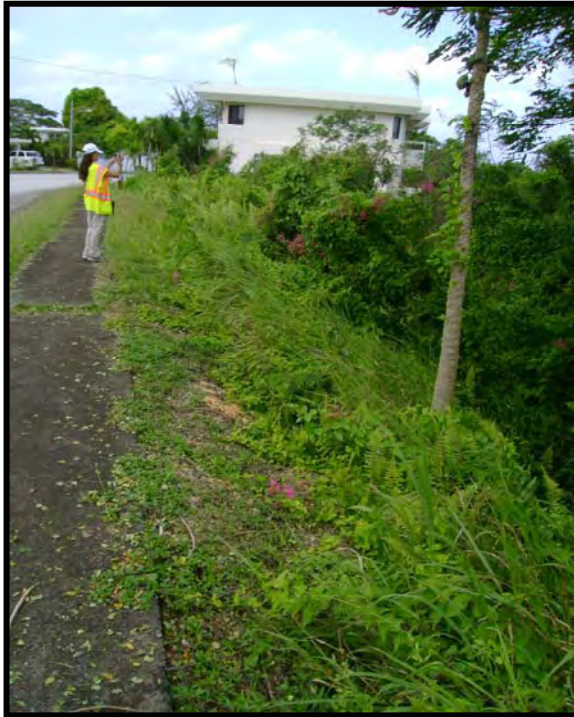
SV-102

LOCATION: RT 24A

RECOMMENDED IMPROVEMENTS To prevent further erosion, a quarter acre of debris removal followed by placement along the road embankment of approximately 500 square feet of rip rap stabilization is needed.

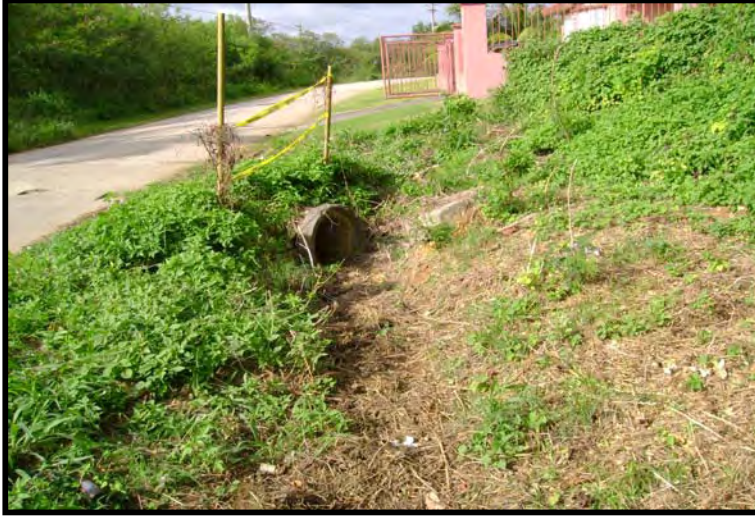
TA-101

LOCATION: E Johnny S Taitague St & San Miguel St

RECOMMENDED IMPROVEMENTS To prevent flooding, construct a storm drainage system along E Johnny S Taitague Street consisting of 500' of channel located on both sides of low point. At low point, add 1 catch basin equipped with apron connecting to existing 24" RCP cross-culvert outletting flow into a 100 square foot rip rap energy dissipator to a bioswale.

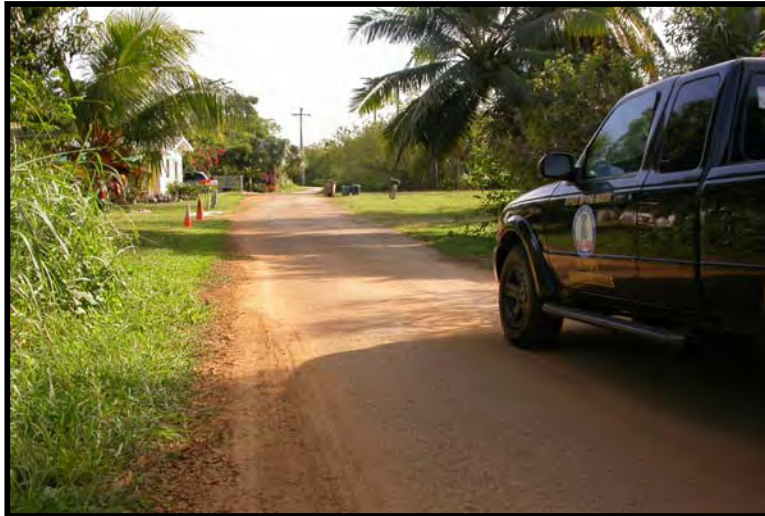
TA-102

LOCATION: Ignacio P Quitugua & Jose P Cruz St

SITE ASSESSMENT: At low point of Ignacio P Quitugua St south of Jose P Cruz St the existing infiltration basin does not work. Need to clear infiltration basin of debris and overgrown vegetation in order to make it work. Also increase depth of basin to add more capacity.

RECOMMENDED IMPROVEMENTS Existing infiltration basin is under capacity. Propose a new, deeper infiltration basin at the same site with a depth of 6 feet, width of 50 feet, and length of 200 feet with 500 linear feet of fencing. Also add an AC spillway to route street runoff into new infiltration basin at this site.

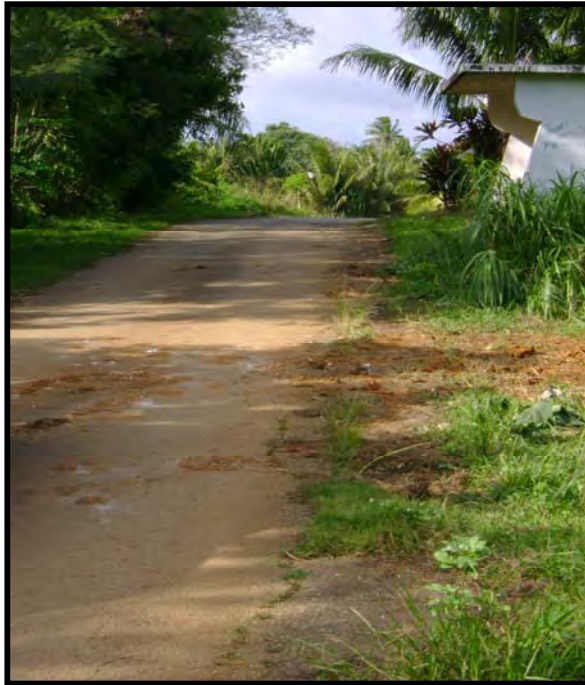
TA-103

LOCATION: Ignacio P Quitugua

SITE ASSESSMENT: Add a drainage conveyance system to collect street runoff, and route to the infiltration basin.

RECOMMENDED IMPROVEMENTS A storm drain system is needed to collect and convey street runoff along Ignacio P Quitugua Street. Propose one catch basin placed at the street's low point, and convey flow to the proposed infiltration basin via 300 linear feet of 24" RCP. Pipeline outlet shall consist of a headwall/wingwall structure with a 100 square foot rip rap energy dissipator located at the infiltration basin.

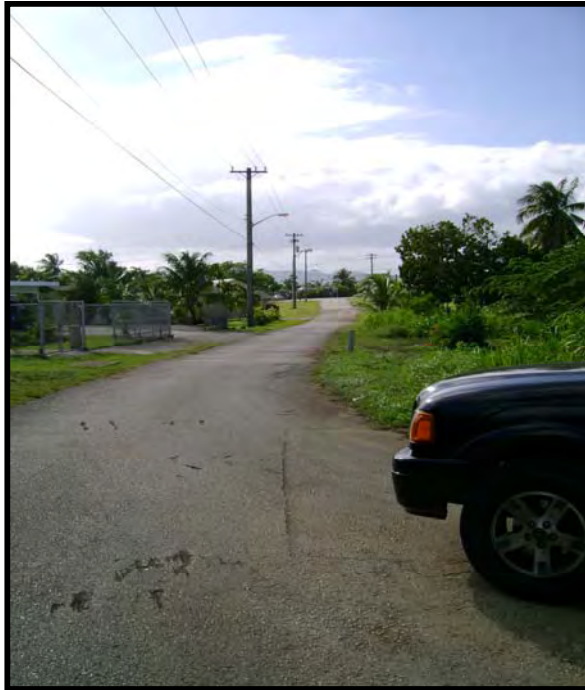
TA-104

LOCATION: Francisco A Reyes Ave & Ignacio P Quitugua

SITE ASSESSMENT: Add swales and cross gutters along north side of Francisco A Reyes Ave. East of Ignacio P. Quitugua will be routed to the infiltration basin at Ignacio P. Quitagua. West of Ignacio P. Quitugua runoff will be routed to the 36" RCP cross culvert at David Gorton St.

RECOMMENDED IMPROVEMENTS A conveyance system is needed to collect and convey street runoff along the north side of Francisco A. Reyes Ave. The system will consist of approximately 1,000 linear ft of concrete ditch with interim culverts located at driveways (consisting of approximately 100 linear foot of 12" RCP and 6 headwall/wingwall structures). The ditch will route flow to the infiltration basin at Ignacio P. Quitugua.

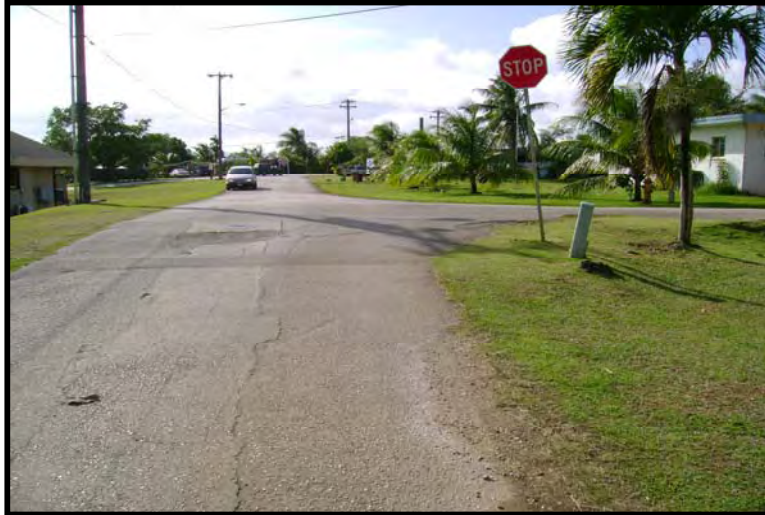
TA-105

LOCATION: Francisco A Reyes Ave & Leonardo C Tenorio St

RECOMMENDED IMPROVEMENTS A conveyance system is needed to collect and convey street runoff along Francisco A. Reyes Ave. (West of Ignacio P. Quitugua). The system will consist of approximately 2,000 linear ft of concrete ditch with interim culverts located at driveways (consisting of approximately 200 linear foot of 12" RCP and 12 headwall/wingwall structures). The ditch will route flow to the 36" RCP cross culvert at David Gorton Street.

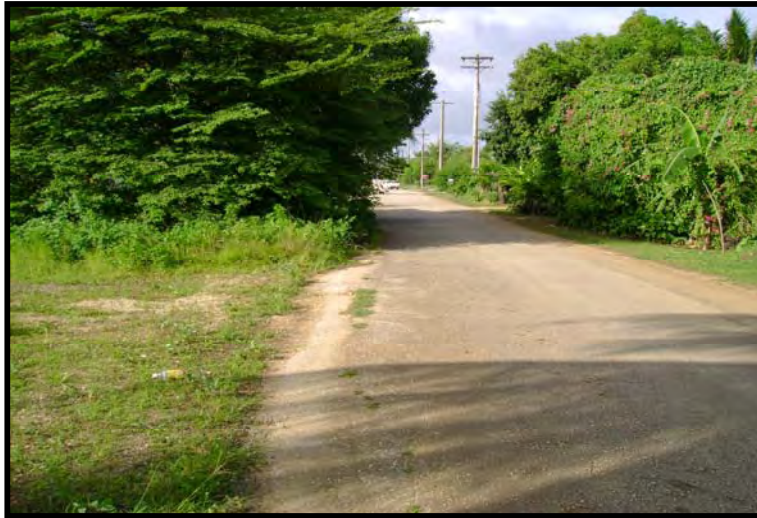
TA-106

LOCATION: Leonardo C Tenorio & Jose P Cruz St

RECOMMENDED IMPROVEMENTS A conveyance system is needed to collect and convey street runoff along Leonardo C Tenorio Street. The system will consist of approximately 2,000 linear ft of concrete ditch with interim culverts located at driveways (consisting of approximately 200 linear foot of 12" RCP and 12 headwall/wingwall structures). The ditch will route flow toward Jose P Cruz, then westerly to the fire station, outleting to an existing flow path toward the Togcha River.

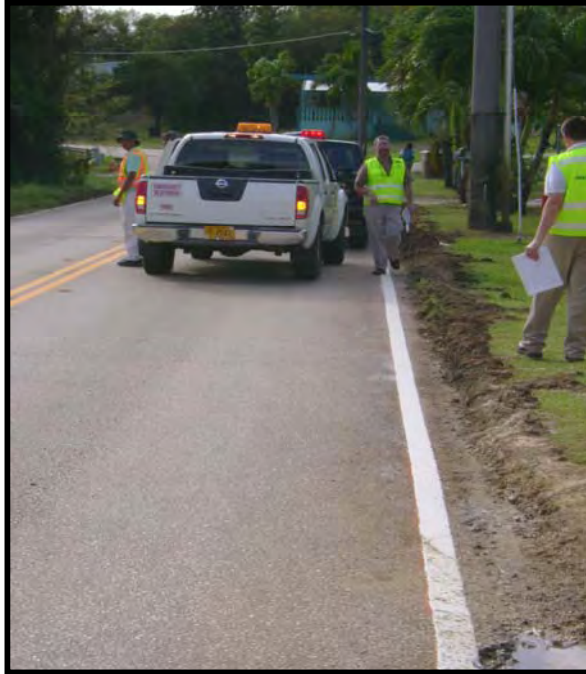
TA-107

LOCATION: Jose P Cruz St & N. San Miguel St

RECOMMENDED IMPROVEMENTS To prevent future flooding, construct a storm drain system along Jose P. Cruz Street. Place two catch basins at the street's low point connecting to 100 linear feet of 24" RCP (routing flow westerly) equipped with a headwall/wingwall structure and a 100 square foot rip rap energy dissipator at its outlet. Add a 100 linear foot bioswale to the end of the energy dissipator.

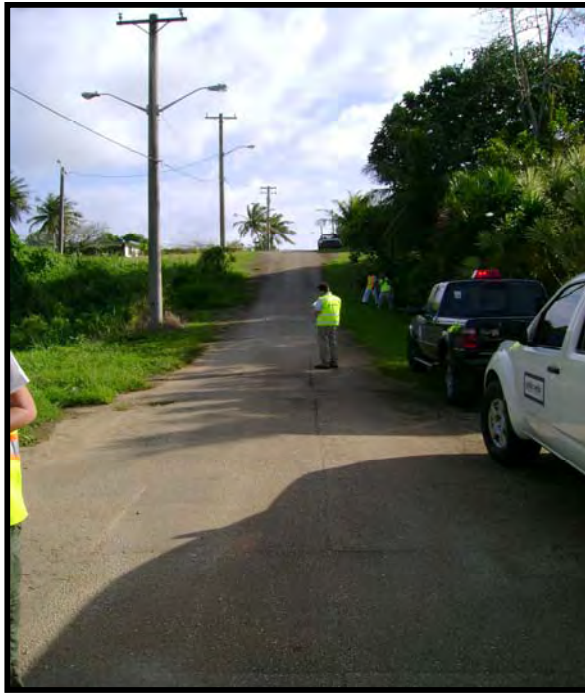
TA-108

LOCATION: David Gorton St & Jose P Cruz St

RECOMMENDED IMPROVEMENTS To prevent further flooding of area properties it is necessary to upsize the current conveyance system. The 36" RCP clvert should be replaced with 100 linear foot of 48" RCP equipped with headwall/wingwall structures on the upstream and downstream side. Downstream, a 100 sq ft rip rap energy dissipator and 200-ft bioswale is recommended.

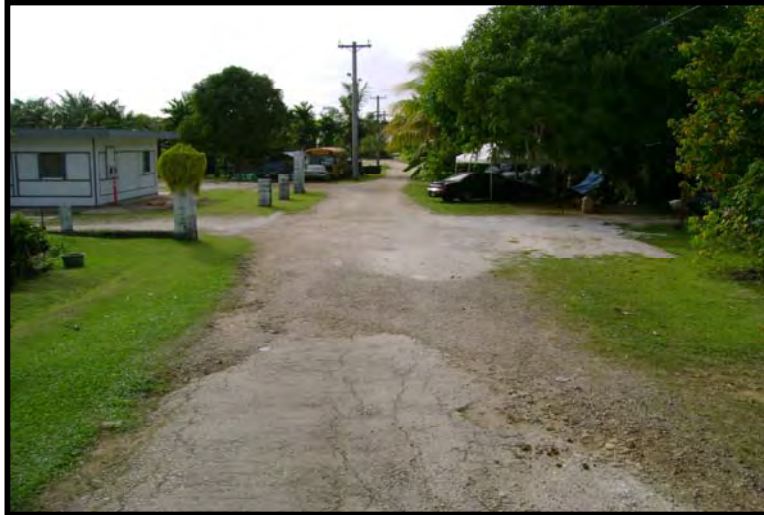
TA-109

LOCATION: Juan P Mantanona St & David Gorton St

RECOMMENDED IMPROVEMENTS Construct a conveyance system to route runoff from David Gordon Street and Juan Mantanona Street to an existing wetland at the end of Juan Mantanona Street. Construct ditches along both streets (totaling approximately 2,000 linear ft of concrete ditch), with interim culverts located at driveways (consisting of approximately 200 linear foot of 12" RCP and 12 headwall/wingwall structures).

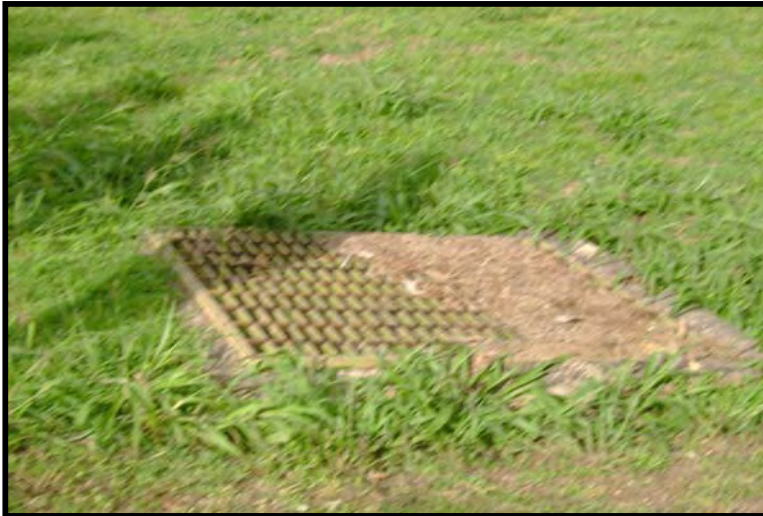
TA-110

LOCATION: Ernest P Santos St & Siguansa

RECOMMENDED IMPROVEMENTS Replace existing catch basin and connect 300 linear feet of 24" RCP to existing RCP. Equip outlet with a headwall/wingwall structure and a 100 square foot rip rap energy dissipator.

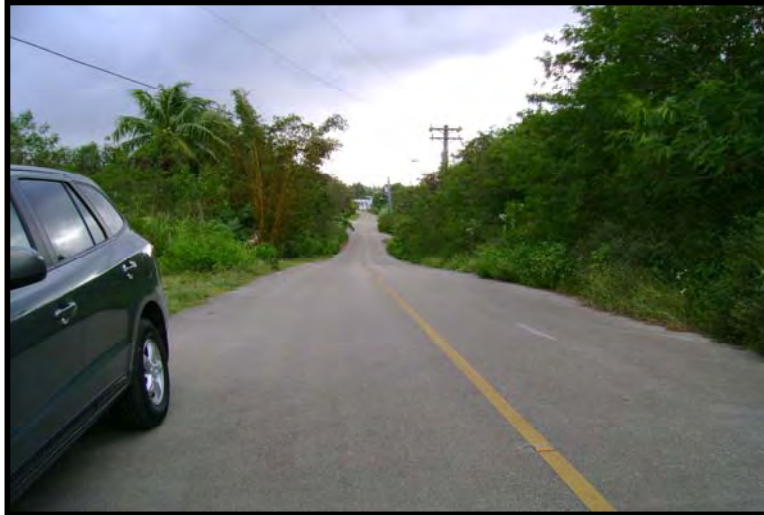
TA-111

LOCATION:	Pasaderun Francisco Diego & Ernest P Santos St
MITIGATION TYPE:	Strom Drain Improvement/ Treatment BMP Improvement
SITE ASSESSMENT:	Runoff from Ernest P Santo St floods five homes along Pasaderun Francisco Diego. Add a drainage conveyance system (Catch basin and 24" culverts) along Ernest P Santos St from its street high point(nort of Pasaderun Francisco Diego) and route it to Siguenza to the existing wetland, this will capture all runoff from Ernest P. Santo St and should prevent flooding of Pasaderun Francisco Diego.
RECOMMENDED IMPROVEMENTS	Runoff floods several homes at this site. A drainage conveyance system needs to be added along Ernest P Santos street conveying runoff from its high point to the wetlands at Siguenza. The flow will be captured with two catch basins (one on each side of the street) at the low point in the road. The catch basins will connect to approximately 200 linear feet of 24" RCP with a headwall/wingwall structure and 100 square foot rip rap energy dissipator at its outlet. Construct a 100 linear foot bioswale downstream prior to conveyance to the wetland.

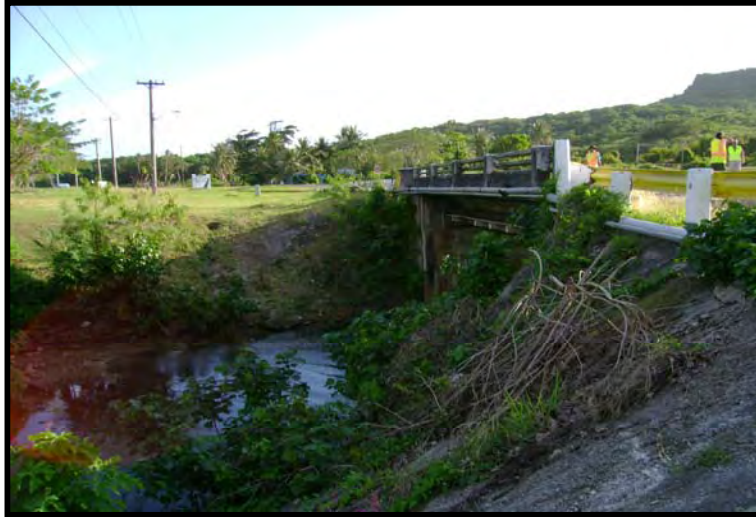
TA-112

LOCATION: RT 4 & Togcha River

RECOMMENDED IMPROVEMENTS To prevent further erosion on the bridge embankment at this site, remove approximately 1,000 square feet of debris at bridge embankments and add approximately 1000 sq ft of rip rap (500 sq feet along each embankment) for embankment stabilization.

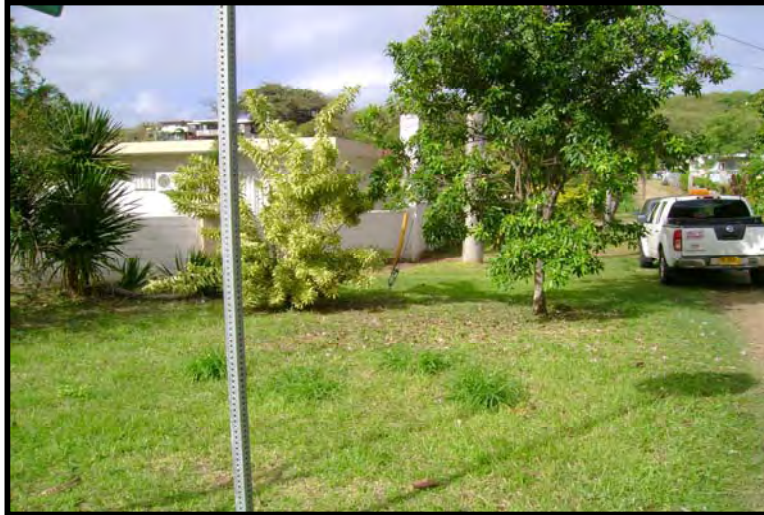
TA-113

LOCATION: RT 4 & Pacifico Drive

RECOMMENDED IMPROVEMENTS To prevent further flooding of properties at this site, construct a storm drain system consisting of 4 catch basins (one at each corner of Pacifico Drive) connected by approximately 400 linear feet of 24" RCP routing flow easterly to an outlet equipped with a headwall/wingwall structure outletting to a 100 square foot rip rap energy dissipator prior to outletting to the Pacific Ocean.

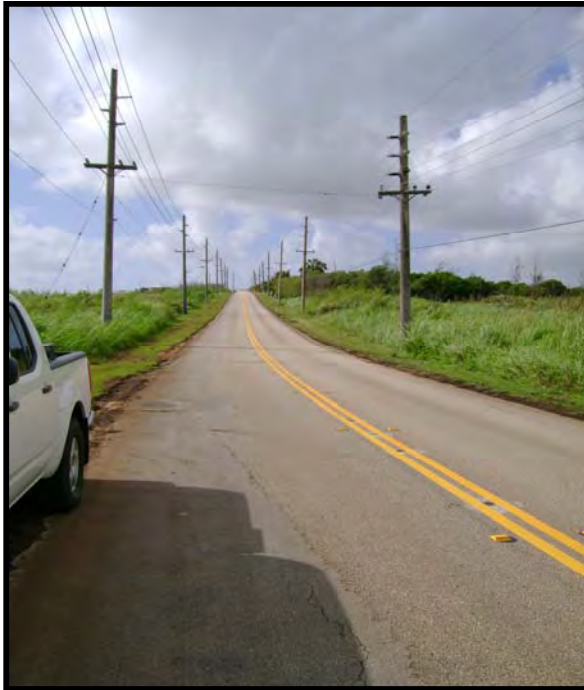
TA-114

LOCATION: RT 4A

RECOMMENDED IMPROVEMENTS To prevent future ponding at the Rte 4A low point, construct a drainage conveyance system along both sides of the road consisting of approximately 3000 LF of ditch on both sides of the low point. Capture flow with two catch basins and convey flow to the south using approximately 50' of 24" RCP.

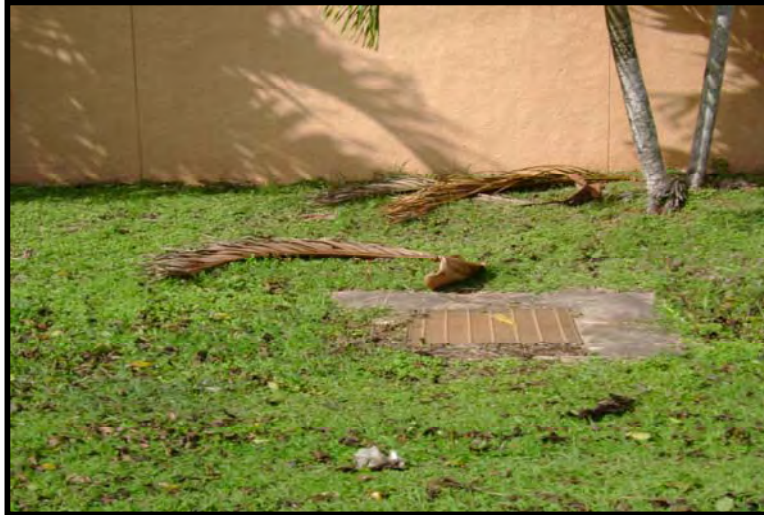
TA-115

LOCATION: RT 4 & Golf Course

RECOMMENDED IMPROVEMENTS: There are currently 2 catch basins at this site that need to be replaced with 2 new grated catch basins with aprons to improve interception capacity.

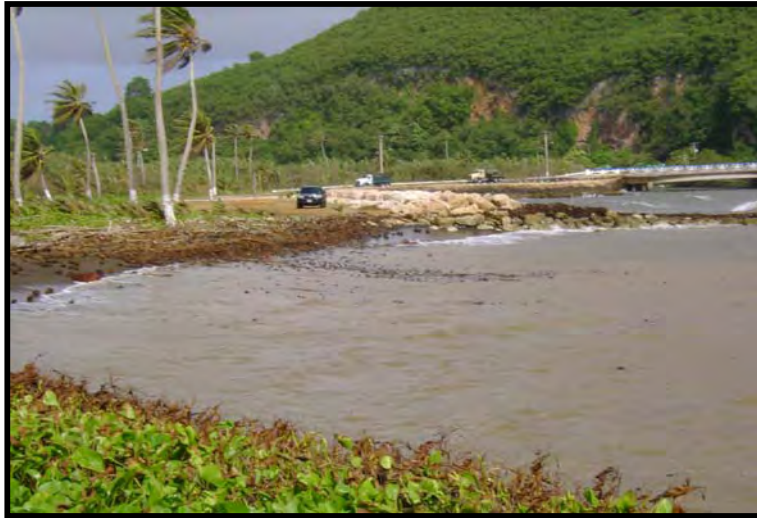
TA-116

LOCATION: RT 4 & Talofoto Beach Park

RECOMMENDED IMPROVEMENTS To prevent further shoreline erosion as a result of high tides, install 20,000 square feet of rip rap coastal stabilization (approximately 10-ft wide along the shoreline) for a distance of approximately 2000 feet along Talofoto Beach at Rte 4.
