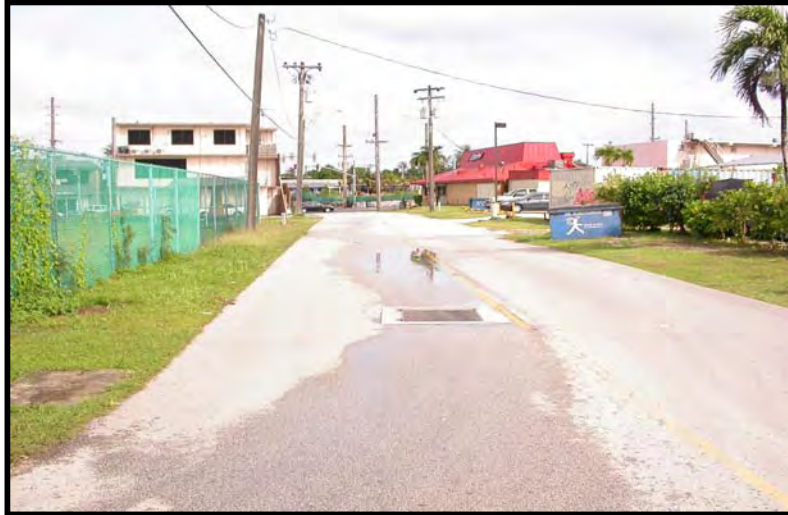
TV-101

LOCATION: RT 1 & Jalaguac wy

RECOMMENDED IMPROVEMENTS To prevent future flooding in this area, construction of a 200 linear foot concrete trapezoidal channel routing flow from Jalagua Way to the Tamuning Drainageway is proposed. A quarter acre of debris removal will be needed along with erosion control at the channel outlet in the form of 1,000 square feet of rip rap.

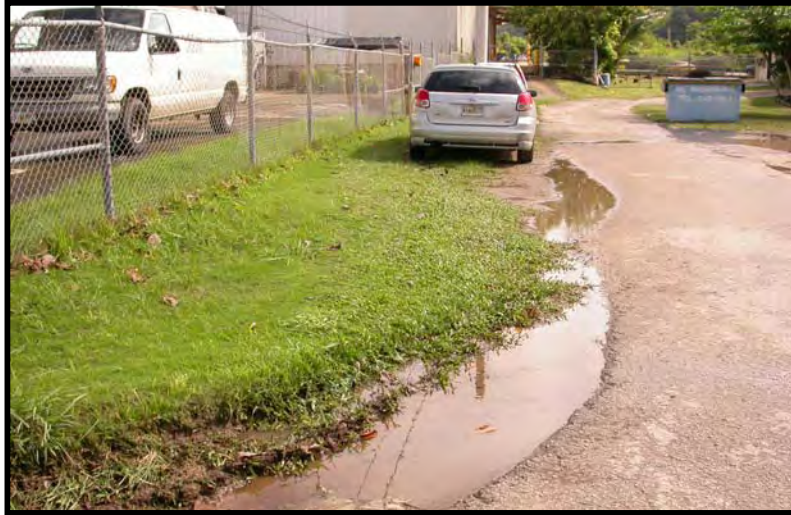
TV-102

LOCATION: Tun Josen Tovas Way

RECOMMENDED IMPROVEMENTS To prevent future flooding in this area, construction of a storm drainage system in this area is required. Construction of 2 catch basins along Tun Josen Tovas Way, connected to 100' of 24" RCP which routes flow to a double 3'x5' RCB is recommended. Approximately 200 linear feet of the RCB will be required to convey flow southerly toward the proposed concrete trap channel at Jalagua Way. An easement will be required for this RCB.

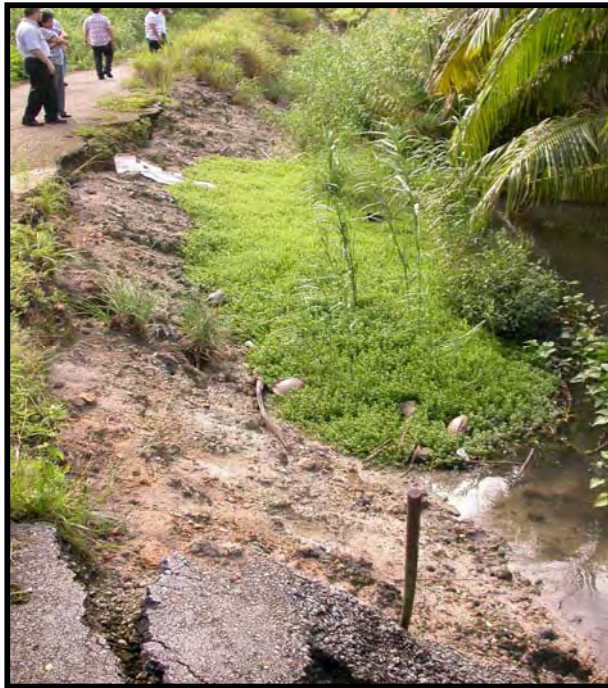
TV-103

LOCATION: Tamuning Outlet Channel

RECOMMENDED IMPROVEMENTS Conveyance maintenance and improvement is needed along the entirety of the Tamuning Drainage Way Channel from Rte 1 to the coast (approximately 2500 feet). Maintenance including approximately five acres of debris removal is needed along with embankment stabilization for both embankments along the 2500 ft length (estimated at 50,000 sq ft of rip rap along each embankment).

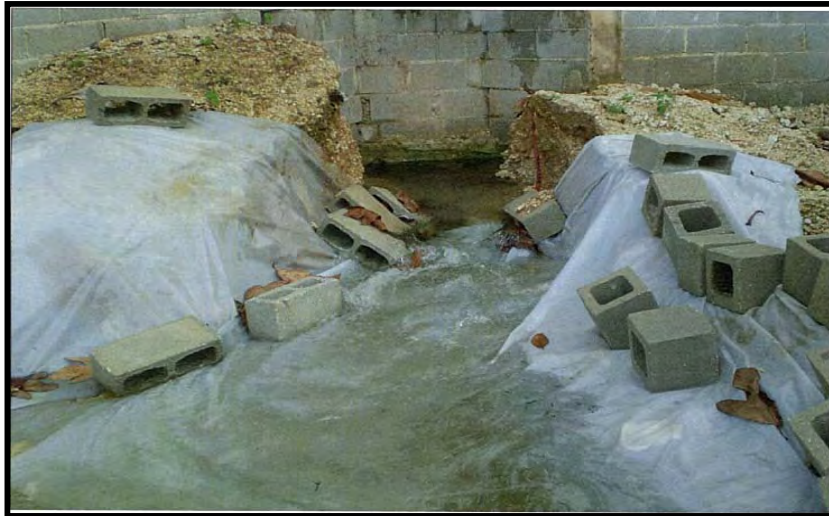
TV-104

LOCATION: Estrellita Court

RECOMMENDED IMPROVEMENTS At this site, a storm drain at the end of Estrillita Court discharges to a private property. It is recommended that a storm drain pipeline be installed at the outlet of the pipe to convey flow westerly (requiring an easement on the existing parcel) to a utility/ street easement located on the west side of the parcel. Along this existing easement, the pipeline should be routed southerly to outlet to the natural flow path of the terrain that eventually drains to the corner of Rte 14 and Pale Leon Murphy Street. The proposed improvements include 400 linear feet of pipeline (24 to 36 inch), 2 junction structures, and an outlet consisting of a headwall/wingwall with a 100 square foot rip rap energy dissipator.

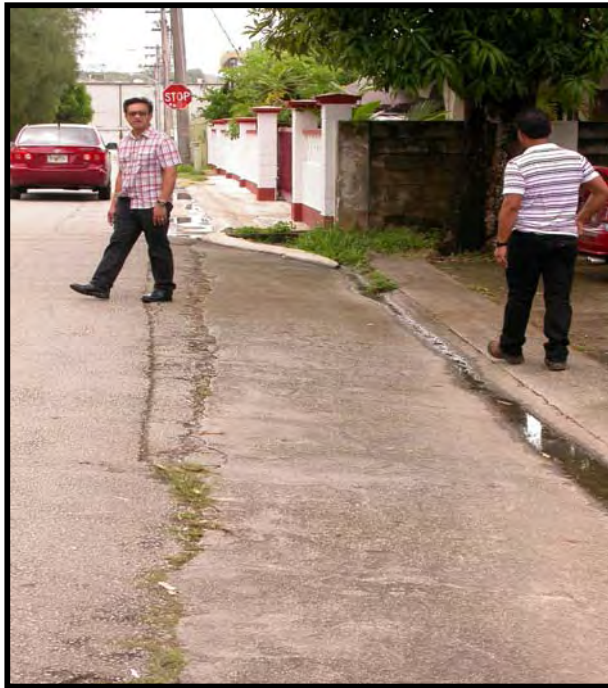
TV-105

SITE ASSESSMENT: There is no drainage conveyance system along this street. Need to add a drainage conveyance system (and possibly infiltration trenches to outlet flow) in order to prevent flooding of street and private properties.

RECOMMENDED IMPROVEMENTS A drainage conveyance system is needed along N. Sgt David Camacho Street to prevent future flooding of the street and surrounding private properties. Recommendations include placement of approximately 200 linear feet of ditch adjacent to the street routing flow to a 200 linear ft infiltration trench.

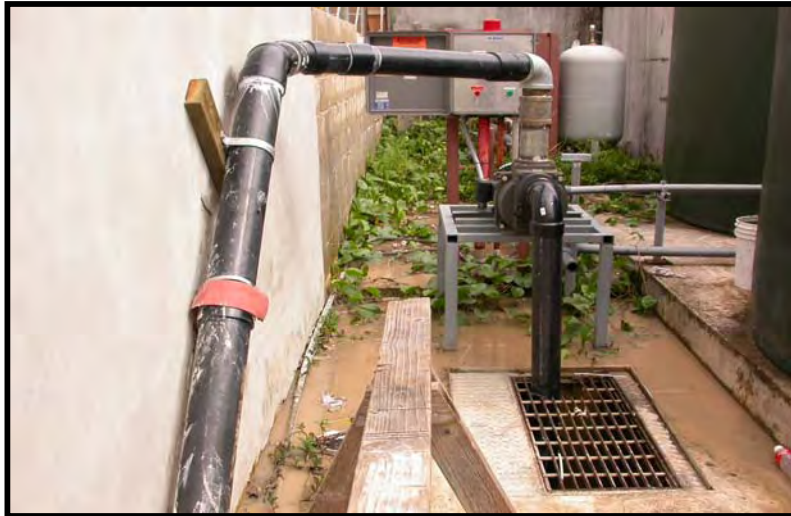
TV-106

LOCATION: Sand Castle & Pale San Vitores Rd

RECOMMENDED IMPROVEMENTS A new development that is being constructed behind the Sand Castle property has created a low point in the back of the property causing flooding. It is recommended that the runoff at the back of the property be intercepted and conveyed to the front of the property and connected to the existing storm drain system in Pale San Vitores Rd. The system would consist of 2 catch basins connecting to 100 feet of 24" RCP that would route the runoff to the existing storm drain system.

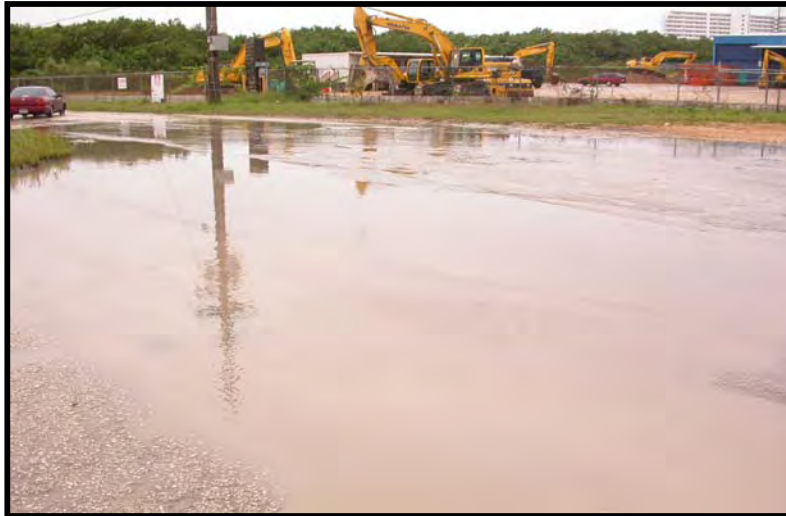
TV-108

SITE ASSESSMENT: There is no drainage conveyance system along this route. Need to build a drainage conveyance system. Possible solution will be to build infiltration trenches along the route.

RECOMMENDED IMPROVEMENTS A storm drain system along this section of Rte 27 is required to alleviate flooding at this site. In order to capture and convey flow at this site, a system including two catch basins connecting to approximately 400 linear feet of 36" RCP routing flow to the storm drain system in Rte 16 is recommended.

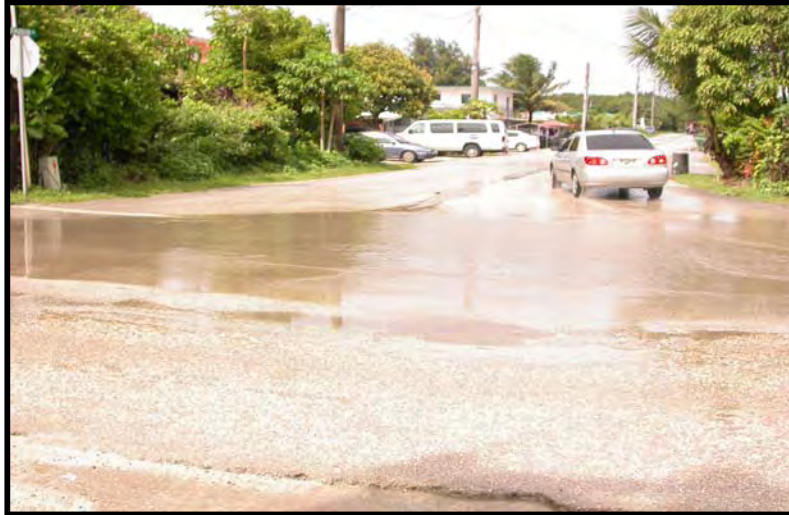
TV-109

SITE ASSESSMENT: At the intersection of Rt27 and Anthurum Ln no drainage conveyance system exists and this interchange constantly floods. Need to build a drainage conveyance system, possible solution will be to build infiltration trenches along Rt27 and along Anthurium Ln.

RECOMMENDED IMPROVEMENTS The lack of a drainage conveyance system along Rte 27 in this area causes constant flooding. A storm drainage system is recommended in Rte 27, capturing runoff at the low point in the crowned roadway with two catch basins connecting to 400 linear feet of 24" RCP outletting to a 100 square foot rip rap energy dissipator. At the outlet, installation of a 200 foot infiltration trench is proposed to resolve the flooding problems that currently take place at this site.

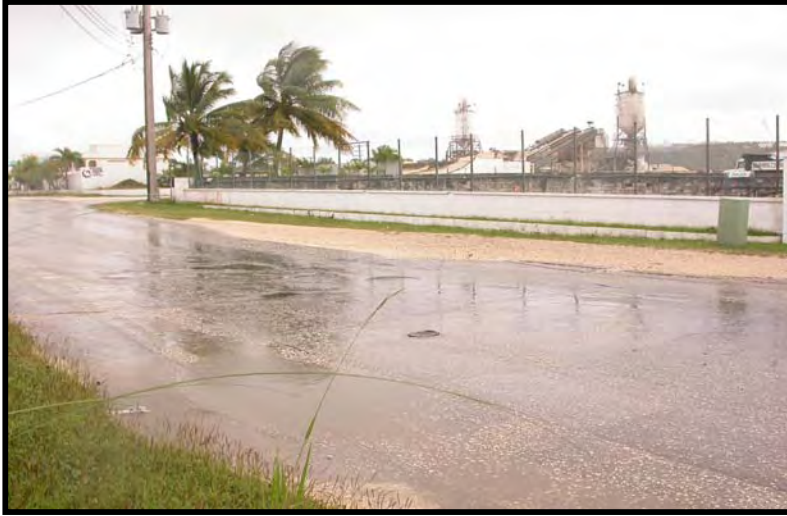
TV-110

LOCATION: RT 27 & RT 1

RECOMMENDED IMPROVEMENTS To avoid further ponding of retail/commercial properties at this intersection, a storm drainage system is needed to intercept and convey flow from Rte 27 to Rte 1. The system will consist of 2 grated catch basins located at the low point along Rte 27 (on both sides of the street), connecting into the existing Rte 1 drainage system via 200 linear feet of 24" RCP.

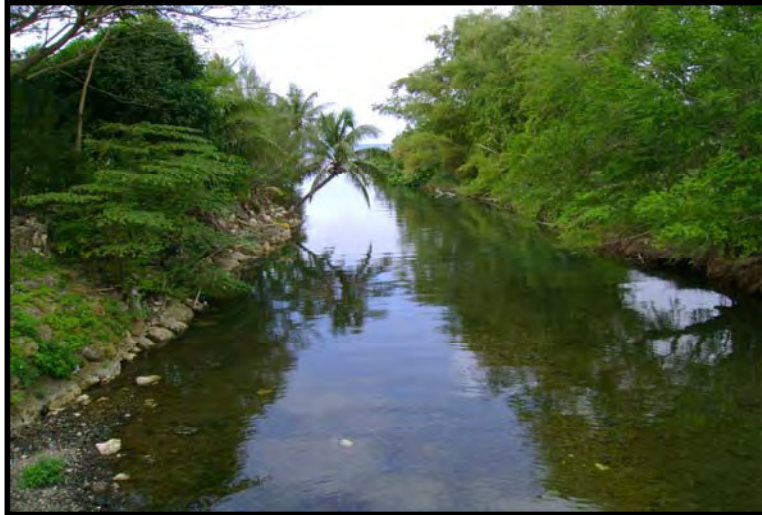
UM-101

LOCATION: RT 2 & Umatac River

RECOMMENDED IMPROVEMENTS To prevent further loss of the river bed and flooding of surrounding homes, approximately two acres of debris removal to clear out all overgrown vegetation and accumulated debris and approximately 2,000 cubic yards of sediment removal is required at the site. Embankment stabilization (both sides) is required from the shoreline upstream for approximately 1000 feet (totaling 20,000 square feet of rip rap placement) as a means of implementing erosion control and to maintain the conveyance system.

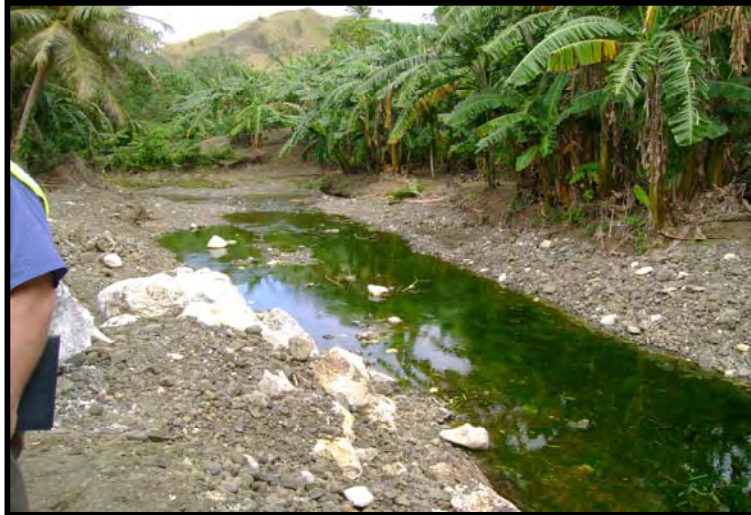
UM-102

LOCATION: Finona St & Madog River

RECOMMENDED IMPROVEMENTS To prevent further flooding of area properties/homes, recommend one acre of debris removal along with 1000 cubic yards of sediment removal within the channel to minimize meandering and improve capacity. Also recommend stabilization of the river embankment through the placement of 10,000 square feet of rip rap channel stabilization for a distance of approximately 400 feet downstream of the site and 100 feet upstream of the site.

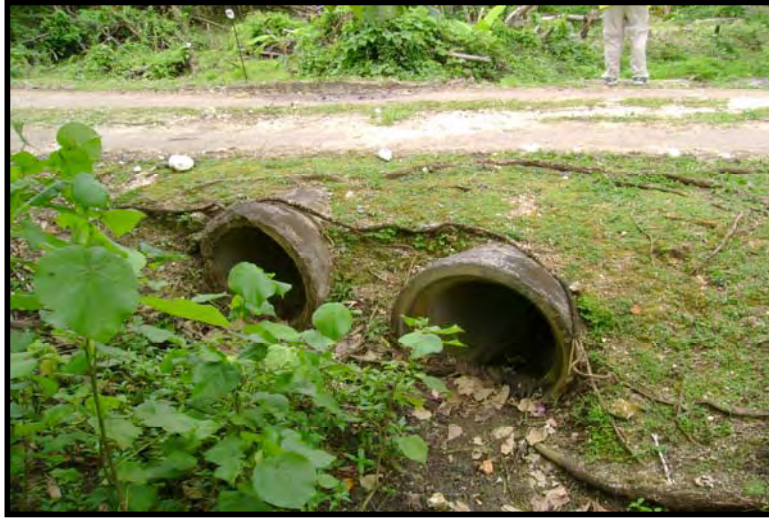
UM-103

LOCATION: Finona St & Jose A Quintana St

RECOMMENDED IMPROVEMENTS A quarter acre of debris removal is needed to clear accumulated debris and any overgrown vegetation upstream and downstream of the existing culverts crossing Finona Street. It is also recommended that an additional 100 linear feet of 24" RCP be placed adjacent to the existing dual 24" RCP culverts to improve capacity and the upstream and downstream headwalls be replaced with new headwall/wingwall structures accomodating all 3 culverts with 100 SF rip rap placed on the upstream and downstream sides. Downstream, approximately 1000-ft of concrete channel outleting to the Umatic River through a 100 sq ft rip rap energy dissipator is recommended.

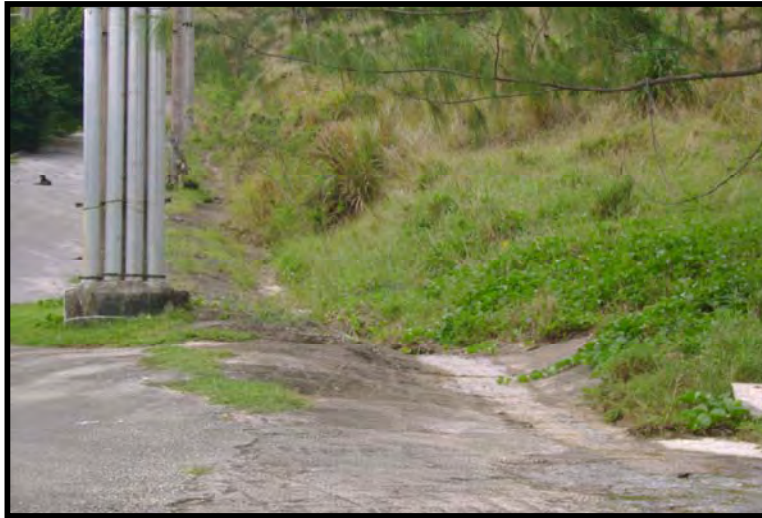
UM-104

SITE ASSESSMENT: There is an existing cross-gutter routing runoff upstream from Finona St and crosses Jose A Quintana St, and discharges to the west of Fiona St which outlets into the Umatac river. This cross-gutter has a non defined configuration, it needs to be replace with a cross gutter that has a defined alignment and cross section that will be capable of routing flow as intended.

RECOMMENDED IMPROVEMENTS Improvements to the strom drain system at Finona Street and Jose A Quintana Street are needed. Recommend replacement of the cross-gutter located at the site with one that has a defined alignment and cross section capable of routing the expected flow. A 1,000 linear foot concrete ditch needs to be constructed leading to a 100 square foot rip rap energy dissipator to satisfy these needs.

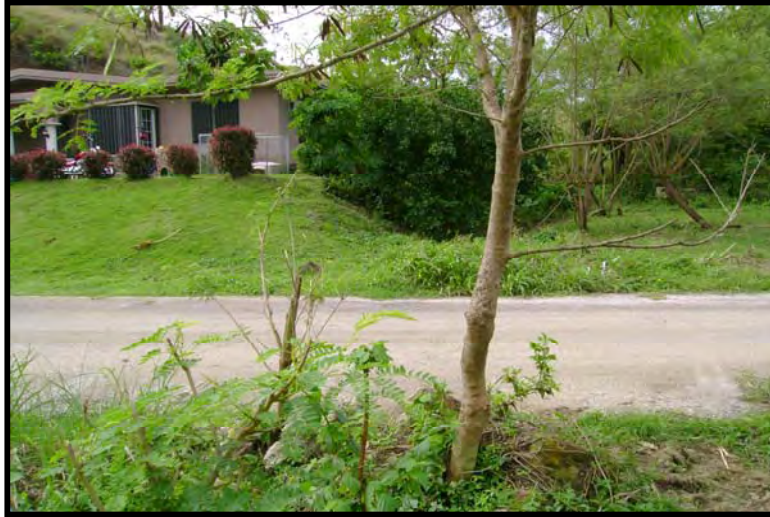
UM-105

LOCATION: Jose A Quintana St & Finona St

RECOMMENDED IMPROVEMENTS To prevent further erosion of the channel embankments and sedimentation of the existing culverts, erosion control and conveyance maintenance and improvements are required. The existing culvert under Jose A Quintana St. should be replaced with a larger 30" culvert (approximately 100- feet long) equipped with upstream and downstream headwall/wingwall structures with 100 SF rip rap energy dissipation placed on the downstream side. One quarter acre debris/ sediment removal will be required as part of the improvements.

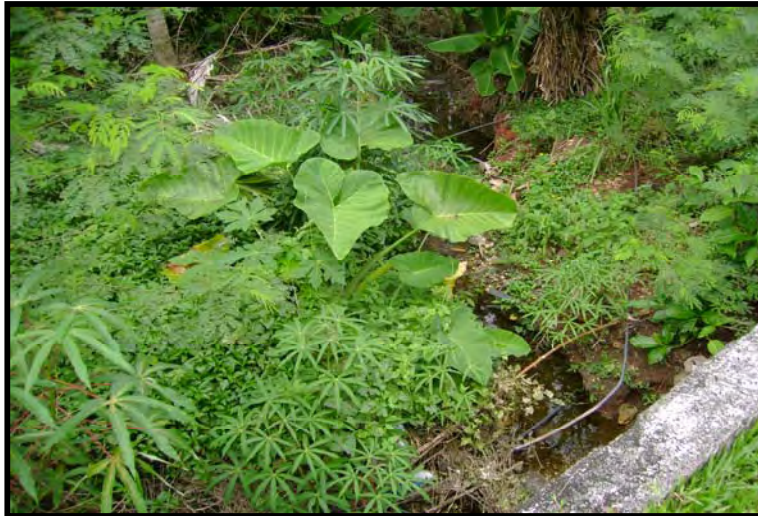
UM-106

LOCATION: RT 2 & Jagar Dr

RECOMMENDED IMPROVEMENTS Recommend modification of the 2 drainage systems located at Route 2 and Jagar Drive in order to minimize future flooding of homes located west of Route 2. Improvements would include abandonment of the existing 36" RCP under Rte 2, placement of a new 36" RCP (estimated at 200 LF in length) under Jagar Drive at its intersection with Route 2 (routing flow northerly along the east side of Rte 2). The outlet of the new 36" RCP would be adjacent to the outlet of the existing 30" RCP that runs diagonally under Jagar Drive. Recommend replacement of the outlet structure with a new, larger headwall/wingwall stucture that can accomodate the 30" and 36" RCP. Recommend replacement of the downstream ditch (conveying flow northerly to the Umatac River) with a concrete trapezoidal channel (estimated at 100 feet in length) and a 100 sq ft rip rap energy dissipator located at the outlet of the concrete ditch. A quarter acre of debris removal is also needed to clear out debris and vegetation that have accumulated around the upstream and downstream headwalls of the existing culverts. A headwall/wingwall structure will also be required at the upstream end of the new 36" RCP culvert.

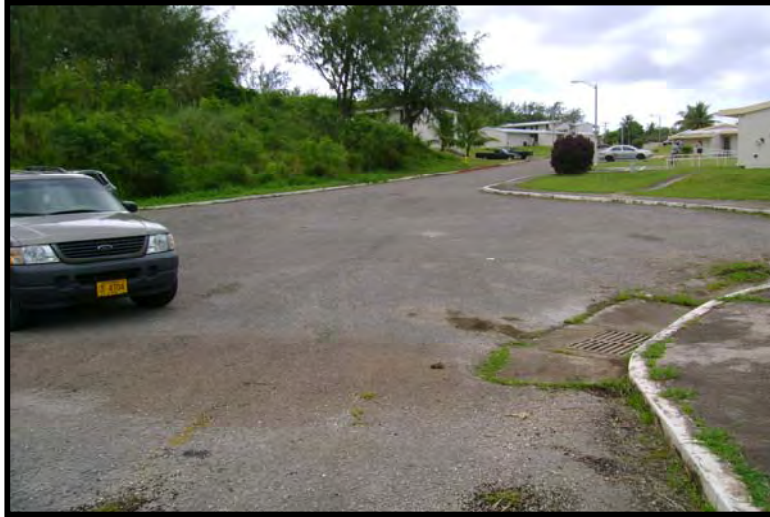
UM-107

LOCATION: Road A

RECOMMENDED IMPROVEMENTS Place a storm drain system at the cul de sac of Road A consisting of 4 catch basins connected by 150 LF of 12" - 24" RCP, outleting to 1000' of concrete ditch that routes flow around the existing homes in an existing drainage easement. A culvert may be required at the downstream end of the channel (assume 50' of 24" RCP equipped with headwall/wingwall structures). This system will ultimately route the flow to the system at Jagar Drive.

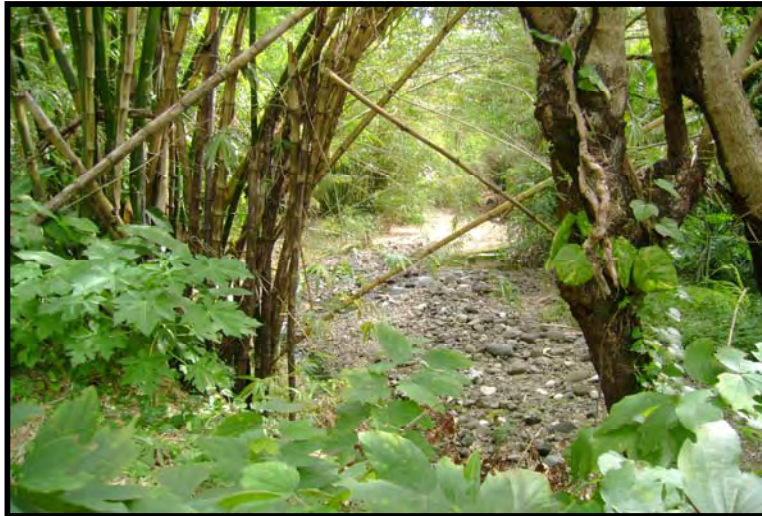
UM-108

LOCATION: Jose Q Aguon St & Laelae River

RECOMMENDED IMPROVEMENTS To prevent further encroachment of the Laelae River into Jose Q Aguon Street, maintenance consisting of a quarter acre of debris removal along with installation of 1,000 square feet rip rap channel stabilization along the river embankment is recommended.

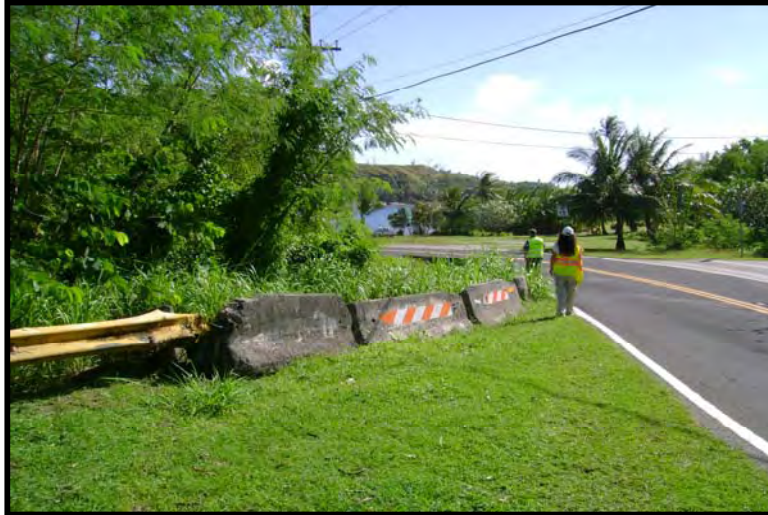
UM-109

LOCATION: RT 2

RECOMMENDED IMPROVEMENTS One acre of debris removal is needed to clear out accumulated debris and the overgrown vegetation. Embankment stabilization of the channel upstream and downstream of the existing culvert under Rte 2 is needed for a distance of 200 linear feet downstream (requiring approximately 4000 sq ft of rip rap stabilization) and about 50 linear feet upstream (requiring approximately 1,000 square feet of rip rap stabilization).

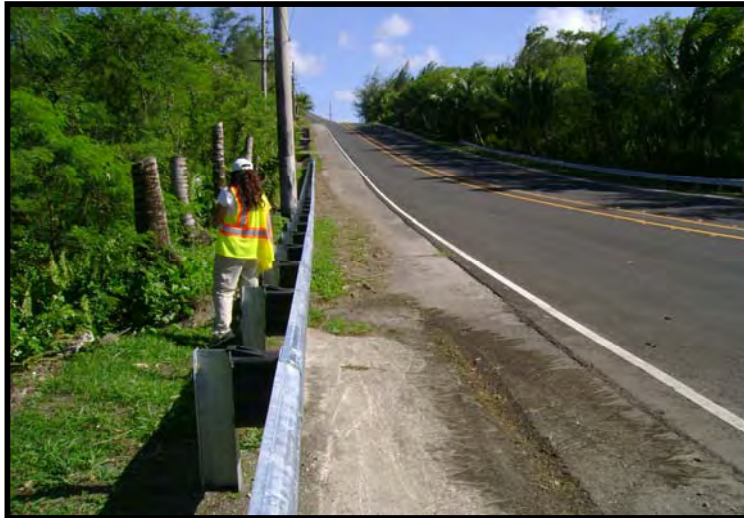
UM-110

LOCATION: RT 2 & La Sa Fua River

RECOMMENDED IMPROVEMENTS Recommend placement of four AC spillways along Route 2 with approximately 100 SF of rip rap stabilization placed downstream of the spillways for energy dissipation. The additional spillways and stabilization will prevent further erosion and flooding of the road at the outlet to the La Sa Fua River.

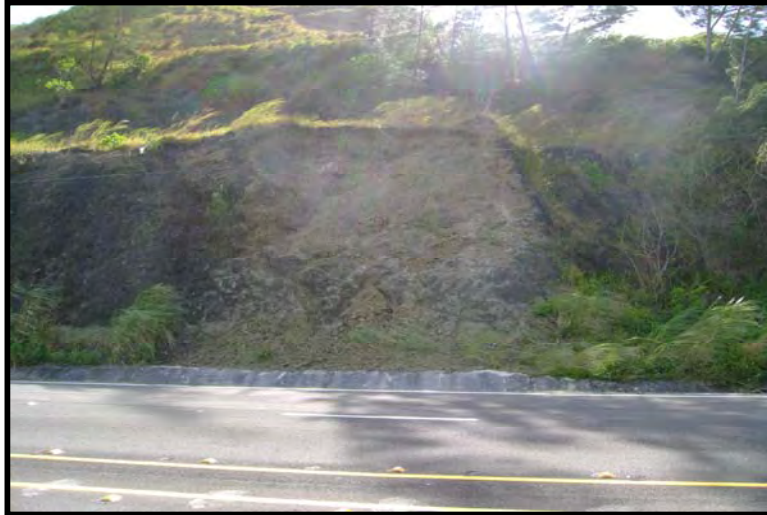
UM-111

LOCATION: RT 2 & Observation Rest Area

RECOMMENDED IMPROVEMENTS Recommend placement of hydroseed w/ a bonded fiber matix over approximately 1 acre of the hillside where groundcover does not exist in an effort to control mass erosion along the hillside.

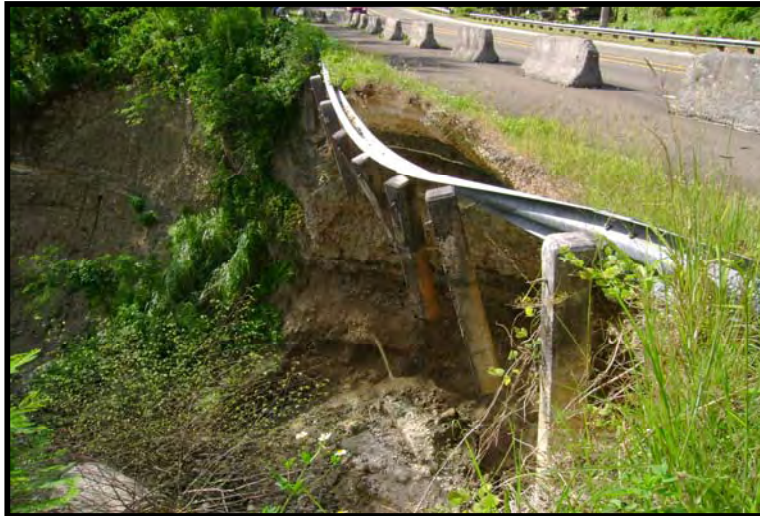
UM-112

LOCATION: RT 2 & Cetti River

RECOMMENDED IMPROVEMENTS To prevent further undermining of the roadway over the Cetti River, erosion control and conveyance maintenance and improvements are required. Existing culverts must be extended to a stabilized embankment. For cost estimating purposes, the extension is estimated at 200-feet and the culvert size is estimated at 5- 48" diameter pipelines. For embankment stabilization, placement of 8000 sq ft of gabions and 1000 sq ft of rip rap at the bottom. An outlet structure (headwall and 2 wingwalls) has also been included.

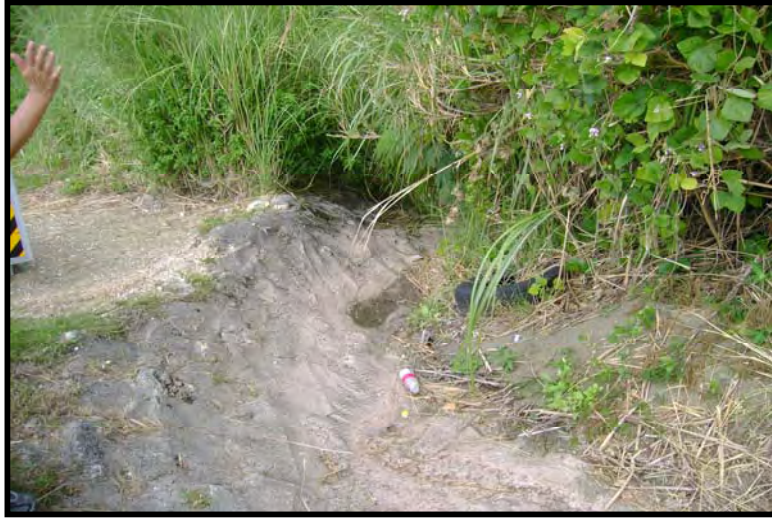
UM-113

SITE ASSESSMENT: A cross culvert under Route 2 routes runoff from a tributary to the Sella River. This cross culvert is in good condition, and no erosion issues are visible; it only needs vegetation removal to prevent any clogging.

RECOMMENDED IMPROVEMENTS To prevent future clogging of the cross culvert at this site it is recommended that a quarter acre of debris/ sediment be removed to promote proper drainage.

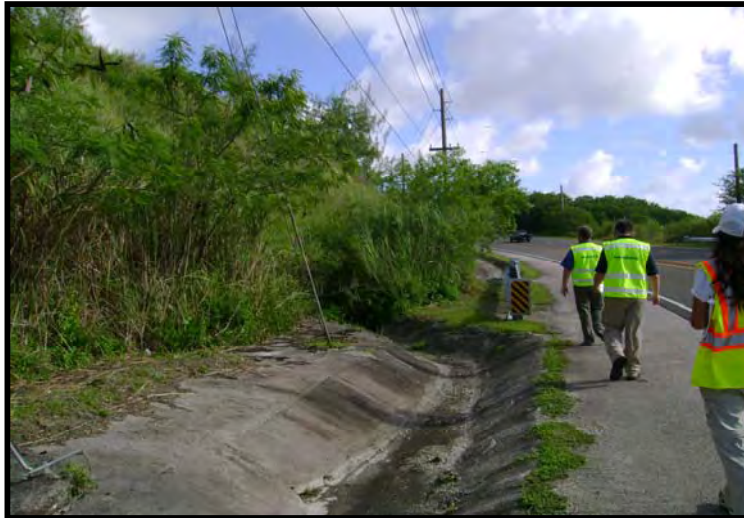
UM-114

SITE ASSESSMENT: A 48" RCP cross culvert routes Sella River flow under Route 2 towards Sella bay. The cross culvert and Headwall/wingwalls are in good condition. Vegetation removal is needed to prevent any debris accumulation and clogging.

RECOMMENDED IMPROVEMENTS To prevent future clogging of the cross culvert at this site it is recommended that a quarter acre of debris/ sediment be removed to promote proper drainage.

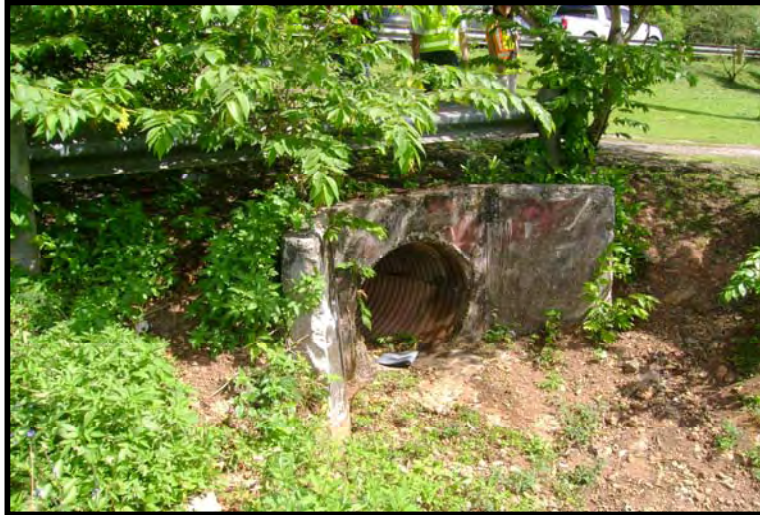
YI-101

LOCATION: RT 9

RECOMMENDED IMPROVEMENTS To prevent further flooding of neighboring properties at this site, approximately 1,000 square feet of debris removal along the downstream side of the culvert (on airforce base property) is needed along with drainage improvements at the culvert inlet including the addition of a headwall and two wingwalls with a 100 square foot rip rap energy dissipator.

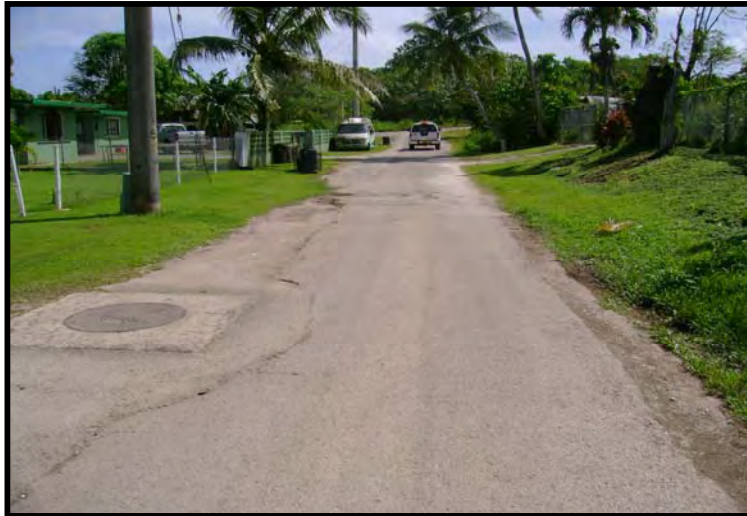
YI-102

SITE ASSESSMENT: This is a low point along the street where ponding creates the flooding of 5-9 properties. There are no existing drainage systems at this location. The solution will be to add infiltration trenches along the street at the lowest location, on both sides of the street.

RECOMMENDED IMPROVEMENTS To prevent further flooding of properties, two 200 linear foot infiltration basins are recommended for construction along the crowned street at its low point.

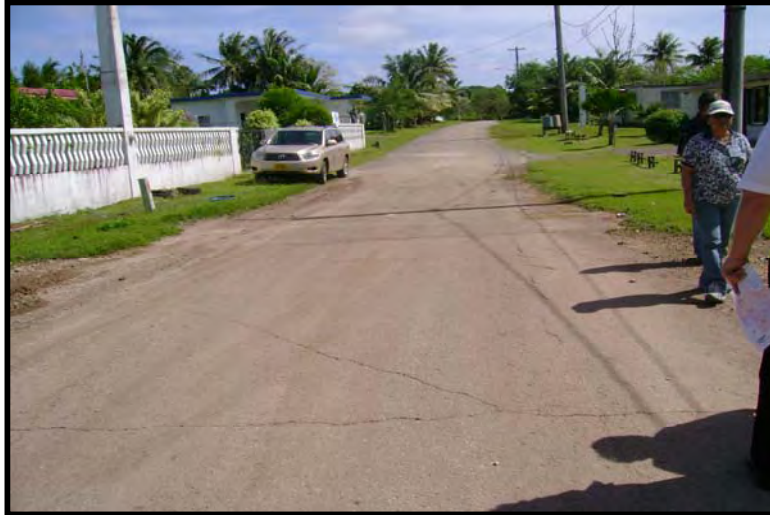
YI-103

SITE ASSESSMENT: This is a low point along the street where ponding creates the flooding of 5-9 properties. There are no existing drainage systems at this location. The solution will be to add infiltration trenches along the street at the lowest location, on both sides of the street.

RECOMMENDED IMPROVEMENTS To prevent further flooding of properties, two 200 linear foot infiltration basins are recommended for construction along the crowned street at its low point.

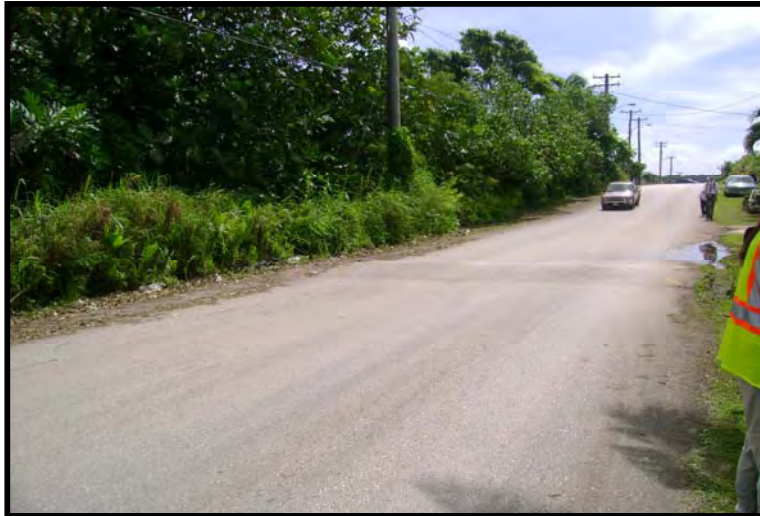
YI-104

SITE ASSESSMENT: This is a low point along the street, thus creating ponding and flooding of one property. There are no existing drainage systems at this location. A possible solution will be to add infiltration trenches along the street at the lowest location, on both sides of the street.

RECOMMENDED IMPROVEMENTS To prevent further flooding of properties, two 200 linear foot infiltration basins are recommended for construction along the crowned street at its low point.

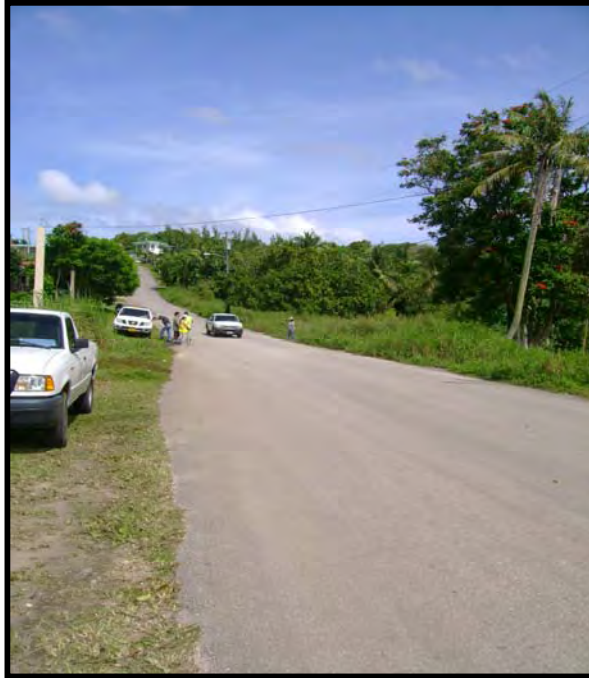
YI-105

SITE ASSESSMENT: This is a low point along the street thus creating ponding and flooding 2-4 properties. There are no existing drainage systems at this location. A possible solution will be to route the flow via a conveyance drainage system to an existing infiltration behind a school's football field, an easement will be needed to run the conveyance line through a private property.

RECOMMENDED IMPROVEMENTS To prevent further flooding of properties at this site, construct a storm drain system consisting of 2 catch basins (placed at the low point of the crowned road) connected by approximately 100 linear feet of 24" RCP routing flow to a drainage ditch approximately 1000 feet in length to an existing infiltration basin located adjacent to a school yard (requiring an easement along the edge of a private property). Place a 100 sq ft rip rap energy dissipator at the outlet to the infiltration basin.

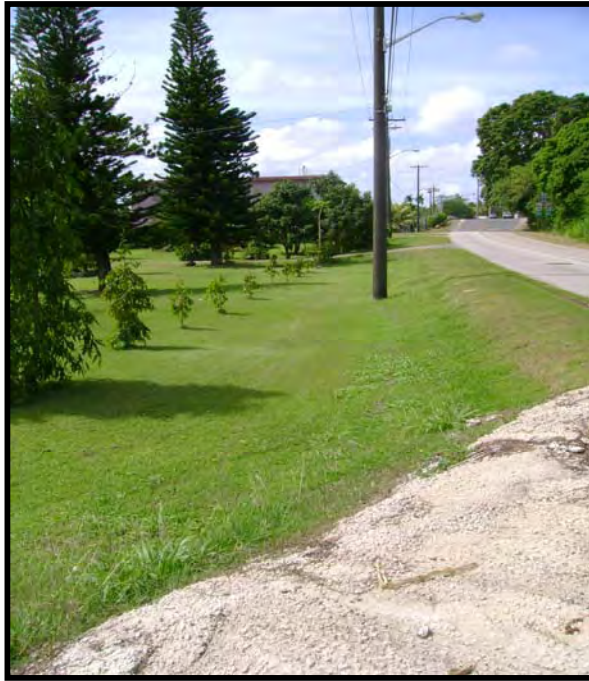
YI-106

LOCATION: RT 29 & Chalan tun Jose Anaco

RECOMMENDED IMPROVEMENTS To prevent further flooding of properties at this site, construct a storm drain system consisting of 2 catch basins (placed at the low point of the crowned road) connected by approximately 200 linear feet of 24" RCP routing flow along the edge of a private property (requiring an easement) to outlet to a sink located behind the property. The outlet shall include a headwall and approximately 1/4 acre of debris removal will be needed for construction and to promote drainage.

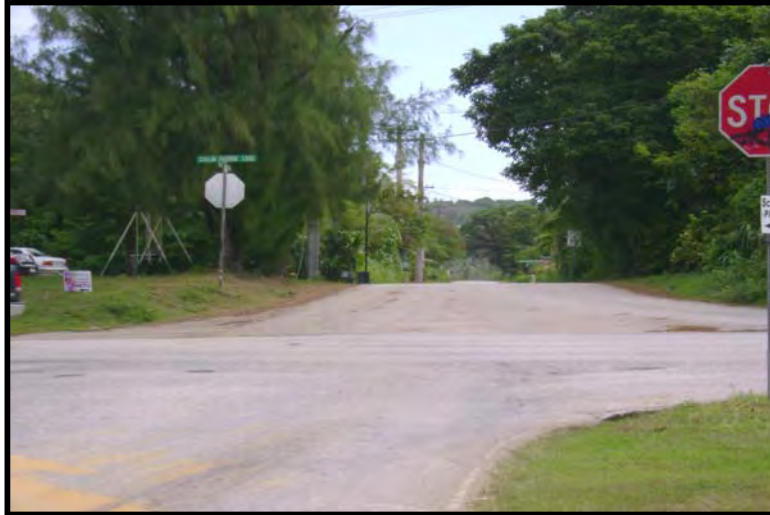
YI-107

SITE ASSESSMENT: At this intersection all four corners flood, and possibly one property. No existing drainage conveyance systems. Add infiltration trenches along both streets.

RECOMMENDED IMPROVEMENTS To prevent further flooding of properties, two 200 linear foot infiltration basins are recommended for construction (one along each street at its low point).

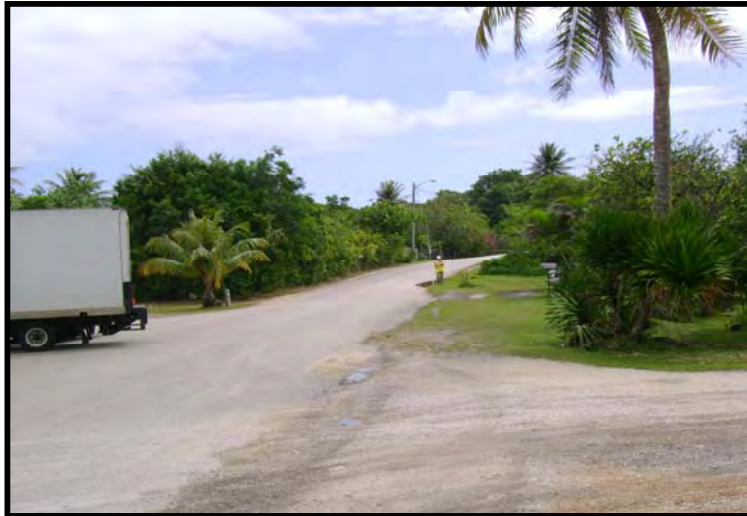
YI-108

SITE ASSESSMENT: There is a low point along Tun Luis Duenas Rd where a home gets flooded. Need to add infiltration trench to prevent ponding, will need to acquire r/w.

RECOMMENDED IMPROVEMENTS To prevent further flooding, one 200 linear foot infiltration basin is recommended for construction along the street at its low point.

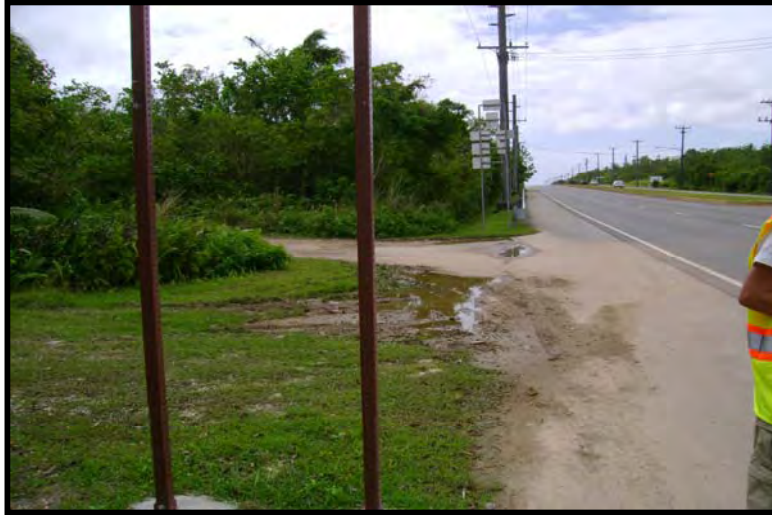
YI-109

LOCATION: RT 1 & Chalan Chamorri

RECOMMENDED IMPROVEMENTS To prevent further flooding, one 200 linear foot infiltration basin is recommended for construction along the street at its low point.

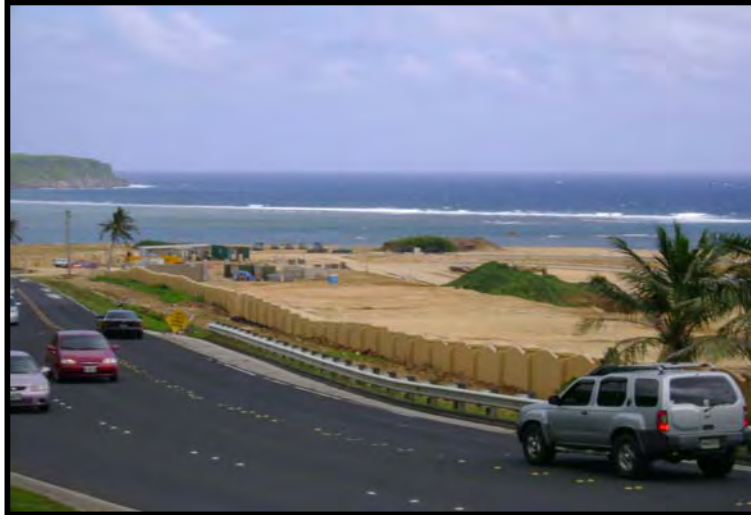
YO-101

LOCATION: RT 4

RECOMMENDED IMPROVEMENTS Recommend improvements to the existing stormwater pollution prevention strategy for this existing construction site in the form of 1 acre of hydromulch and 2000 LF of silt fence to prevent sediment from entering downstream waters.

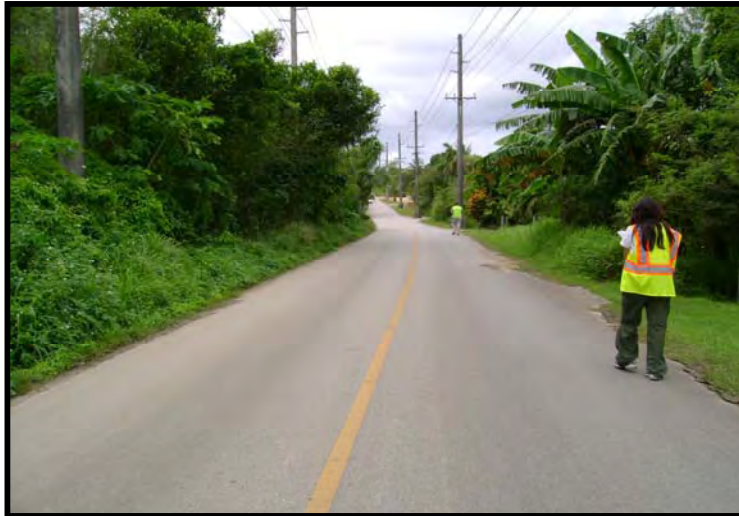
YO-102

LOCATION: Chalan Telefofo

RECOMMENDED IMPROVEMENTS Recommend placement of a storm drain system along the road. Place 2 catch basins at low point, connected by 100 LF of 24" RCP outleting to natural drainage path through a headwall/wingwall structure equipped with a 100 SF rip rap energy dissipator.

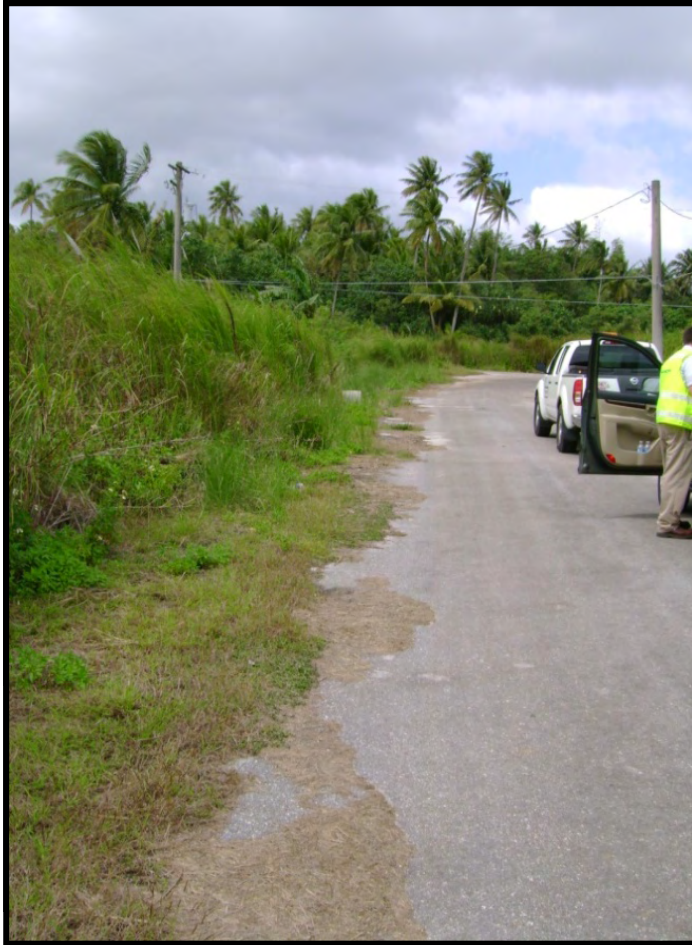
YO-103

LOCATION: Jesus Santos Rd

RECOMMENDED IMPROVEMENTS Recommend placement of a storm drain system along the road. Place 2 catch basins at low point, connected by 400 LF of 24" RCP outleting to an existing infiltration system located at the end of the street. Equip outlet with

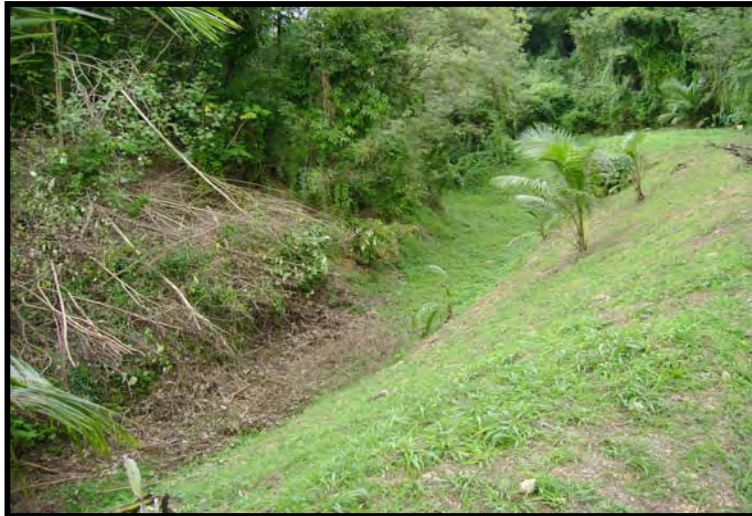
YO-104

LOCATION: Balajadia Rd

RECOMMENDED IMPROVEMENTS Recommend placement of a storm drain system along the road. Place 2 overside drains (AC spillways) at low points in road, each outletting to a 100 SF rip rap energy dissipator at bottom of embankment.

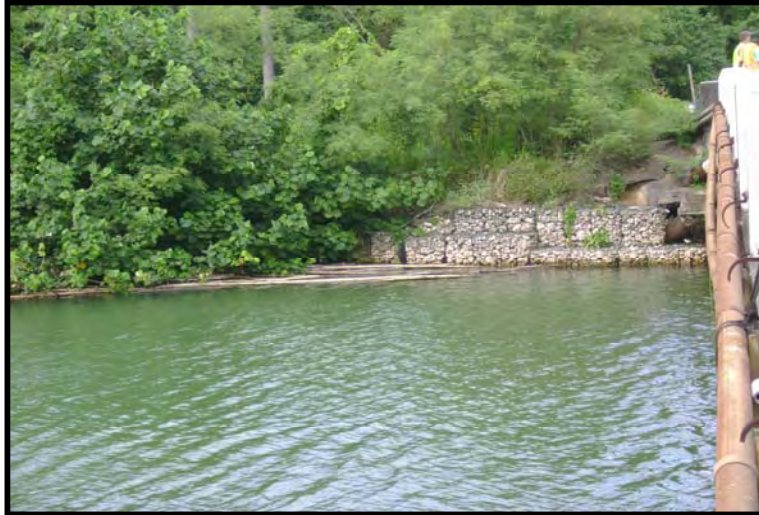
YO-105

SITE ASSESSMENT: Ylig bridge, undermining of approach slabs on both north and south embankments. Need to add more gabions to approach slabs embankments, north section is in worse conditions.

RECOMMENDED IMPROVEMENTS Embankment stabilization is needed in the vicinity of the bridge approach slabs. Recommend the placement of approximately 400 sq ft of gabions along the north and south embankments and 500 sq ft of rip rap at the bottom of each embankment. A quarter acre of debris removal is required for maintenance.
